ATSB TRANSPORT SAFETY REPORT

Aviation Occurrence Investigation –AO-2008-001

Elevator balance tab failure

VH-OZX

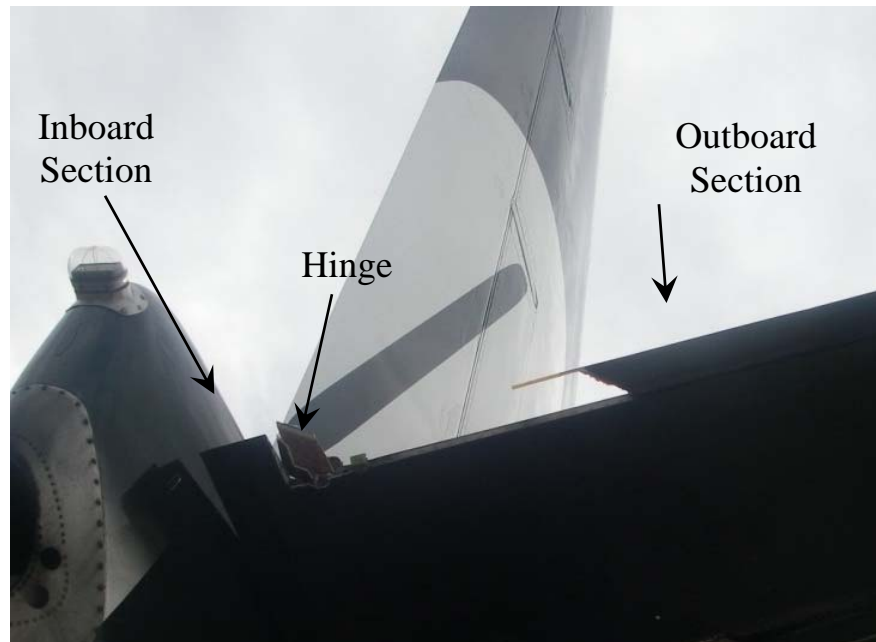
A subsequent examination of the aircraft found that a section of the right elevator balance tab had detached and was missing from the aircraft (Figure 1).

Figure 1: Right elevator balance tab section detached

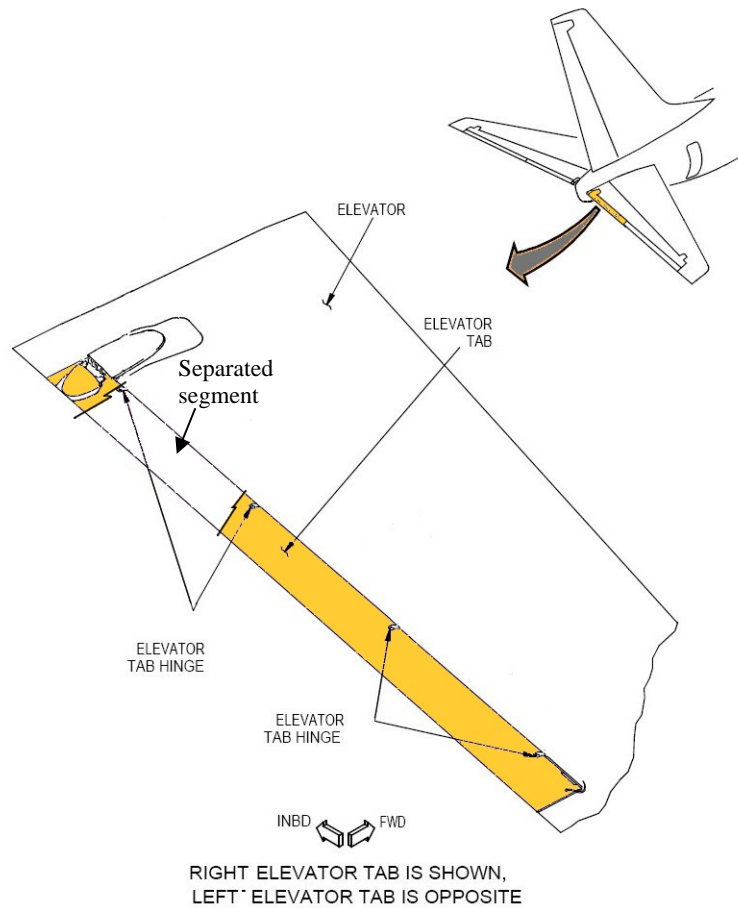
Figure 2: Elevator balance tab

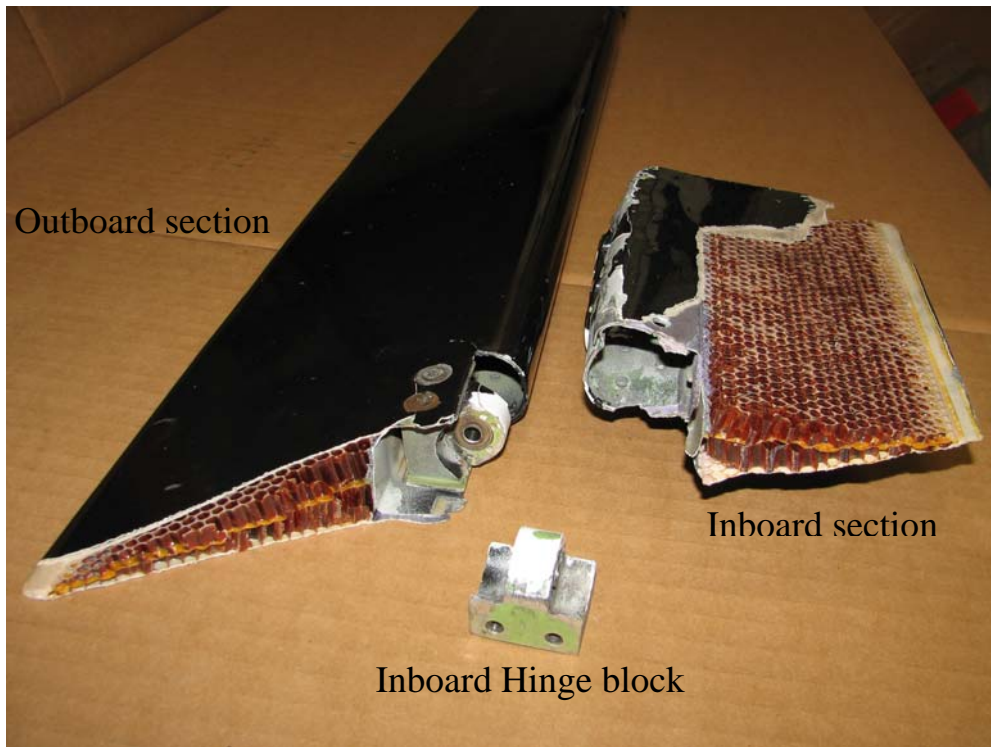
The ATSB examination of the recovered parts of the failed balance tab found that the upper skin of the outboard balance tab section was intact to the edge of the fracture, with the lower skin having peeled away slightly from the honeycomb core. The skin around the hinge cut-out, adjacent to the missing section, showed a crack extending from the corner of the cut-out.

Figure 3: Sections of elevator balance tab

Subsequent examination of the elevator balance tab sections showed that the fracture origins were associated with the leading edge of the hinge cut-outs. Despite the predominantly adhesive failure between the skin and the honeycomb core, there was no evidence of poor adhesive coverage or indication that the bond had failed prematurely. Therefore, it is probable that the initial failure was at the elevator balance tab hinge points.

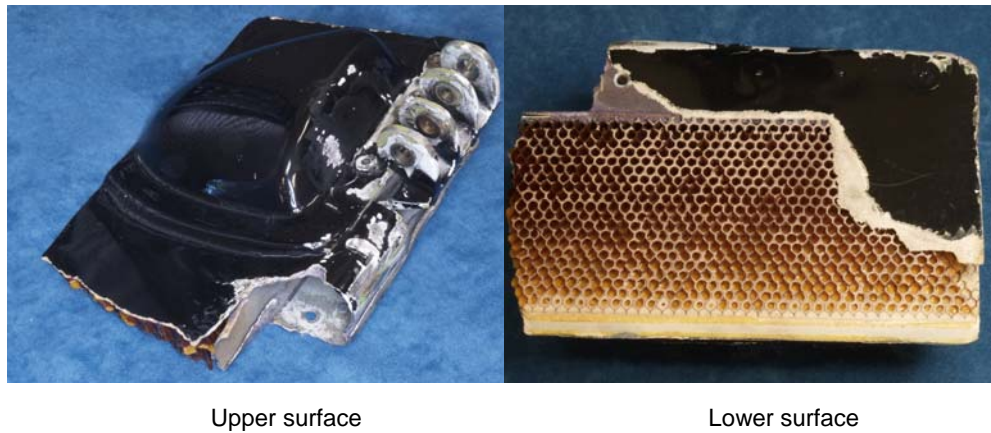
The fracture of the inboard balance tab section extended through a cut-out in the leading edge for the location of the inboard hinge fitting. The fibreglass skin was intact up to the edge of the fracture on the upper surface, but the majority of the skin had separated from the lower surface (Figure 4).

Figure 4: Inboard tab section

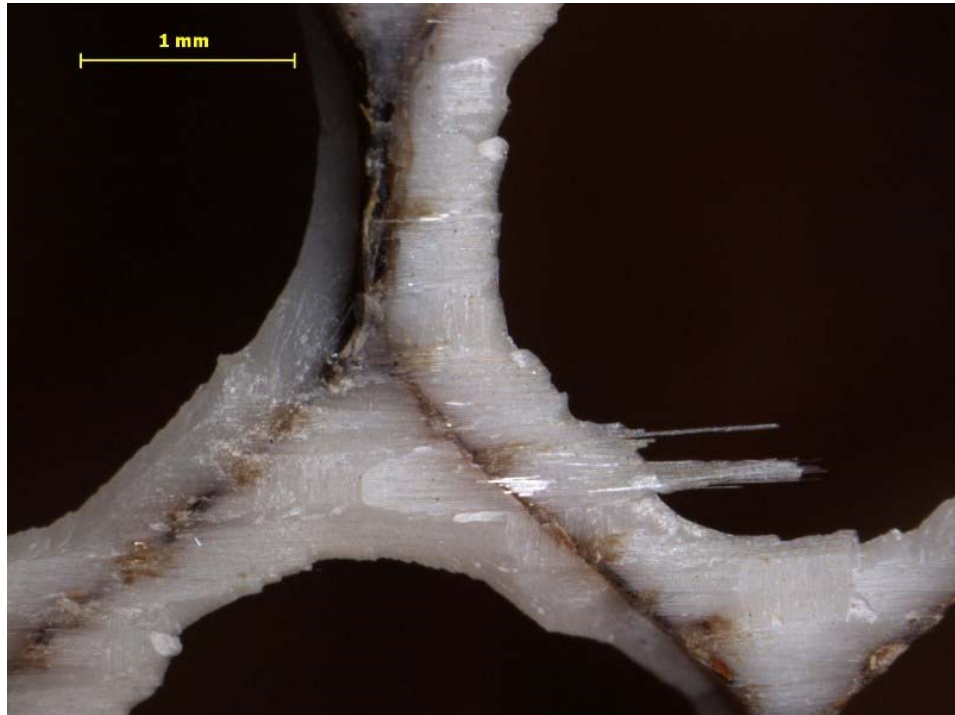
The adhesive between the skin and honeycomb core had remained bonded to most of the core surface. However, in some areas, the adhesive had separated from the honeycomb cell walls, indicative of an adhesive failure⁴. The adhesive appeared to be uniform across the core surface, with no evidence of un-bonded regions visible. Microscopic examination of the adhesive surface revealed an impression of the

fibreglass weave, which was also indicative of a predominantly adhesive failure (Figure 5).

Figure 5: Fibreglass weave pattern in adhesive

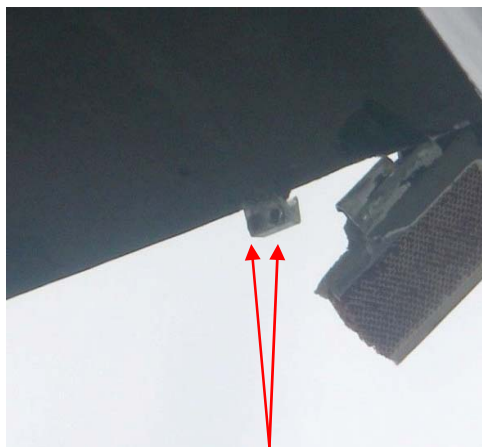
The inboard hinge fitting appeared to have separated from the inboard tab section adjacent to the fracture through the honeycomb. Two screws were engaged in the underside (Figure 6), but the corresponding screws from the upper side were missing. It was reported that these screws were not present when the hinge was removed from the aircraft. An examination of the sectioned hinge and thread insert found the thread insert to be in good condition (Figure 7).

Screws on lower surface visible

Two upper hinge screws were missing from the inboard hinge block when the remaining elevator tab sections were removed from the aircraft. The inboard hinge block thread inserts were found to be in good condition and showed no evidence of the attaching screws being removed by force. As a result, the most likely scenario for the elevator balance tab failure was that, at some point during operation, the upper tab hinge screws had loosened and 'backed out' of the hinge block. The liberation of the upper hinge screws led to structural weakness and cracking of the elevator tab upper skin at the hinge cut-outs in the tab leading edge. That resulted in the vibration experienced and subsequent failure of the elevator balance tab.

Although not identified as a safety issue, as a result of the accident, the operator implemented a 'fleet campaign directive' requiring the immediate accomplishment of service bulletin (SB) SB737-55A1070 Revision 3 on all of its aircraft.

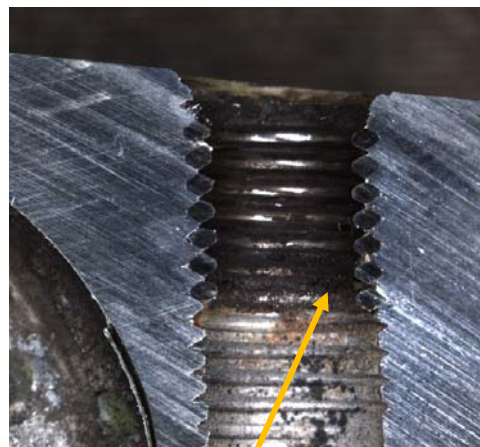
Figure 7: Inboard hinge sectioned

Thread insert
