Jan10/ATSB49

Ditching – Norfolk Island – 18 November 2009

Abstract

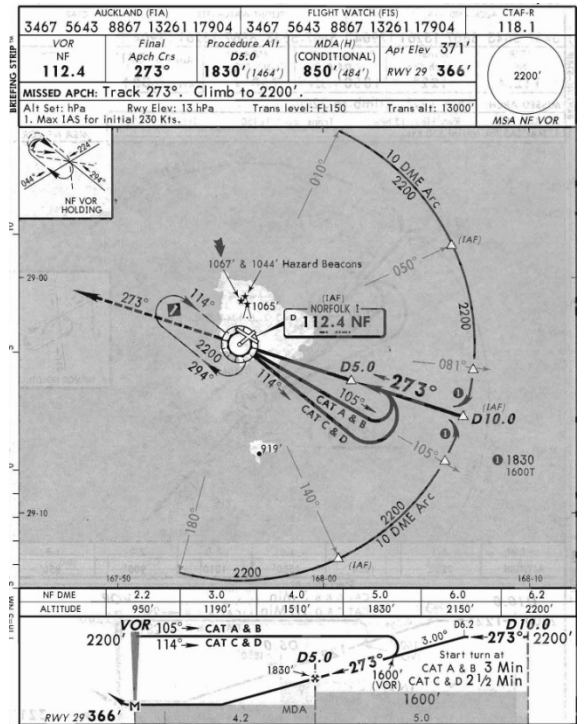
Figure 1: Runway 29 VOR/DME instrument approach procedure

Upon arrival at Norfolk Island, the copilot conducted a very high frequency omnidirectional radio range/distance measuring equipment (VOR/DME) instrument approach procedure⁶ for a landing on runway 29 (Figure 1). However, the flight crew was not 'visual' at the missed approach point,^{7,8} and a missed approach was carried out at 1004. At that time, it was dark and raining with low cloud and poor visibility.

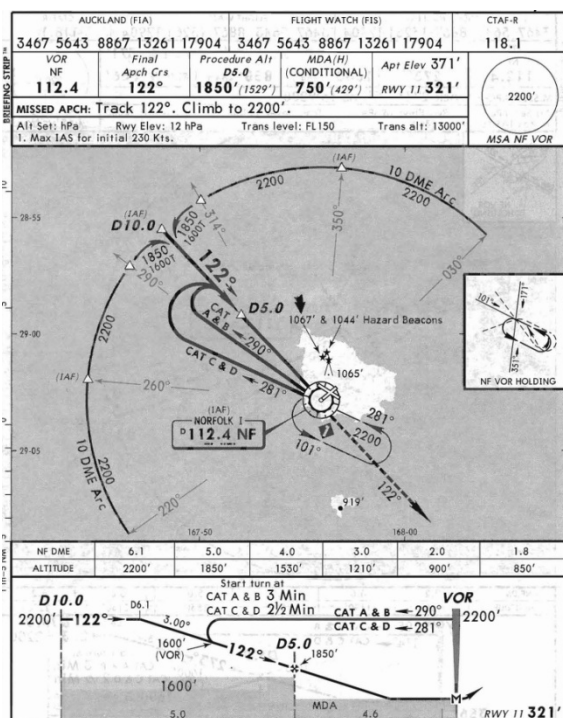
Figure 2: Runway 11 VOR/DME instrument approach procedure

The flight crew then repositioned to conduct a VOR/DME instrument approach for landing on runway 11. The runway 11 instrument approach procedure permitted the crew to descend 100 ft lower than the runway 29 approach before acquiring visual reference with the runway (Figure 2).

The crew did not gain visual reference with runway 11 and conducted a third missed approach at about 1019, before reporting to Norfolk Unicom that they were planning to ditch because the aircraft was running out of fuel. The crew then conducted a third instrument approach for runway 29 (four approaches in total), but again did not visually acquire the runway.

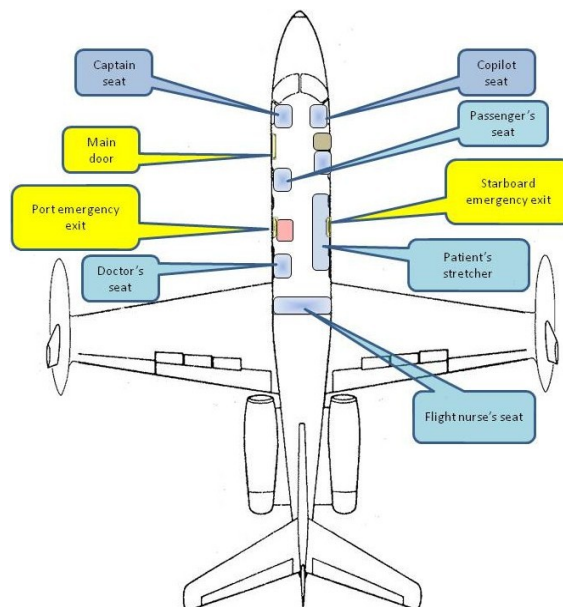
Figure 3: Seating positions

The aircraft's seating configuration included two flight crew seats, a passenger's and doctor's seat on the left of the cabin, the patient's stretcher and an unused passenger seat on the right of the cabin, and the flight nurse's seat across the rear of the cabin (Figure 3).

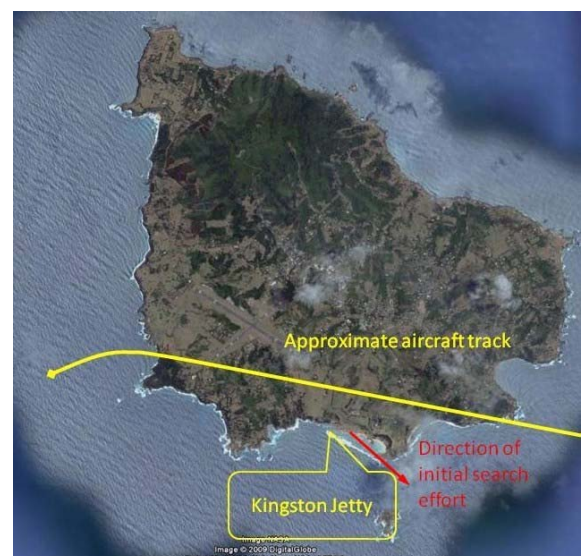
Figure 4: Approximate runway 29 VOR/DME final approach and overshoot track (Kingston Jetty highlighted)

The Norfolk Unicom operator had alerted the Norfolk Island emergency response agencies to a local standby condition when the weather first deteriorated to the extent that the Unicom operator felt it might be difficult for an aircraft to land. The Unicom operator subsequently initiated a deployment of the emergency services following the aircraft's second missed approach. In addition, two local boat owners prepared to launch their fishing vessels at Kingston Jetty to search for the ditched aircraft and its occupants (Figure 4).
