ATSB TRANSPORT SAFETY REPORT
Aviation Investigation AO-2009-077
Preliminary

Collision with terrain Dorrigo, NSW 9 December 2009

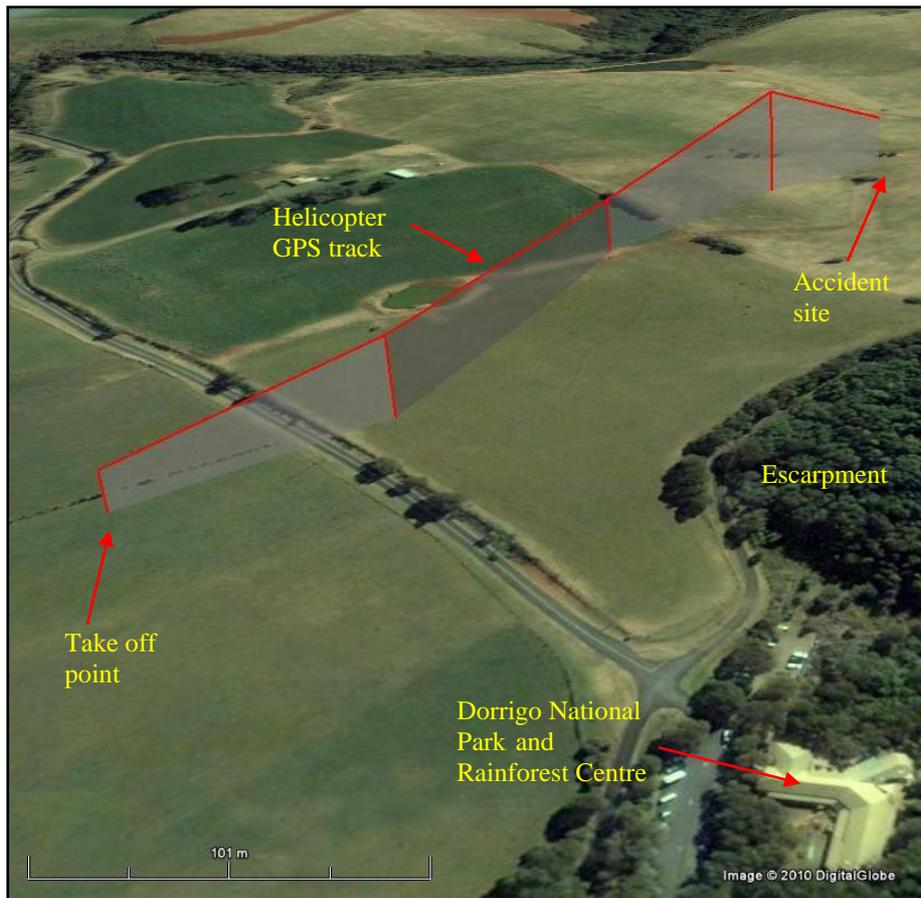
Figure 1: Helicopter GPS track

The pilot attempted to maintain a neutral hover in the expectation of regaining adequate visibility to land, however, the helicopter was inadvertently moving to the north at a slow speed (Figure 1). The pilot stated that he then saw trees and a spur line through the cloud and that the helicopter appeared to be in a sideways crab motion to the left. With limited visual reference, the pilot attempted to land, however, the helicopter impacted the ground with significant vertical force and came to rest on its right side (Figure 2).

The helicopter was fitted with a Garmin 296 Global Positioning System (GPS). The GPS was taken to the Australian Transport Safety Bureau (ATSB) technical facilities where its stored data was successfully downloaded. The data showed the helicopter's movements on the day of the accident. The information included time and date, latitude, longitude and altitude position which was recorded at distance intervals of 0.1 NM (185 m). The GPS recorded five positions during the accident flight and the information was overlaid on a Google Earth map of the area³ (Figure 1). The duration of the flight, not including start up and static hover, was approximately 1 minute and 20 seconds. During that time, the helicopter travelled a distance of approximately 550 m.

³ The GPS recorded 5 positions during the period of the accident flight, the red line depicting the helicopter's flight path, while reasonably accurate at the points recorded, does not accurately illustrate the position of the helicopter at any point between the recorded locations.

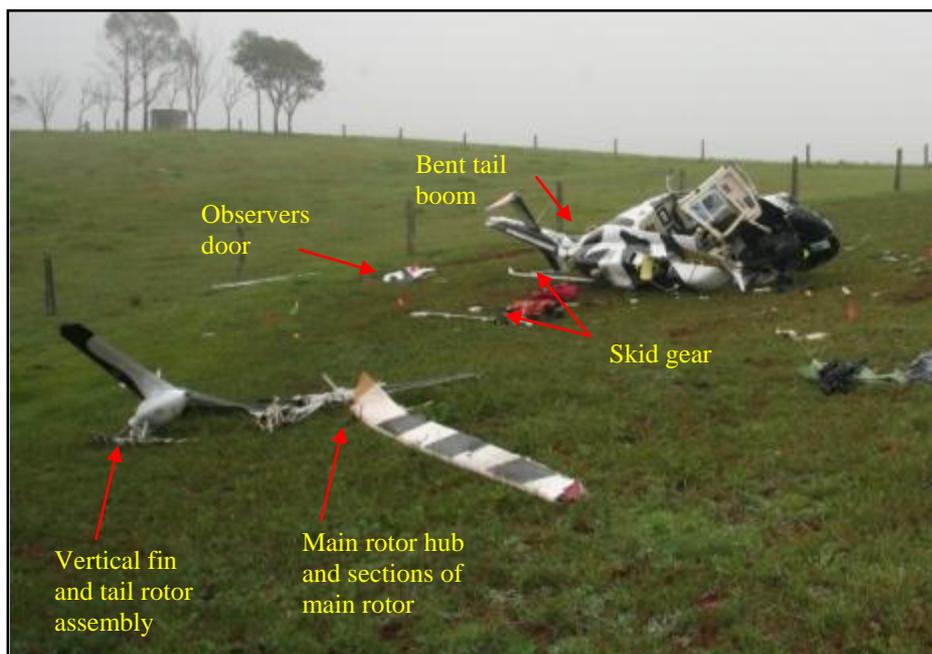
Figure 2: Accident site

The helicopter was seriously damaged⁴ by impact forces (Figure 2). Examination of the wreckage showed that the vertical fin assembly, main rotor assembly, skid gear and observer's side door had separated from the helicopter during the accident sequence. The tail boom showed signs of downward bending and the skid gear cross tubes had been rotated and splayed, indicating a high vertical decent rate at impact. The lack of ground impact marks outside the immediate wreckage area also indicated a low forward velocity when the helicopter impacted the ground. The extent of damage observed on the main rotor blades indicated that the engine was operating at impact.
