ATSB TRANSPORT SAFETY REPORT

Aviation Occurrence Investigation – AO-2008-046

Airframe event
Orange aerodrome, NSW
6 July 2008
SAAB SF340B VH-ZLC

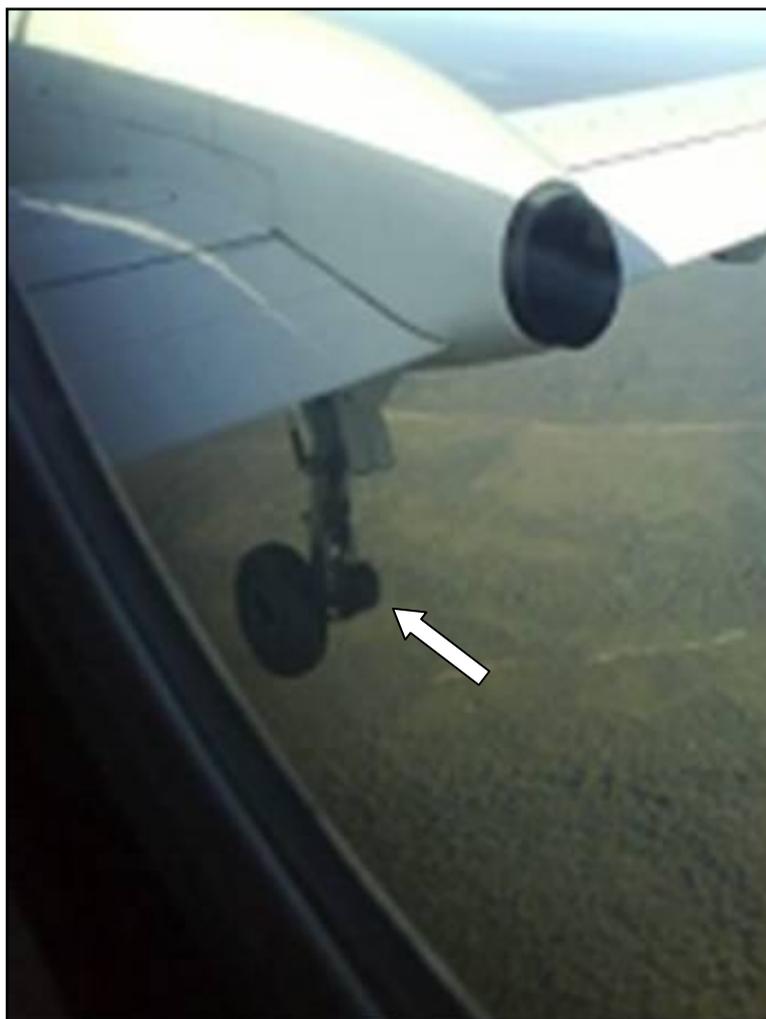
The landing gear was lowered approximately 25 nm out from Sydney and was inspected by the passenger-first officer from a main cabin window (Figure 1). It was reported to the crew that the wheel was missing but no further damage was evident.

Figure 1: Right landing gear as observed from cabin. Location of the missing outboard wheel is arrowed.

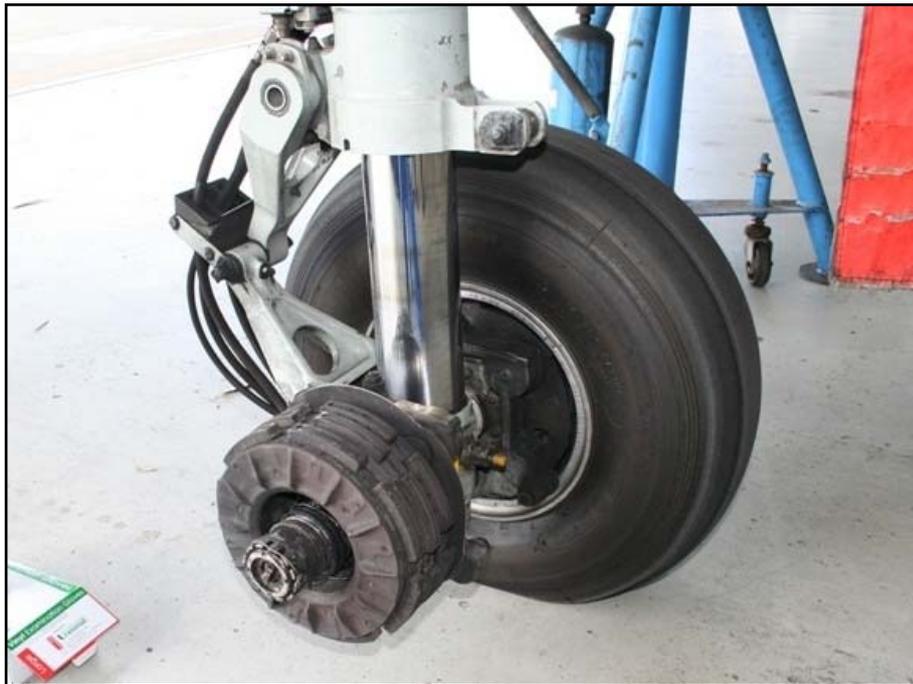
Figure 2: Right main landing gear

Figure 2 shows the right landing gear. The wheel nut was bolted and lock-wired in place, retaining the remains of the bearing cones, cages and seals. Removal of these components revealed minor damage to the axle from contact with the wheel assembly. There appeared to be no damage to brake lines or surrounding components.

A significant amount of grease and metal debris was observed at the back of the brake assembly. Several bearing rollers were found embedded in the grease. The brake assembly also exhibited marks consistent with wheel contact, including evidence of abrasion on the inside of the brake hub.

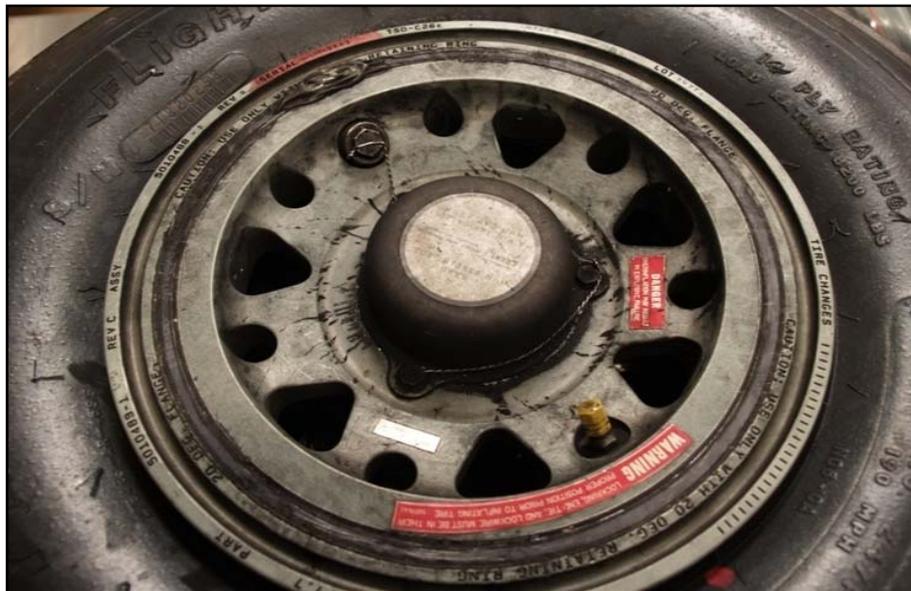
Figure 3: Right outboard wheel, as recovered

The wheel was recovered with the tyre inflated and the hub cap lock-wired in place. There was evidence of grease splatter on the surface of the wheel from underneath the hub cap (Figure 3).

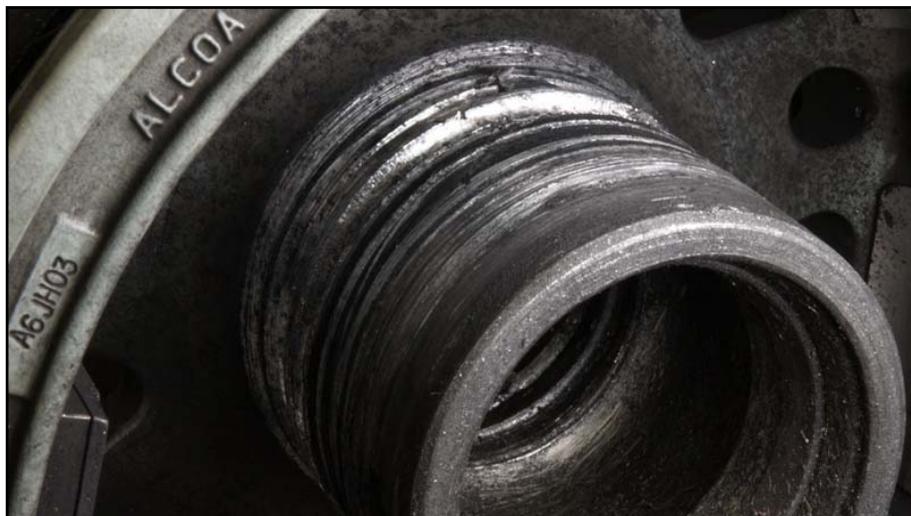
Figure 4: Wheel hub damage

Deep gouging was present on the outside of the hub, consistent with heavy contact against the brake assembly (Figure 4). The inside wall of the wheel hub and hub cap was coated with a thin layer of grease and metal debris. The wheel hub was also scored in the areas around the outboard bearing cup as a result of the bearing breakdown.

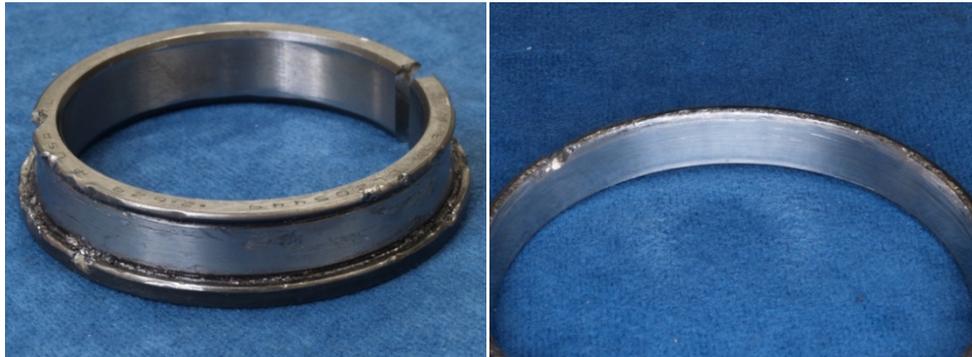
Figure 7: Inboard bearing cone and cup

The inboard and outboard cone assemblies were not intact (Figures 7 and 8). Both cones showed evidence of impact damage on the cone ribs that was likely caused by bearing breakdown and contact with liberated rolling elements. The inboard cone also showed impact marks on the rolling surface which were secondary to the bearing failure. The outboard bearing cone exhibited extreme metal smearing and heat discoloration.

Both bearing cups were present in the wheel hub, with the outboard cup exhibiting metal smearing and damage associated with heavy wear. The inboard cup was in reasonable condition with the surface showing light scoring and secondary contact damage with the cone assembly. The outboard cup showed evidence of metal smearing.

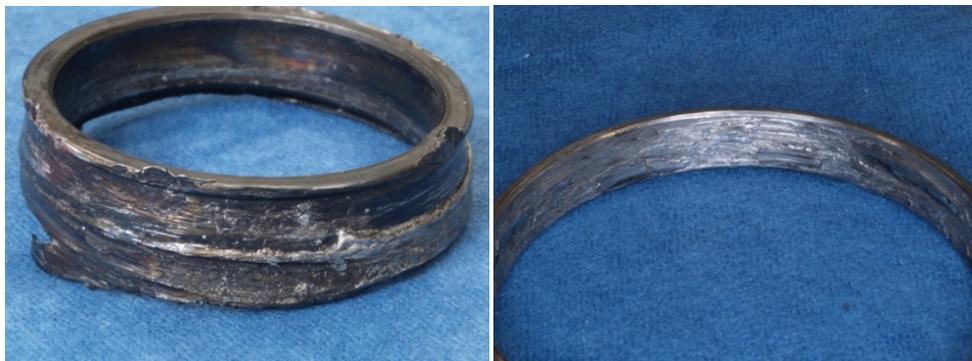
Figure 8: Outboard bearing cone and cup

The detachment of VH-ZLC's right main, outboard wheel during takeoff on 6 July 2008, was as a result of the failure of the outboard wheel bearing, which allowed the wheel unit to move axially outward to a point where it was no longer restrained by the landing gear axle.
