**ATSB TRANSPORT SAFETY REPORT**

Aviation Occurrence Investigation –AO-2007-055

**Procedures-related event**

**Melbourne Airport, Vic.**

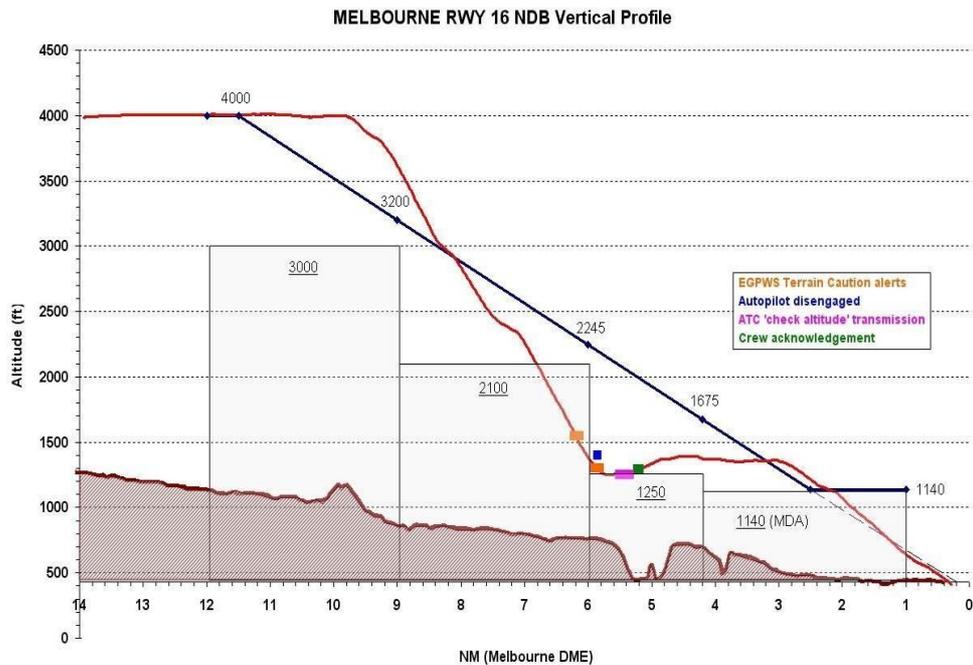
The FDR indicated that the average rate of descent from 4,000 ft was 1,500 ft/min, with a maximum of 1,808 ft/min when the aircraft was at 8.5 DME (16 km). The aircraft descended below the 2,100 ft segment minimum altitude step at 6.8 DME (12 km).

1309:08 The aircraft was approximately 6.25 DME (7 km) and descending through 1,544 ft, which was 556 ft below the 2,100 ft segment minimum safe altitude.

1309:20 The copilot disengaged the autopilot and initiated a pitch-up manoeuvre. The lowest altitude recorded during the manoeuvre was 1,247 ft, which was 513 ft above ground level (AGL).

**Figure 2: Approach profile (in red) derived from recorded flight data, published constant angle descent path (in blue), segment minimum altitude limiting steps (in grey) and terrain profile (in brown).**
