ATSB TRANSPORT SAFETY INVESTIGATION REPORT

Depressurisation

VH-AJP

Israel Aircraft Industries Ltd. 1124 Westwind

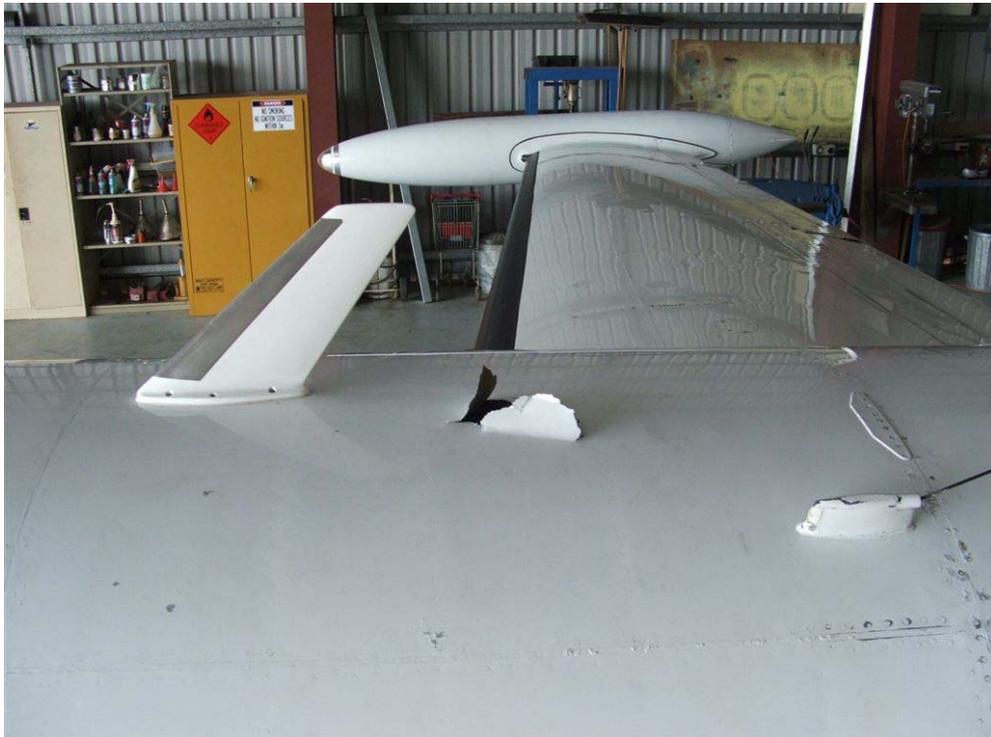
An inspection of the aircraft revealed a hole in a top rear fuselage skin panel² (Figure 1). The panel was removed from the aircraft and sent to the Australian Transport Safety Bureau (ATSB) for examination.

Figure 1: Outside of the damaged fuselage skin panel in situ

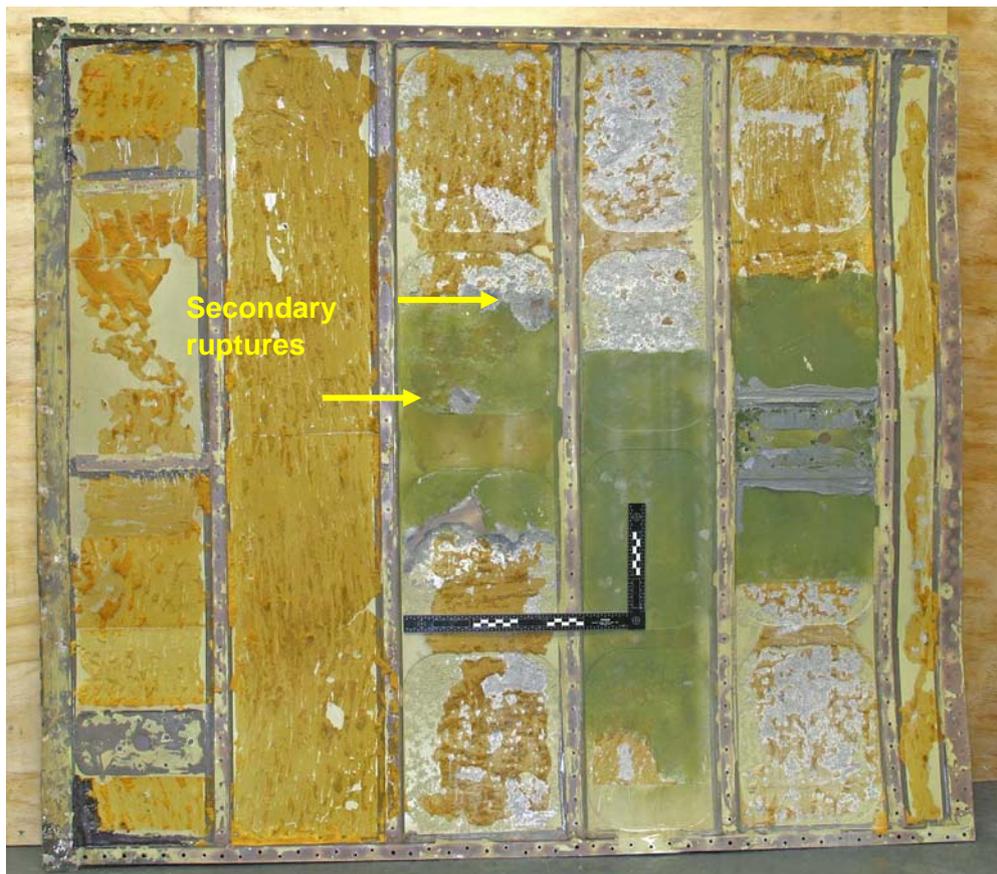
With the insulation removed, initial examination showed that the panel contained one large primary point of rupture. Another two smaller points of rupture were also found. However, these had developed during the panel's removal from the aircraft and transportation to the ATSB.

The examination revealed that approximately 60% of the panel had been damaged by corrosion. The damage was most severe at the primary site of rupture, in the centre of the panel, which was located two frames behind an Ultra High Frequency (UHF) antenna mount (Figure 2 and Figure 3). It was also noted that the corrosion damage was predominately contained within the chemically milled³ sections of the panel.

Figure 2: Internal view of the fuselage skin panel after the removal of the insulation pads. The rupture sites and the location of the antenna mount are shown.

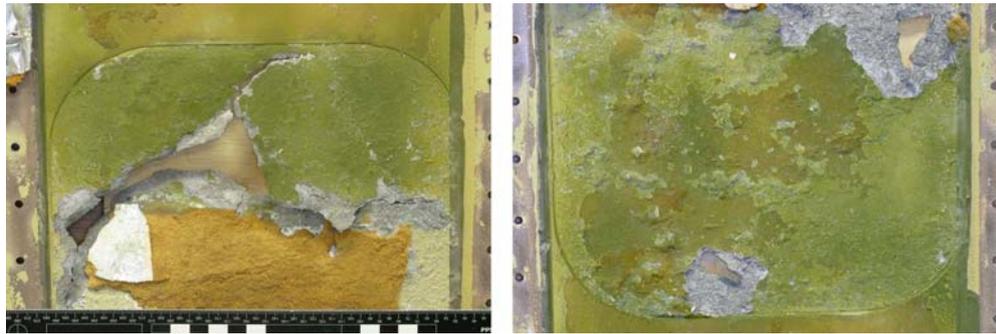
Figure 3: Close-up of the primary (left) and secondary (right) points of panel rupture.

Close examination of the most severely effected regions revealed a substantial reduction in skin thickness. Nearly all of the corrosion damage was categorised by thin flakes of aluminium alloy that had peeled from the panel.

Visual examination of the panel found that a section of the panel had previously been treated for corrosion damage. In the treated area, the corrosion products had been abrasively removed and over-sprayed with what appeared to be a dark green chromate-based primer. The primary site of rupture was located at the edge of the treated area; the two later failures were located within the treated area. There was evidence that the corrosion had extended beyond the treated area at the time of the treatment. No records were found for the repair of the corrosion in the aircraft's maintenance records.

The examination of the failed panel showed that the corrosion extended beyond the area that was treated for the corrosion damage. The panel also failed within the treated area. Based on this, it is likely that the repair did not prevent further growth of the corrosion on the panel.

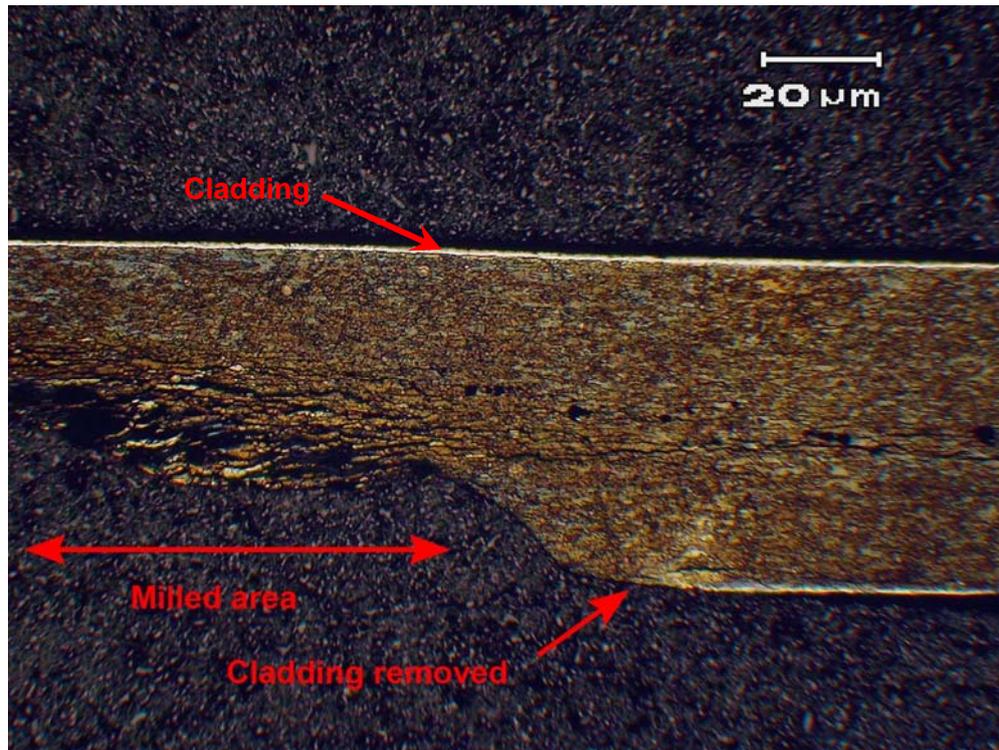
In order to establish the corrosion mechanism that had developed within the panel, some sections of skin in and around the primary point of rupture were removed for further examination. Metallurgical examination determined that the fuselage panel was primarily comprised of 2024 aluminium alloy that had been clad with a thin layer of pure aluminium alloy (ALCLAD). The cladding had been applied during the manufacturing process in order to improve the corrosion resistance of the panel. It was observed that, in the regions that had been chemically milled, the thin protective layer of aluminium had been removed.

The panel had a protective coating, which consisted of a chromate conversion coating and an epoxy primer. This had been applied during the manufacturing process to provide corrosion resistance to the chemical milled areas and additional protection to the clad areas. This type of coating has been found to be an effective barrier to corrosion, provided it has not been damaged. However, over time, the coating can break down and, in the presence of water, the chromate can leach out of the coating, degrading the protective qualities.

The metallurgical examination also confirmed that exfoliation corrosion⁴ was the principal corrosion mechanism that had developed within the panel (Figure 4). This form of intergranular⁵ corrosive attack was found to have extensively proceeded through the grain boundaries of the 2024 aluminium alloy and beneath the cladding in some areas.

Figure 4: Cross-sectional view through the fuselage skin panel showing extensive penetration of exfoliation corrosion.

To prevent corrosion, the aircraft's design used corrosion resistant pure aluminium sheeting to clad the fuselage panel; however, the chemical milling process removed the cladding. Therefore, to provide corrosion resistance to the chemical milled sections, a protective coating had been applied to the panel. Over time, it is likely that the coating would have deteriorated. Furthermore, with the fibrous insulation pads holding moisture close to the aircraft skin, it is likely that, with time, the chromate leached out of the coating, leaving the chemical milled sections susceptible to corrosion damage from the external service environment.
