ATSB TRANSPORT SAFETY INVESTIGATION REPORT

Aviation Occurrence Report – 200603438

**Smoke Event
Maroochydore, Qld**

Fairchild Industries SA227-AC

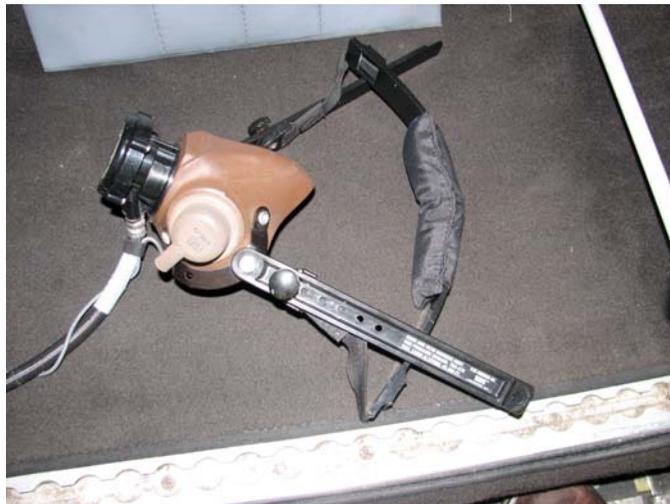
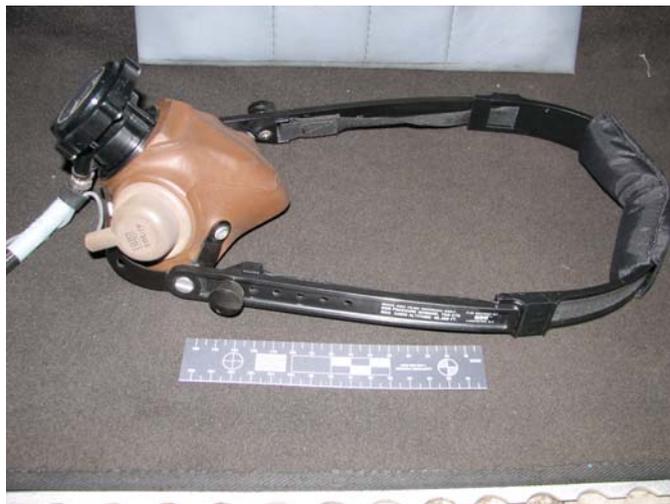
Figure 2. Crew oxygen mask.

Both crew members found that the elastic strap fitted to their masks was not tight enough to provide an adequate positive seal of the mask against their face, resulting in the need to physically hold the mask against their face to obtain effective oxygen flow.

The effectiveness of the straps on each of the crew's oxygen masks to provide sufficient contact of the mask face piece to its user was inadequate. As a result, the crew had to physically hold the masks in place to ensure sufficient oxygen flow was obtained, hindering their ability to control the aircraft.

The design of the mask required that the strap be placed in a 'quick donning' stretched position for the duration of flight, accelerating the wear of its elastic fibres. The pilot in command's (PIC's) mask had been fitted to the aircraft for only two weeks after being overhauled. The elastic tension in the strap however, was still found to be insufficient to hold the mask firmly against the PIC's face.

As a result of this investigation, on 26 July 2007, the Civil Aviation Safety Authority (CASA) issued Airworthiness Bulletin (AWB) 35-002, Quick-Donning Oxygen Mask Maintenance. The AWB recommended that oxygen mask head harnesses should be inspected at an appropriate interval to ensure correct functioning. The AWB also recommended that maintenance schedules be corrected to include oxygen masks and any other aircraft equipment not currently covered by the schedule. A copy of the AWB is at Appendix A.

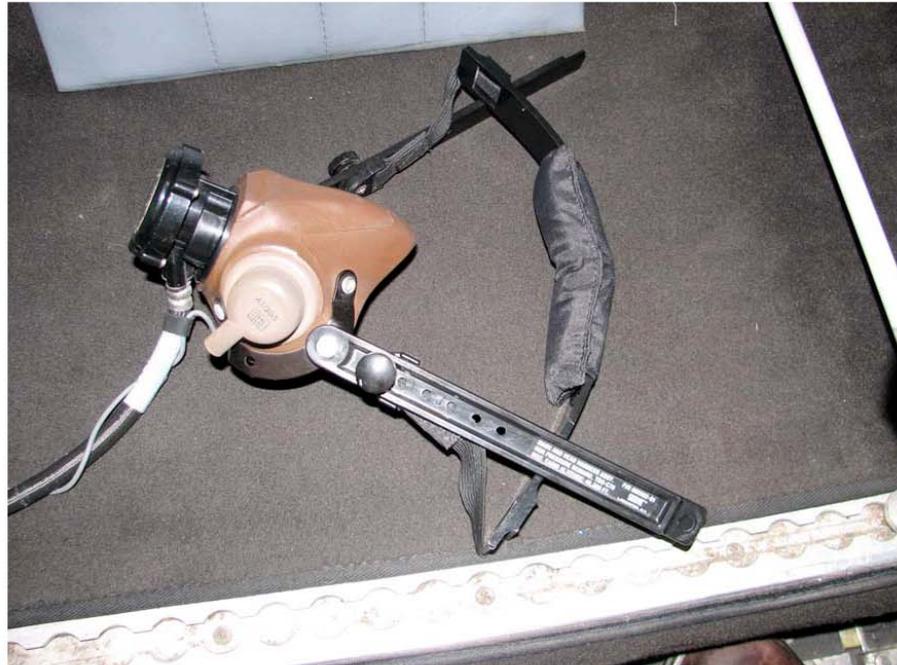
Figure 2 - Stretched Band

A random check of these types of masks, fitted to another operator's aircraft also found that the elastic straps had been stretched to a point where the mask was no longer held tight on the user's head.

Oxygen head harness assemblies should be inspected to ensure correct functioning and repaired if required. A check of any relevant maintenance schedule should be undertaken and if these items are not included in the maintenance schedule then the maintenance schedule must be corrected to include them and any other aircraft equipment not covered by the schedule (Refer to CAR (1998) 42 - *Defective or inappropriate maintenance schedule*).
