ATSB TRANSPORT SAFETY INVESTIGATION REPORT

Aviation Occurrence Investigation – AO-2007-065

Preliminary

**Midair Collision
Latrobe Valley Aerodrome, Vic.
1 December 2007
Cessna 172 VH-EUI/Avid Flyer 28-0929**

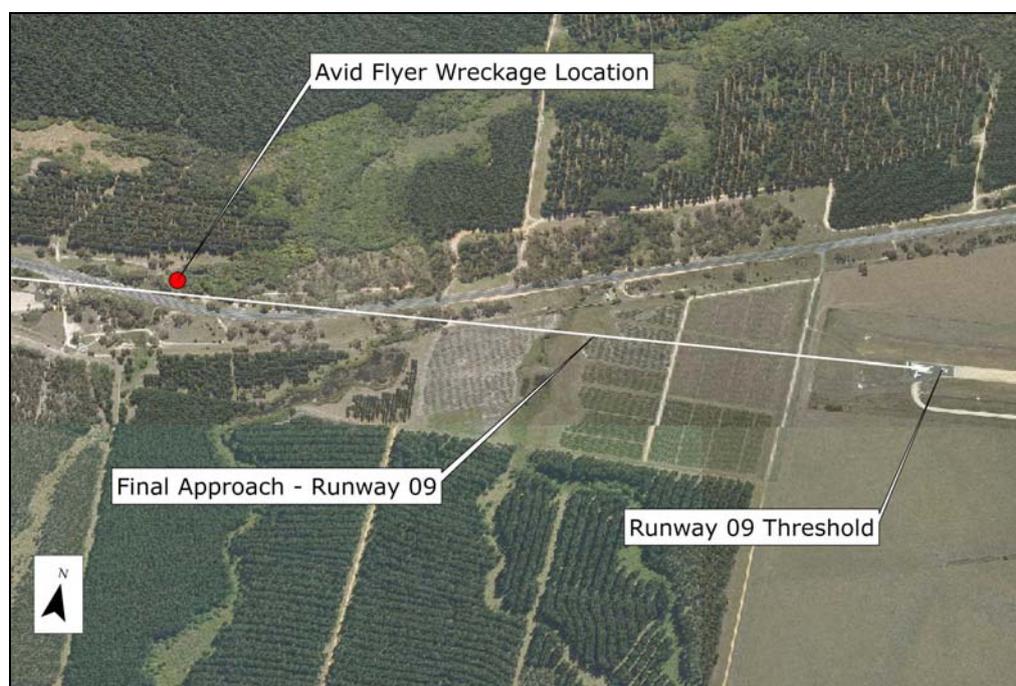
Figure 2: Avid Flyer wreckage location relative to runway 09 final approach path

Following the collision, witnesses reported that the Avid appeared to spiral to the ground in an uncontrolled manner. The Avid came to rest upright, partially on the edge of a concrete and steel bridge, with the remainder in a small creek. That location was on an old road bridge that once formed part of the Old Melbourne Road (Figure 2). The wreckage was located slightly to the north of the final approach path to runway 09. The Avid was destroyed by impact forces and a post-impact fire.

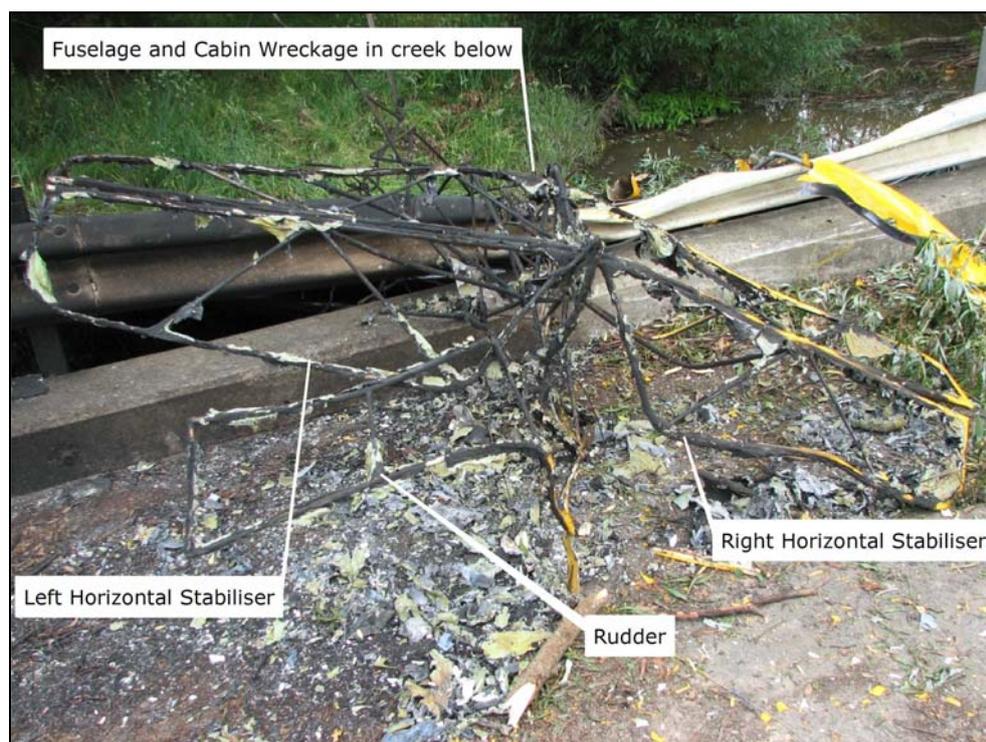
Figure 3: Avid Flyer wreckage showing tail section

The Avid remained essentially intact following the collision, with only the left wing control surface and the top section of the vertical stabiliser detaching. There was no propeller damage to the horizontal stabiliser of the Avid and the vertical stabiliser and rudder displayed damage consistent with being impacted from above (Figure 3). The top section of the vertical stabiliser was located some distance from the main wreckage. A section of the left wing control surface of the Avid was reported to have been entangled around the left wing root of the Cessna when it taxied to the apron area following the collision. All other components of the Avid were located at the main wreckage site.

A ballistic recovery parachute fitted to the Avid had not been activated and was not capable of being activated as the safety pin was still fitted to the firing mechanism.

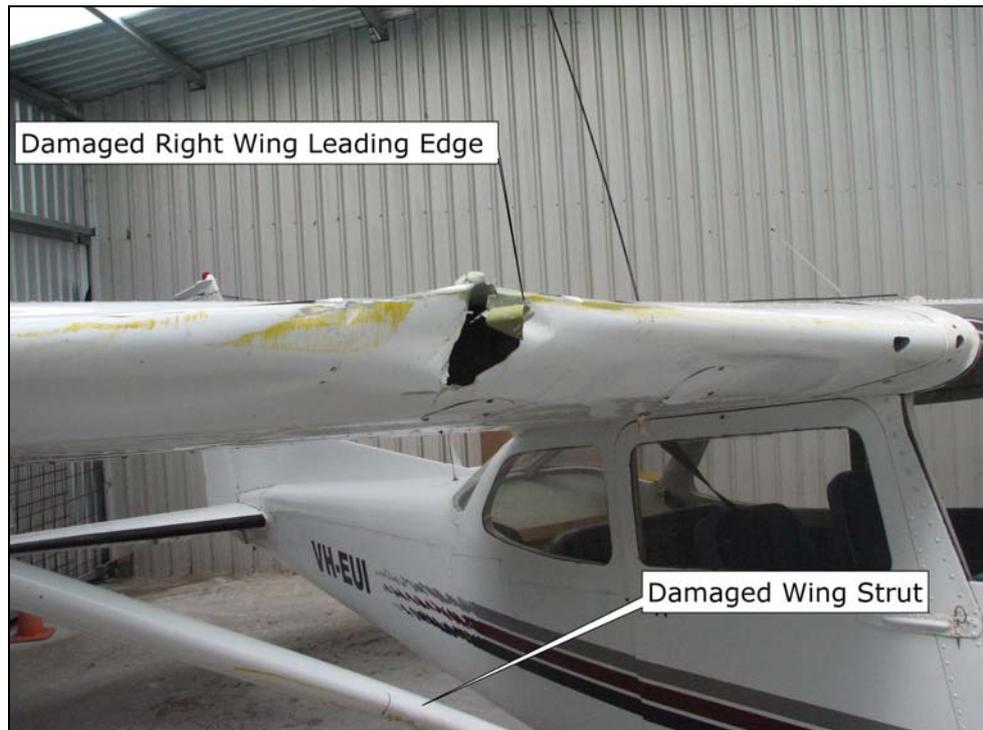
Figure 4: Damage to the Cessna's right wing and support strut

Initial examination of both aircraft indicated that the Cessna contacted the left wing of the Avid, from above and behind. Detailed examination of the positions of both aircraft at the point of impact is continuing.

The Cessna exhibited damage to the right wing and support strut, with additional minor damage to the propeller, spinner, cowling and windscreen (Figures 4 & 5). There were also minor scrape marks, consistent with the colour of the paint on the Avid, on the left wing.
