Aviation Occurrence Report – 200607815

Engine failure – Kununurra Airport, WA

VH-FNP

Embraer EMB-110P2 Bandeirante

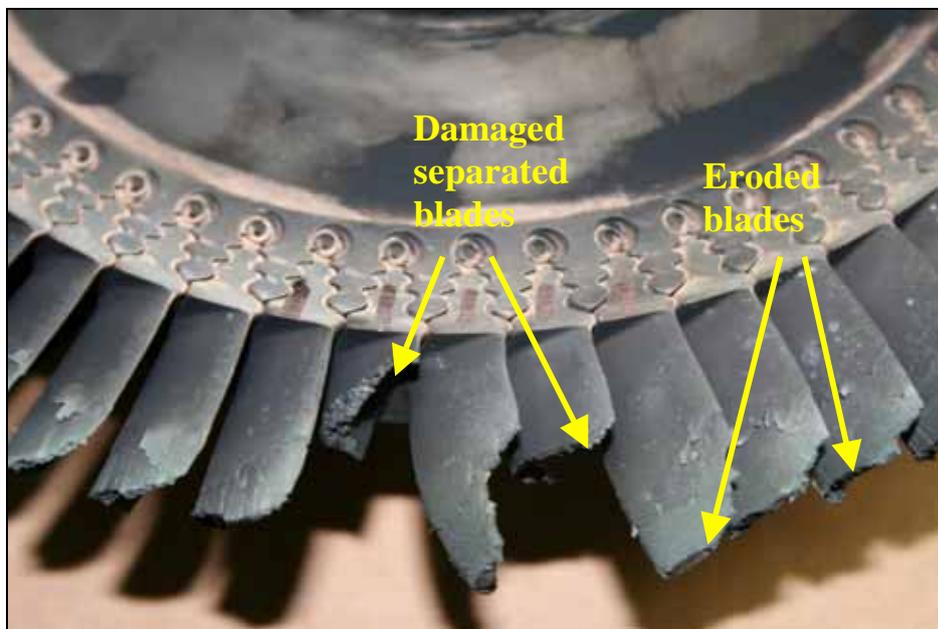
Figure 1: Compressor turbine disk and blades

Examination of the compressor, fuel nozzles and engine bearings did not reveal any anomalies. The examination determined that a CT blade failure was the initiator of the damage, with secondary damage to the compressor section as a result of severe vibration following release of the two CT blades (Figure 1).

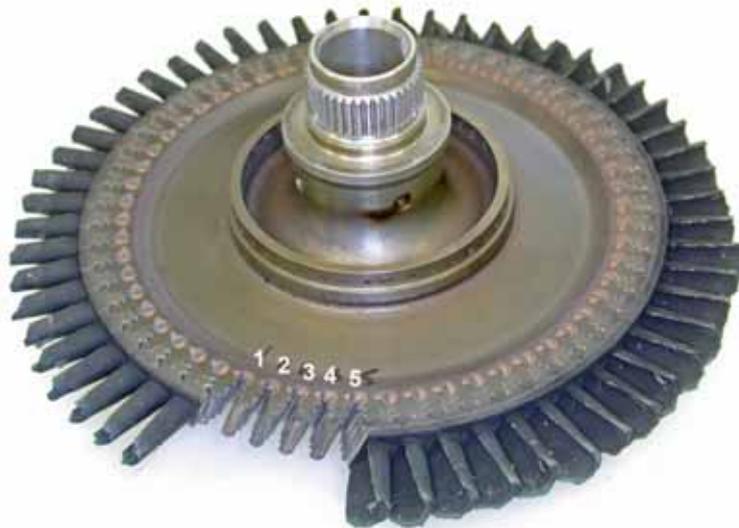
Figure 2: The compressor turbine disk and blade assembly as-received by the ATSB⁵

In order to establish the contributing factors leading to the engine failure, the CT disk and several other associated components were examined and analysed at the ATSB's laboratories. An initial examination of the CT disk revealed that in general, each blade within the assembly displayed significant distress. The damage pattern for each blade was observed to be reasonably consistent with blade tip portions having fractured from the main airfoil body (Figure 2).

5 Blades labelled 1 to 5 were removed during the engine disassembly.

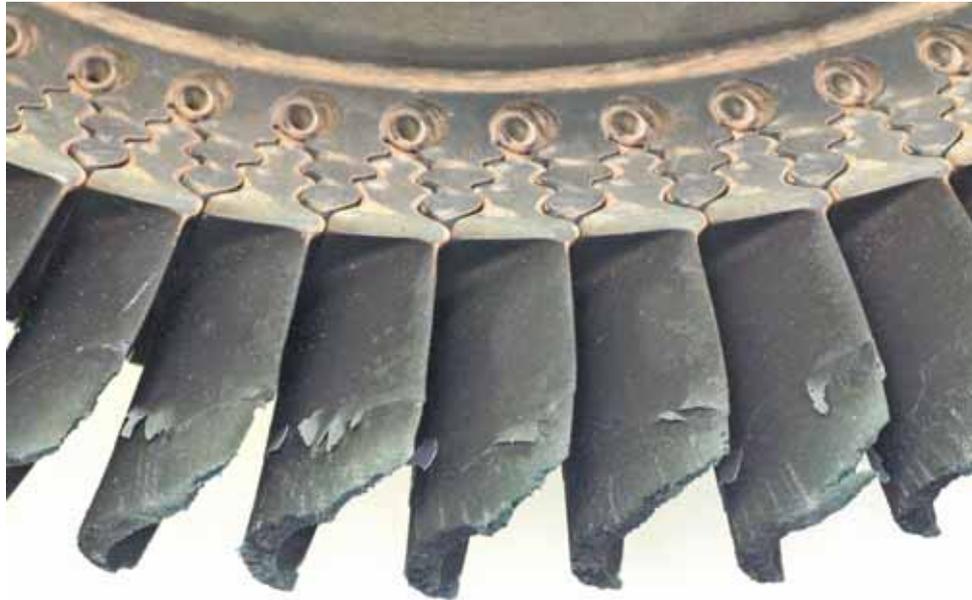
Figure 3: The compressor turbine blades showing flaking of the blade coating and damage to the blade tips

Other significant damage included disruption to the diffusion bonded Sermaloy J coating on the airfoil surfaces of all blades within the CT disk. The aluminide coating damage was characterised by peeling and fracture of the outer layer away

from the nickel alloy substrate. The coating loss was most severe toward the tip of each blade, with negligible damage observed at the platform or root end. No evidence of corrosive attack from sulphidation was observed on any of the blade airfoils (Figure 3).

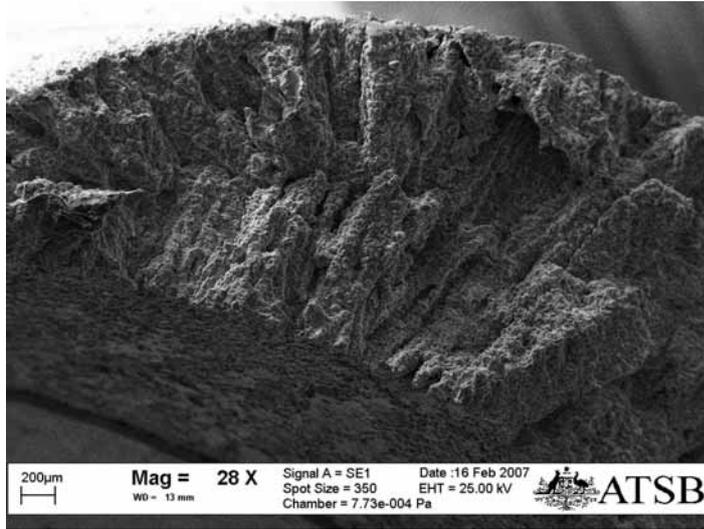
Figure 4: SEM image of the fracture surface from one of fractured CT blades showing intergranular features

Low power magnified examination of the blade tip fracture surfaces from the CT blade assembly revealed no obvious evidence of fatigue or any other such form of progressive failure mechanism. When the fracture surfaces were examined at high magnification using a scanning electron microscope (SEM), a combination of intergranular features coupled with an accumulation of melted/resolidified nickel alloy were observed (Figure 4). Numerous secondary cracks intersecting the main fracture surface were also observed. No evidence of fatigue cracking was found during the SEM examination.

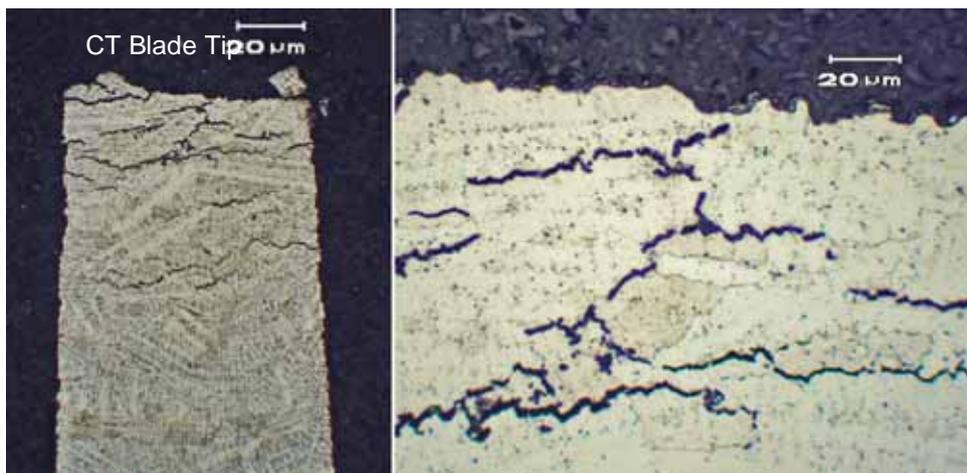
Figure 5: Low and high magnification images showing the extensive intergranular cracking

In order to further quantify the failure mechanism of the CT blade assembly, a number of blades were longitudinally sectioned and then prepared using metallographic techniques. When the etched microstructure of the CT blades was examined, numerous intergranular cracks were observed within the microstructure of the CT blades. The cracks were concentrated in a parallel arrangement in close proximity toward the fractured tip of each blade. When viewed at high magnification, the cracks were identified to have initiated at the nickel alloy dendritic grain boundaries (Figure 5). These features indicated that the blades had been subjected to a ‘high temperature creep’ event, leading to stress rupture of the CT blade assembly.

The majority of the engine damage was confined to the compressor turbine (CT) section of the engine. When the CT blade tip fracture surfaces were examined, a combination of features associated with high temperature exposure and intergranular stress rupture were observed. In addition, the cast internal structure of the examined nickel-base alloy blades each contained a fine network of cracks that had developed at the blade tips. Intergranular crack growth of this type is strongly indicative of stress rupture from advanced creep.
