ATSB TRANSPORT SAFETY INVESTIGATION REPORT

Aviation Occurrence Investigation – 200600001

Collision with terrain - Willowbank, Qld

VH-UYB

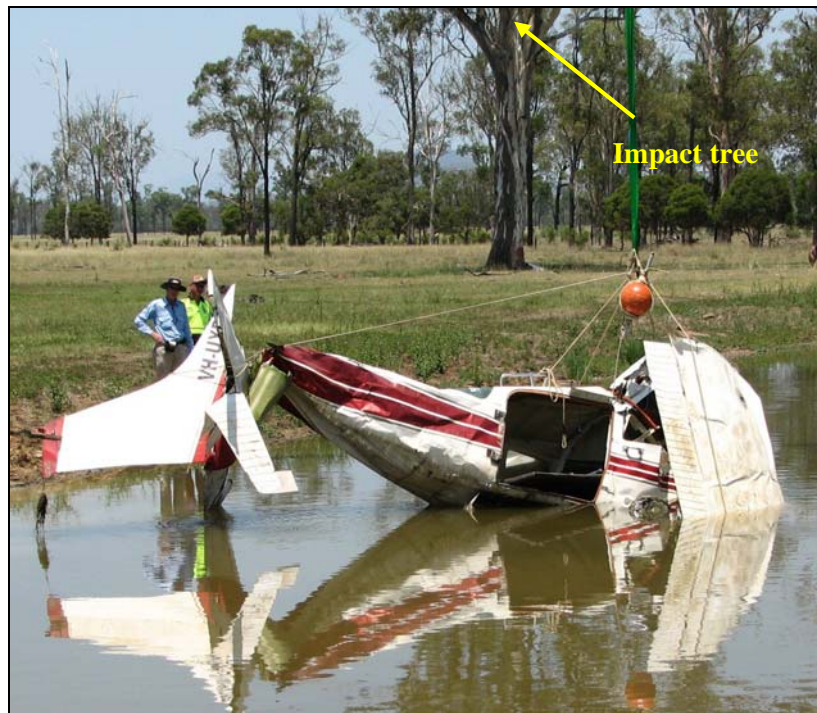
Figure 3: Recovered wreckage¹²

On the day following the accident, the aircraft wreckage was recovered from the dam by the Australian Transport Safety Bureau (ATSB) for subsequent examination.

The aircraft had impacted a 23 m (75 ft) high tree that was about 1,200 m from the end of the runway before then impacting water and submerging in a small, 2 m deep dam that was located about 47 m from the tree. The aircraft entered the dam in a nose-down, left wing-low attitude. The forward section of the cabin was extensively damaged by impact forces, but the cabin section remained relatively intact. The tail section was heavily damaged.

The right wingtip was separated by the initial impact with the tree and was located near the impact tree. The right and left wings had impact damage to their leading edges. The right wing strut had failed in overload at the mid-strut point. Both fuel tanks were intact, but the fuel lines connected to the right wing tank had separated, resulting in the fuel draining from that tank. The nose landing gear was deflected aft, and the left main landing gear wheel and strut had separated.

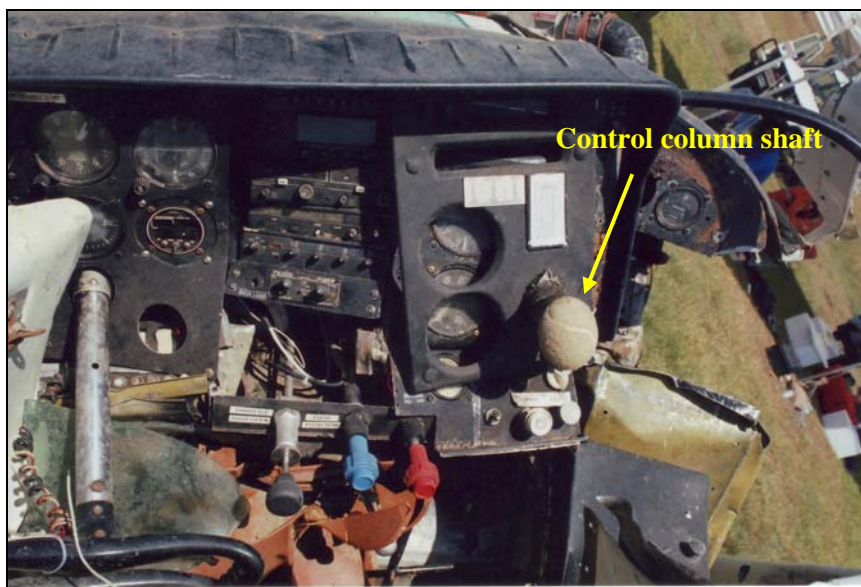
Figure 4: Control panel indicating disabled copilot's control column shaft

Additionally, the aircraft flight control system had been modified to disconnect the copilot's control column behind the aircraft instrument panel, and a tennis ball had been fitted to the end of the control wheel shaft (Figure 4). The owner/operator reported that that modification was completed in accordance with the APF *Jump Pilot's Handbook & Aircraft Operation Procedures Manual* Section 3.0 AIRCRAFT MODIFICATIONS. No other aircraft documentation, such as a Engineering Order, could be located in support of that modification.

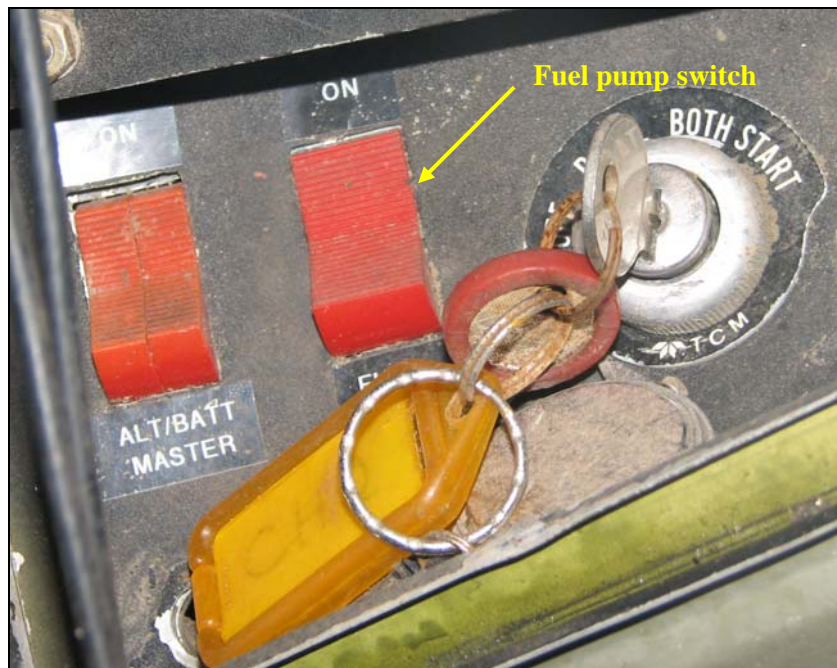
Figure 5: Auxiliary fuel pump switch

Following the accident, the auxiliary fuel pump switch was found in the ON position (Figure 5). The investigation confirmed the continuity of all wiring to the fuel pump and bench-tested the pump. That testing confirmed the serviceability of the pump.

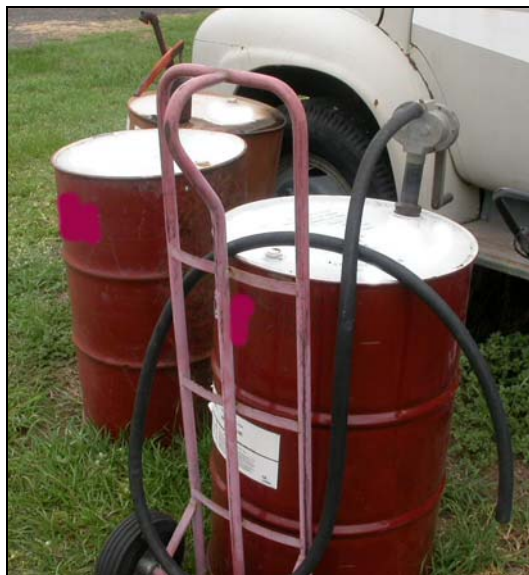
Figure 6: Fuel drum and pump used to fuel the company aircraft the previous night²⁹

morning, he placed approximately 100 L of fuel from the same drum (Figure 6) in the company's Cessna 182.²⁸

The owner/operator reported normally using a fuel filter-equipped fuel truck to refuel the company's aircraft. However, the fuel truck was empty the night before the accident, and replacement fuel had been unavailable during the holiday period. The fuel pump used to fuel the aircraft from the fuel drum did not include a monitor type cartridge filter or filter/water separator cartridge.

Comments: The sample does not meet the relevant specification. The sample fails visual appearance due to the presence of visible solid matter. It fails the distillation 10% evaporated limit and also fails the existent gum limit. From the distillation results, it is estimated that the fuel has lost approximately 6% volume due to weathering (evaporation). This suggests that the storage and integrity of the sealing of the drum were less than adequate. The presence of solid matter also suggests probable poor handling and storage.

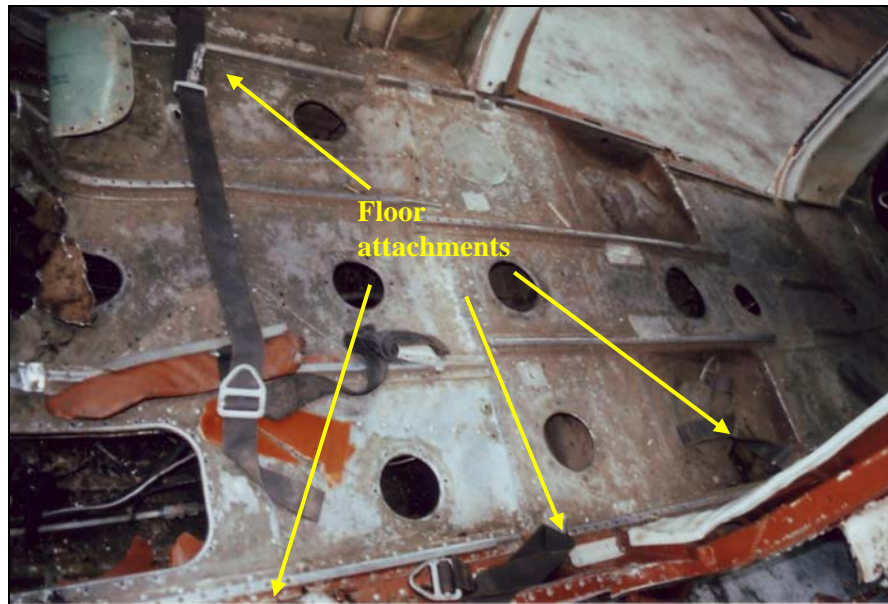
Figure 7: Cabin floor restraint attachments

The aircraft cabin had four cabin floor restraint attachments for the six cabin occupants. The pilot's seatbelt attachment also served as one of the cabin floor restraint points for a Tandem pair (Figure 7).

Evidence indicated that none of the Tandem Student parachutists or Tandem Masters were restrained to the floor of the aircraft. Witness reports and video evidence indicated that there was no pre-flight briefing on the use of the available cabin restraints, or of the procedures for emergency exit from the aircraft in the event of a forced landing, fire or other emergency. None of the student parachutists were wearing a helmet.
