ATSB TRANSPORT SAFETY INVESTIGATION REPORT

Aviation Occurrence Report – 200603140

Fuel Starvation
2.4 km north-west Bathurst Island Aerodrome, NT
1 June 2006
VH-JDJ
Beech Aircraft Corp A36

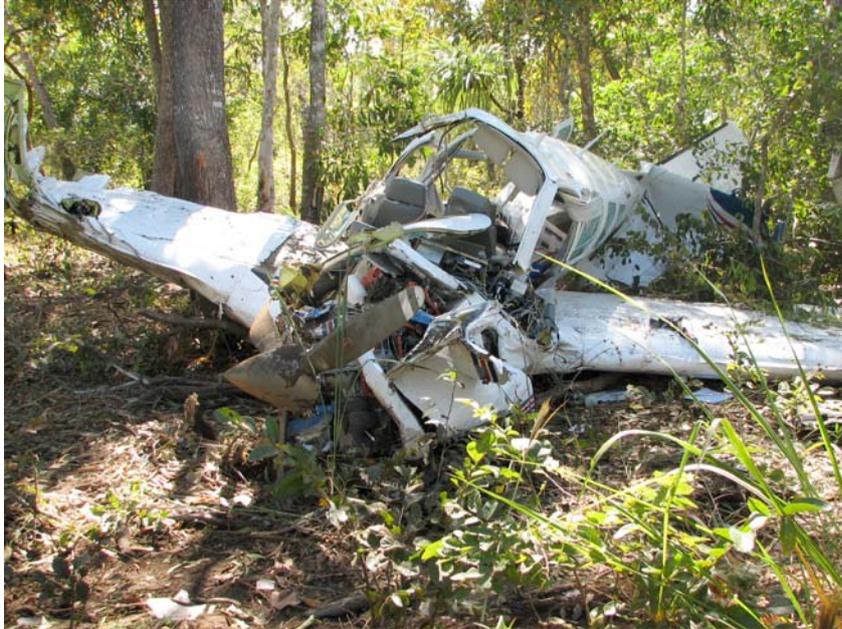
Figure 2: Accident site and surrounds

Examination of the aircraft's wreckage indicated the aircraft impacted the ground in a left wing-low, steep nose-down attitude. Although the aircraft remained substantially intact, it sustained significant damage due to impact forces (Figure 2). There was no post-impact fire.

The aircraft collided with the upper tree canopy during the final stages of the descent. Fragments from the outboard portion of the right wing and the right wingtip fuel tank were found along the wreckage trail and had detached from the aircraft during the contact with the trees. Damage to the foliage was consistent with the aircraft descending steeply as it approached the ground.

The aircraft travelled approximately 30 m from the point of first tree contact along a track of about 100 degrees magnetic. The aircraft came to rest within 5 m of the point of the initial ground impact.

A small clearing that may have been suitable as an emergency landing area was located a short distance beyond the aircraft wreckage and along the final flight path as evidenced by the wreckage trail.

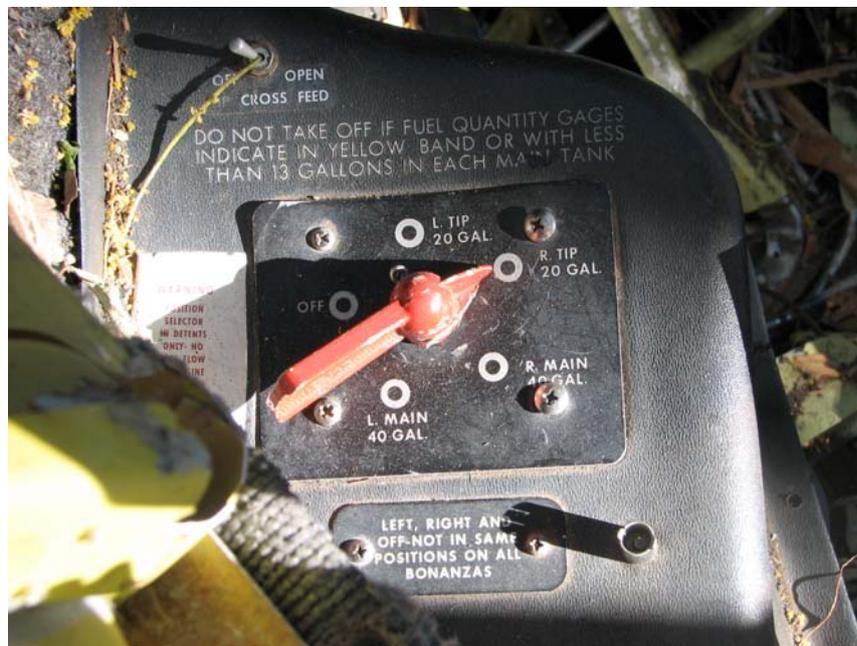
Figure 3: Aircraft fuel tank selector

The aircraft fuel selector was in the R. TIP position (Figure 3), and there was no evidence that the selector had moved as a consequence of impact forces. The cross-feed selector for the tip tanks was in the OFF position. The switch for the tip tank fuel gauge was positioned to indicate the contents of the left tip tank.

The normal operation of the aircraft's fuel system during examination and test, and the availability and quality of the fuel in the aircraft's main fuel tanks, suggested that the interruption to the fuel flow was most probably the consequence of low or no fuel in the tip tanks. The as-found position of the fuel selector in the R.TIP position was consistent with the 0757 flight plan annotation by the pilot, and the lack of any indication that the pilot had subsequently deselected that tank prior to the accident.
