ATSB TRANSPORT SAFETY INVESTIGATION REPORT

Aviation Occurrence Report – 200505536

Breakdown of co-ordination
Gold Coast Airport, Qld – 3 November 2005
VH-VQH
Boeing Company 717–200
VH-VQV
Airbus Industrie A320–232

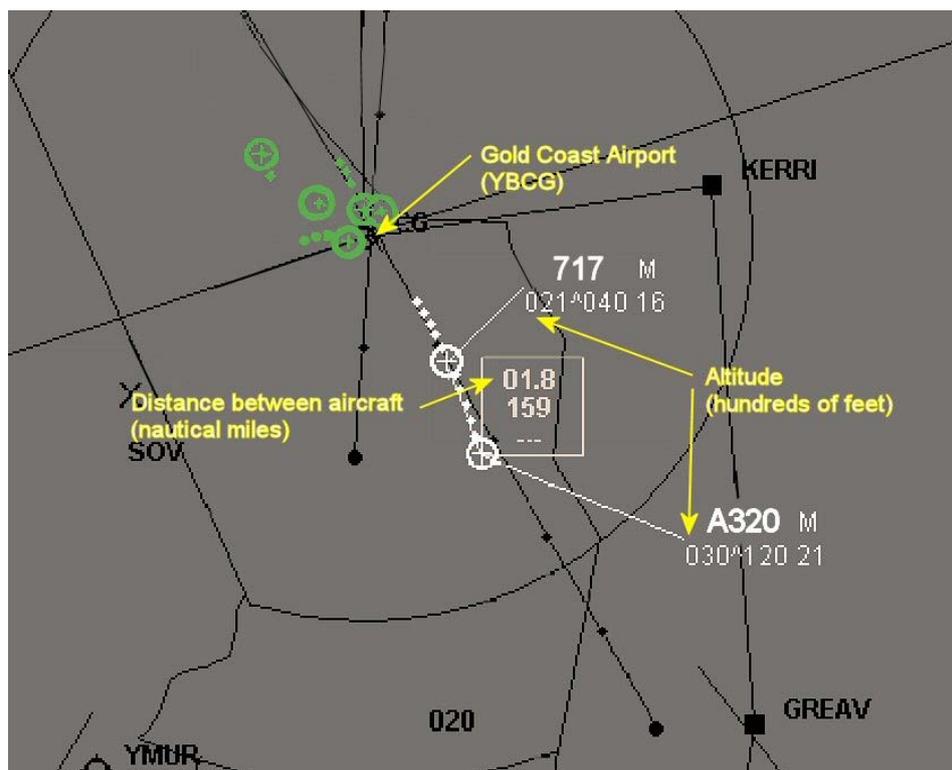
Figure 1: Extract from Airservices Australia computer replay² at 1018

At 1015:52, the ADC issued a take-off clearance to the crew of the A320. At 1017:05, after observing a runway separation standard with the preceding A320, the ADC issued a take-off clearance to the crew of the 717. The two aircraft entered the approach controller's airspace with a longitudinal spacing of 1.8 NM observed by radar (Figure 1). In the absence of any other form of separation being coordinated from the ADC, the approach controller required a minimum radar separation standard of 3 NM. The ADC later reported that on departure, he was able to visually separate the two aircraft, but was unable to coordinate this with the approach controller. There was a breakdown in co-ordination.

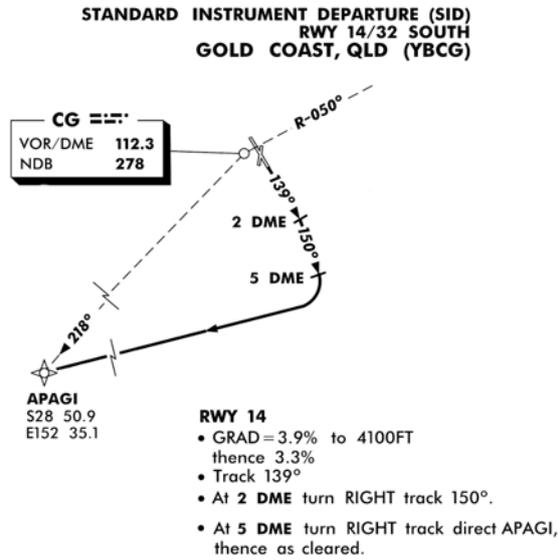
Figure 2: Extract from Gold Coast Runway 14/32 South SID (via APAGI)

At about the same time, the crew of the A320 had turned onto the SID track of 150 degrees and were about to turn onto the direct track to APAGI (Figure 2). With the angle between the tracks of the two aircraft increasing to about 135 degrees, the distance between the aircraft increased rapidly. At 1020, after the approach controller observed a radar separation standard had been established, the crew of the 717 crew were issued with another radar heading and then an instruction to track direct to APAGI.

The Gold Coast Runway 14/32 South Standard Instrument Departure (APAGI SID) required a track of 139 degrees⁶ until 2 NM from the VOR/DME⁷ then a right turn onto a track of 150 degrees until 5 NM and then a further right turn to track direct to APAGI. The track direct to APAGI after this turn is approximately 225 degrees.
