**ATSB TRANSPORT SAFETY INVESTIGATION REPORT**

Technical Analysis Investigation Report – 200601133

# **Turbopropeller engine output shaft examination**

## **Allied-Signal (Honeywell) TPE331-12**

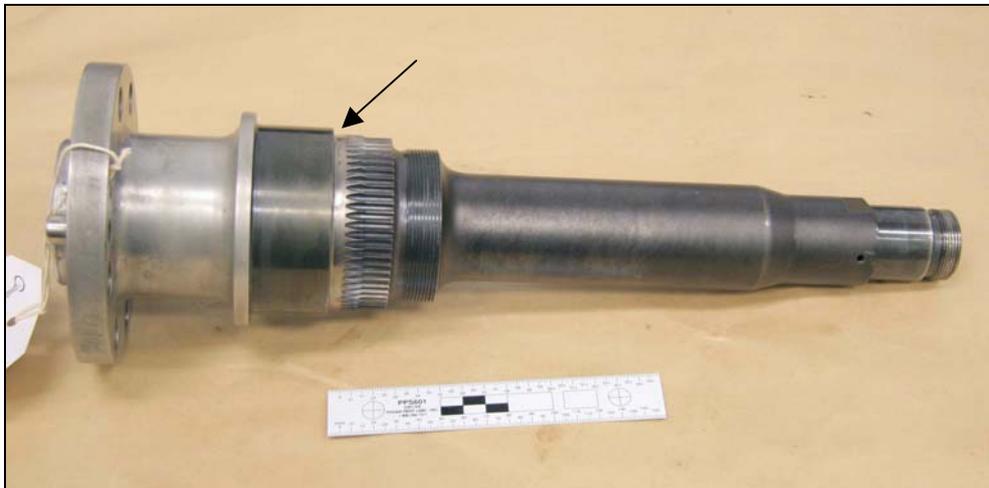
On 9 February 2006, representatives from the Civil Aviation Safety Authority (CASA) requested the Australian Transport Safety Bureau (ATSB) to assist in the technical evaluation of a possible unsafe condition identified within a Honeywell TPE331-12 turbopropeller engine propeller shaft. The condition related to the potential existence of a material flaw, anomaly or defect around the inboard edge of the forward bearing/seal seat (see figure 1).

**Figure 1: Part no. 3102572-2 propeller shaft as-received, with anomalous area indicated**

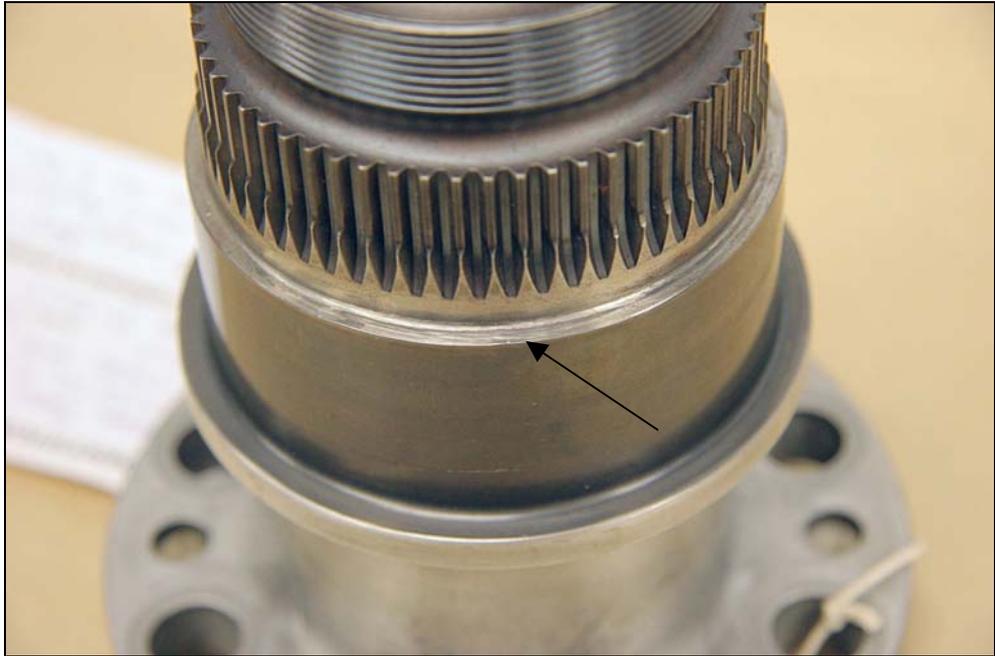
As received, the propeller shaft appeared to be in sound general condition, with no outward evidence of mechanical damage or thermal distress. On inspection, the shaft presented evidence of irregular and coarse abrasive dressing around the full periphery of the shaft, at the inboard end of the forward bearing/seal seat (see figure 2). The uneven and variable nature of the surface was characteristic of a manual dressing, or similar abrasive process. Low-power stereomicroscopic examination of the dressed surface, revealed intermittent, patchy areas of metallic material that had been deposited over the underlying surface, which had a rough, dimpled appearance of an abrasive blasted or sprayed surface (see figure 3). There was no evidence of cracking, undercutting, or other intrusive defects, nor were there any areas of metal loss, other than a small number of shallow corner features that resembled small chips in the edge profile. At the opposite (forward) end of the bearing/seal seat, the radiussed flange transition showed a clear demarcation between seat surface material and the roughened end face material (see figure 4). Such a feature was considered entirely typical of the profiling/dressing process used, following the application of a thermal surface reclamation coating.

**Figure 2: Irregular abrasive work noted around edge of journal surface (arrowed)**

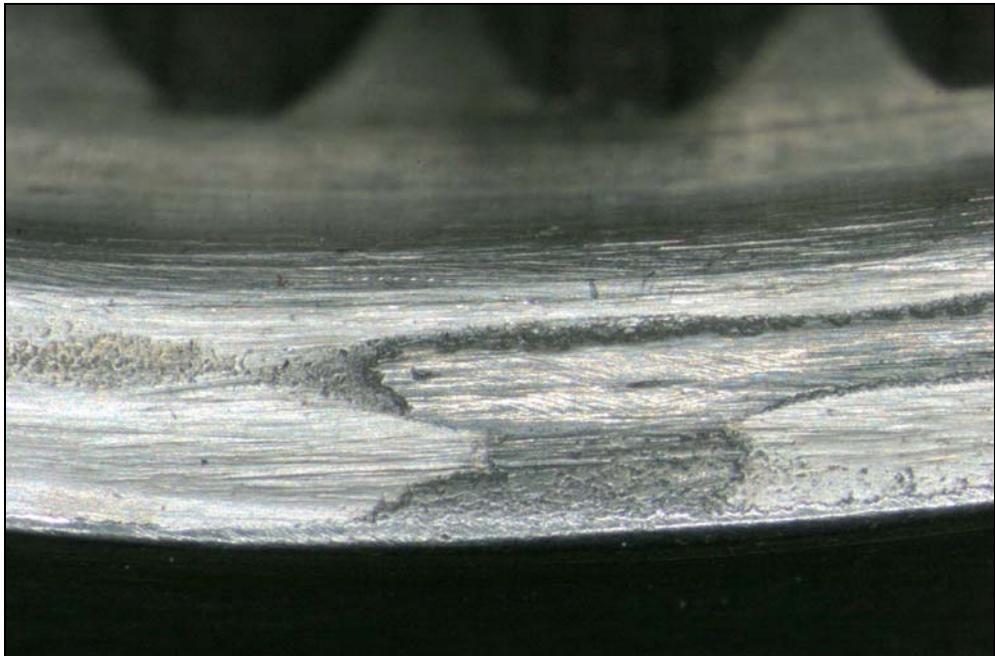
**Figure 3: Journal edge area showing an irregular build-up of material on what appears to be an abrasive-blasted or sprayed undersurface**

On the basis of the visual studies conducted, the appearance of the propeller shaft forward bearing/seal seat region was entirely consistent with the application of a thermally sprayed coating to the journal surface as part of a repair/reclamation process. The dressing to the inboard end was likely carried out to remove gross oversprayed material from the spline transition. While irregular, the dressed surfaces presented no features that were considered to be potentially injurious to the physical integrity, or service performance of the propeller shaft.

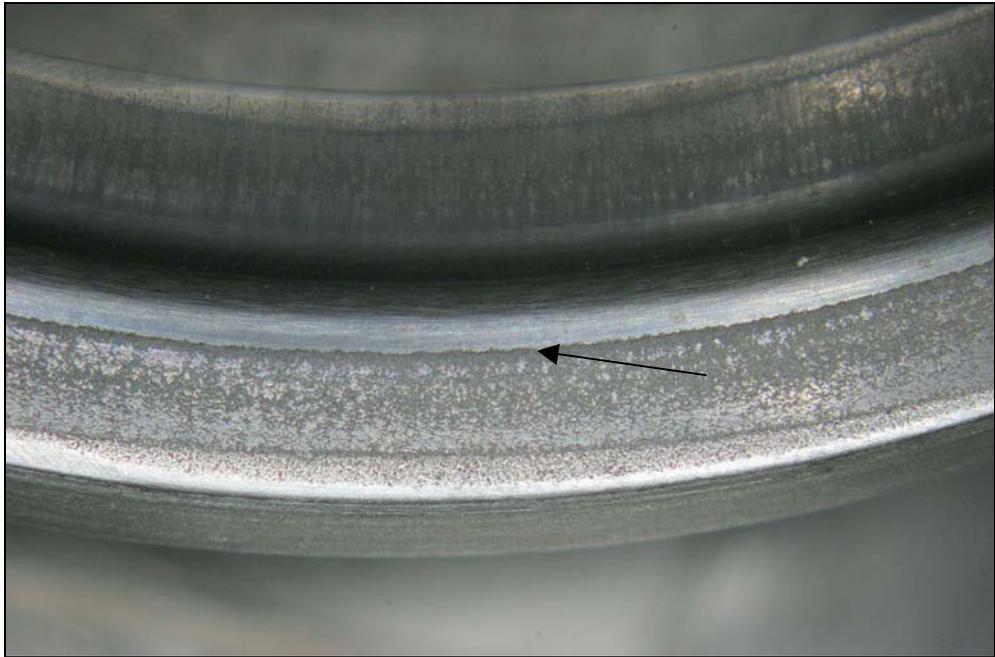
**Figure 4: Forward end of the journal showing a prominent transition between the machined journal surface and the rougher, lightly abraded end face**

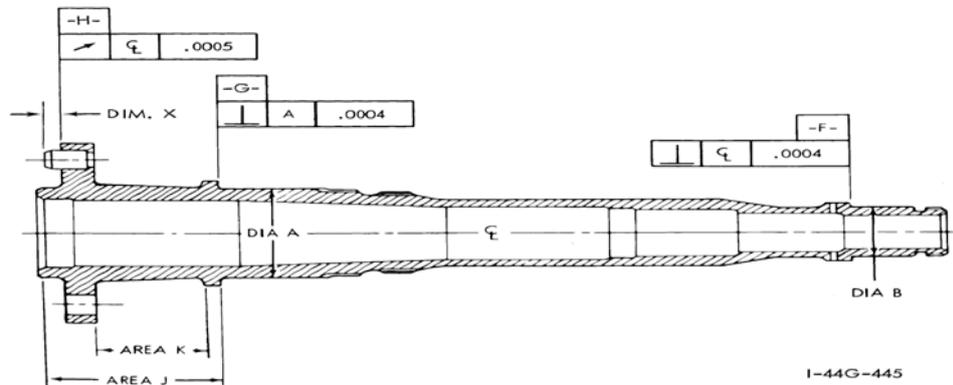
**Figure 5: Critical diameters and locations – p/n 3102572 propeller shaft<sup>1</sup>**

The engine manufacturer's inspection/repair manual for the part number 3102572-1/-2 propeller shaft assembly<sup>1</sup>, established a number of approved repair procedures for the restoration of wear and damage sustained during operational service. Those procedures included the application of a plasma spray process for the restoration of diameter 'A' (see figure 5). Included in the spraying procedure was the requirement for hand-finishing to deburr and remove excess plasma spray deposits.
