ATSB TRANSPORT SAFETY INVESTIGATION REPORT

Aviation Occurrence Report – 200506834

Engine failure – 93 km east of Adelaide Airport, SA

VH-OAE

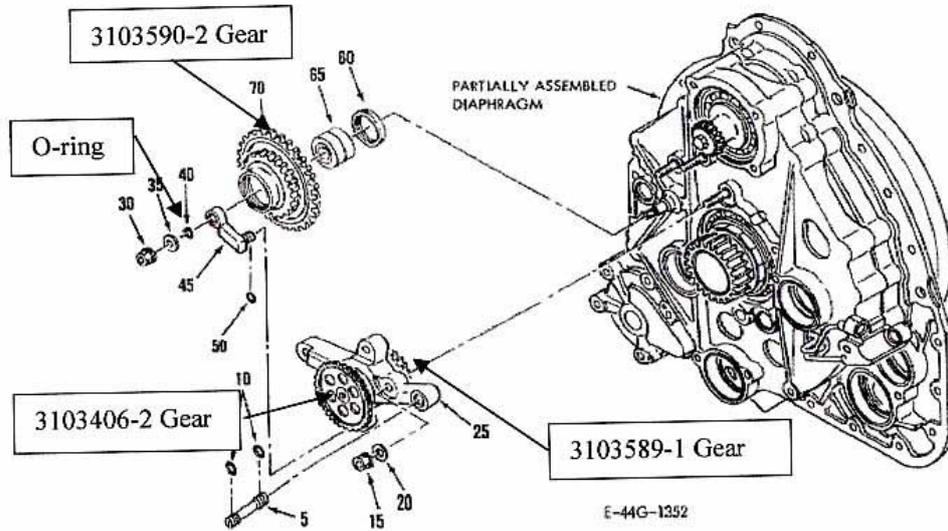
Figure 1: Diagram showing relationship between the gears

The operator had purchased the engine from the manufacturer in November 2005. Prior to purchase, in October 2005, the engine had undergone a scheduled continuous airworthiness maintenance (CAM) inspection. The manufacturer reported that during the CAM inspection a gear, part number (P/N) 3103589-1, and bearing, P/N 3103585-1, from the reduction gearbox were replaced with new items. The gear had been replaced due to wear on the spur gear teeth². The gear, P/N 3103590-2, which was part of the P/N 3103598-2 assembly (figure 1), was inspected and refitted to the assembly. That gear had been in the engine since manufacture.

The report of the engine examination indicated that the P/N 3103589-1 gear had a separated section of one gear tooth and several other damaged teeth. The splined shaft that connected that gear to the P/N 3103406-2 gear had evidence of bent splines. The P/N 3103590-2 gear that meshed with the P/N 3103589-1 gear was missing all of its teeth. None of the bearings exhibited any pre-existing wear or evidence of any damage from oil starvation and all jets that supplied oil to the affected components were unobstructed. There was no wear or damage noted to the gearbox pressure oil pump. The scavenge pump had been contaminated with material from the worn gears. The gearbox oil filter impending bypass indicator had not operated during the incident.

During the examination, it was noted that the 'O' ring that sealed the oil jet supply (figure 1, item 45) to the bearing (figure 1, item 65) in the P/N 3103590-2 gear was incorrectly positioned between the jet and the bearing instead of under the washer as required (figure 1, item 35). The report indicated that there was no evidence of any oil starvation to that bearing and the incorrect placement of the seal was not considered to be a factor in the occurrence.

A metallurgical examination of the damaged components and the metal fragments found in the gearbox showed that there had been significant wear of the mating surfaces of the [spur] gear teeth of both gears. The report further stated that experience had shown that the mating of a new or a different gear, and a worn gear can accelerate tooth wear and lead to tooth fatigue cracking. In this instance, the smearing of the separated surfaces and the damage sustained by the components prevented an assessment of whether the failure was due to fatigue.

The engine failure was due to the separation of the gear teeth on the P/N 3103590-2 gear and the subsequent related damage to the P/N 3103589-1 gear.

It is likely that the P/N 3103590-2 gear teeth separated as a result of accelerated tooth wear due to the mating of new and worn components leading to fatigue failure and the subsequent loss of one or more teeth from that gear. However, the possibility of the damage having occurred from a foreign object could not be discounted.

The engine manufacturer advised that it has submitted a Publication Change Request (PCR 029601) to the Inspection and Repair Manual 72-IR-15 specifically requiring an inspection for wear of the P/N 3103590-2 gear. That change is expected to be issued in late 2007.
