**ATSB TRANSPORT SAFETY INVESTIGATION REPORT**

Aviation Occurrence Report – 200500004

**Collision with terrain  
Wynella Station, Qld  
6 January 2005  
VH-BQN  
Air Tractor AT-802A**

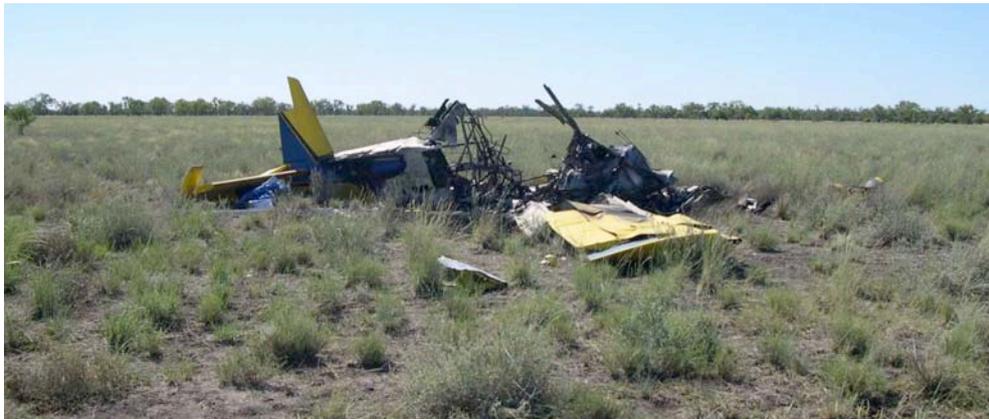
**Figure 2: Accident site and aircraft wreckage**

The aircraft had impacted the ground in a wings-level, nose-low attitude, and heading approximately 030 degrees M (figure 2). There was no evidence that the aircraft had collided with any obstacles prior to impacting the ground.

There was no evidence that the aircraft was banked, slipping, yawing or rolling at impact. Almost all detached components of the aircraft were located in close proximity to the main wreckage. One propeller blade had separated at impact and was located 112 m from the main wreckage. All control surfaces were located at the accident site. The aircraft came to rest virtually at the point at which it impacted the ground.

The wing flaps were retracted, and the elevator trim wheel was in a slightly nose-up position. Flight control cable continuity was established between the flight controls and the cockpit area. Post-impact fire destroyed the cockpit and inboard sections of the wings, including most of the instrumentation and the connections between the flight control cables and the control stick and rudder pedals. Damage to the engine and propeller indicated that the engine was delivering power to the propeller at the time of impact.
