# Collision between *F & K* and *Jolly Roger* off Groote Eylandt, Northern Territory

16 April 2009

MAR10/ATSB57

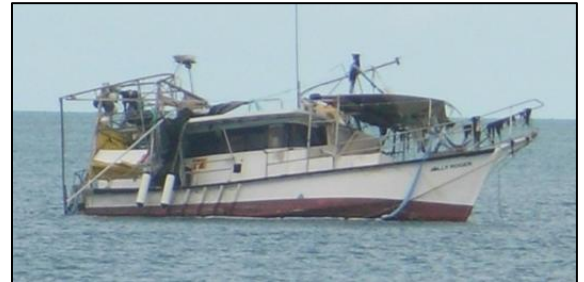
**Figure 2: *Jolly Roger* after the collision, refloated**

At the time of the incident, the hull and wheelhouse were painted white. A yellow canvas dodger was fitted around the after deck to protect the area from wind (Figure 2).

The collision pushed *Jolly Roger* over to port, as the starboard outrigger came into contact with the ship's hull, and water began flooding into the vessel. The deck hands managed to get clear and into one of its dinghies.

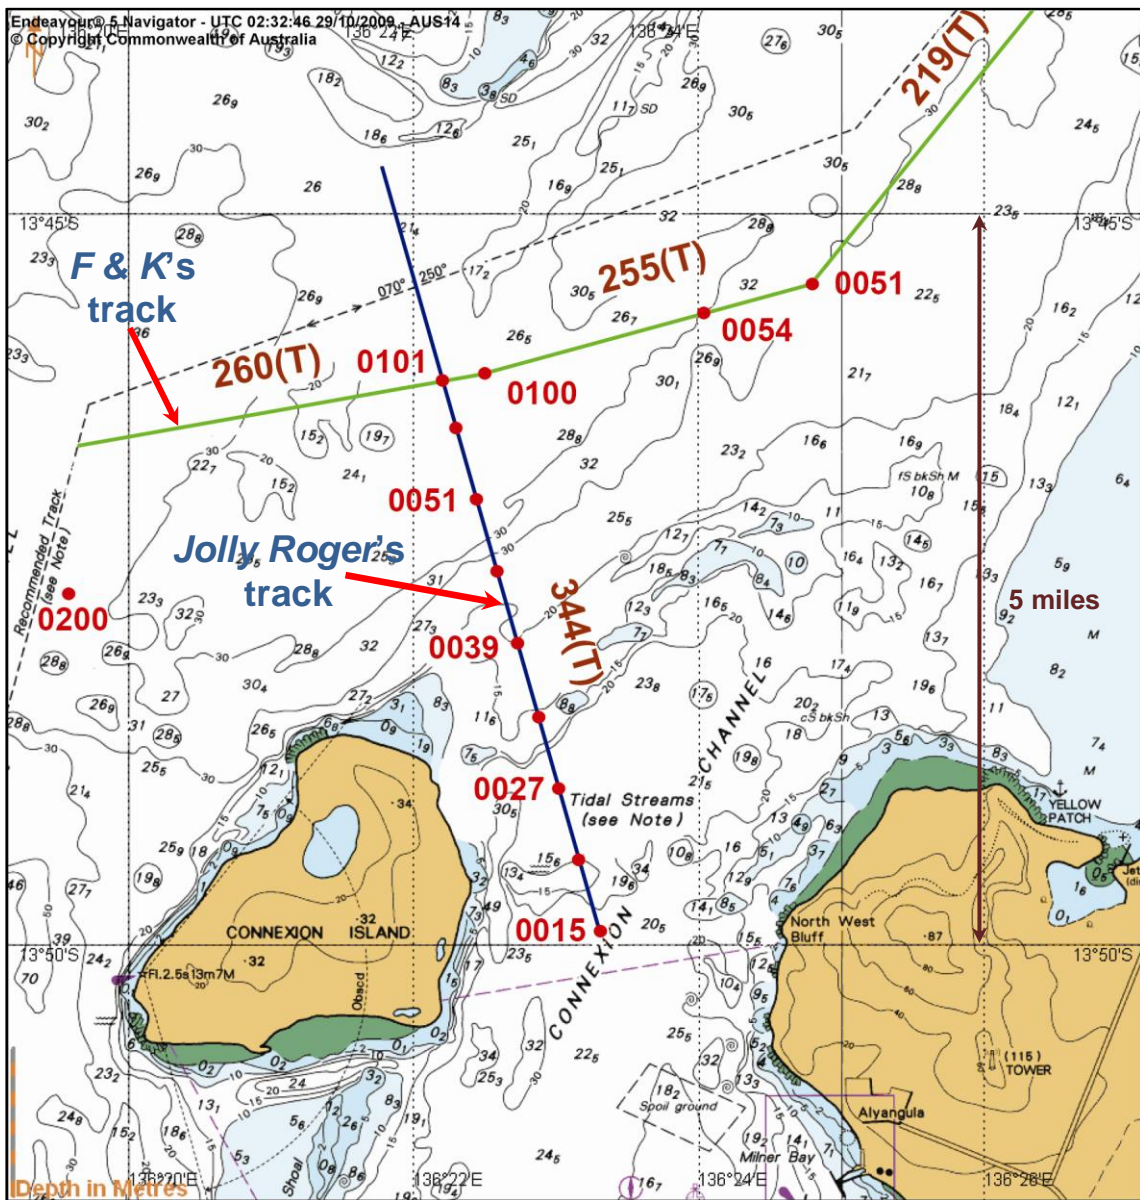
Figure 3: Section of navigational chart Aus 14 showing respective positions of the two vessels leading up to the collision

At about 0050, *F & K's* lookout took the helm and the master ordered an alteration of course to 255°(T). At that time, the ship was to the south of the recommended track of 250°(T) between Connexion and Warwick Channels (Figure 3).

When *F & K's* bridge team first became aware of the small vessel, it was fine on the ship's port bow. At about 0050, the ship's course was altered to starboard. This then placed *Jolly Roger* about 2 points<sup>9</sup> on the ship's port bow; the master then thought that the alteration had made *F & K* an overtaking vessel and that a heading of 255°(T) would result in a sufficient passing distance between the two vessels. However, by now the compass bearing between the two vessels was almost constant and they were in danger of colliding.

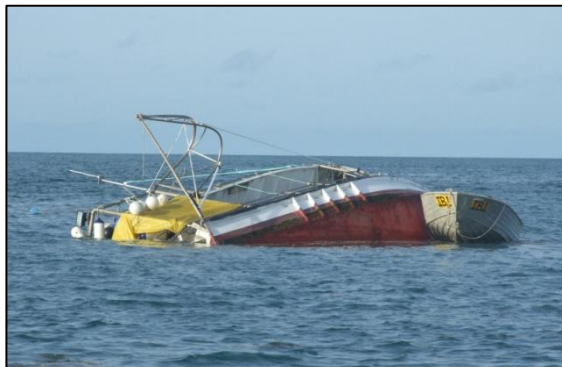
**Figure 4: The semi-submerged *Jolly Roger***

Having tried unsuccessfully to get *F & K*'s master and second mate to come down to talk further with them about the collision, *Jolly Roger*'s crew's decided to leave the vessel floating in the channel (Figure 4) and make their way back to Alyangula.
