Man overboard fatality from the research survey ship *Geosounder* 25 August 2007

ABSTRACT

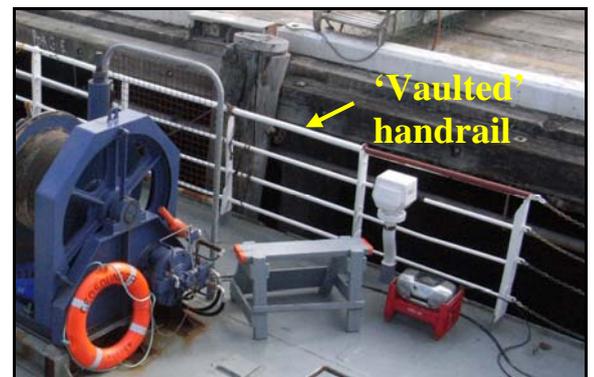
Figure 3: Handrail that IR1 fell over

At about the same time, IR2 who had been assigned to the twelve to four watch, was conducting his rounds. He passed IR1 and the boatswain while they were near the shelter deck portside handrail (Figure 3).

At about 0310, as IR1 pretended to vault the rail, his movement was amplified by the ship's motion so that he overbalanced and fell over the port handrail and into the sea.

Both IR2 and the boatswain saw IR1 overbalance and they reached out to grab him but were unable to prevent him falling overboard.

At about 0230, the second mate thought that IR1 was a little unsteady on his feet when he passed through the wheelhouse. He was probably affected by fatigue and by his alcohol intake at that time. This, in turn, would have affected his judgement, resulting in his skylarking on the shelter deck handrails in the first place, but also his ability to recover from overbalancing once he had started to fall over the railing.
