Crew member seriously burned by steam on board *MSC Sonia*

At about 0945¹ on 10 April 2007, *MSC Sonia's* boatswain and ordinary seaman were on the top platform of the ship's funnel casing, painting the starboard main engine exhaust pipe, when steam unexpectedly exhausted from the nearby boiler safety valve vent pipe. The ordinary seaman was seriously burned by the steam.

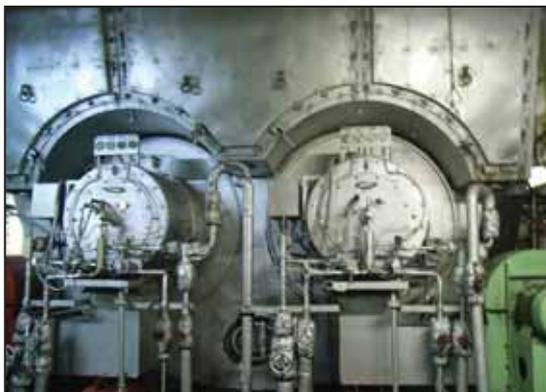
Figure 2: Auxiliary boiler

When in port, the ship's steam demand is serviced by a single Osaka Boiler Mfg Company DE 48030-150 cylindrical smoke tube boiler (Figure 2). The boiler is fitted with

At full load, the boiler produces 15 000 kg of steam per hour at a nominal working pressure of 7.5 bar⁴.

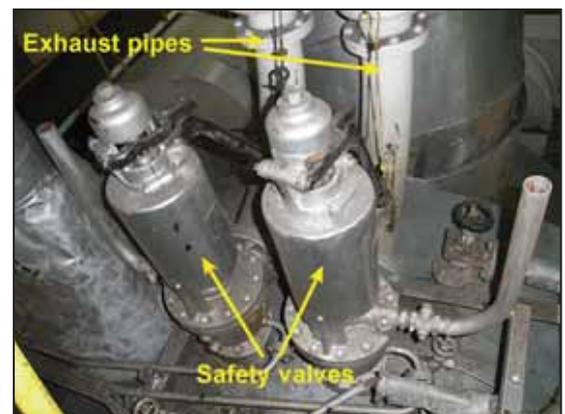
Figure 3: Auxiliary boiler safety valves

The boiler is fitted with two safety valves (Figure 3). These valves are designed to limit boiler pressure to a maximum of 13 bar. However, due to the age of the boiler, the safety valve settings had been lowered to 11 bar.

Each boiler safety valve is fitted with an exhaust pipe which connects into a common line that vents at the top of the funnel casing.

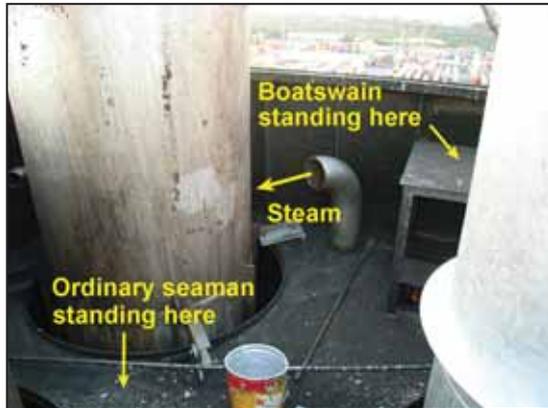
Figure 4: Funnel casing top platform

The boiler safety valve vent pipe (Figure 4) is mounted on the starboard side of the funnel casing top platform. It stands about 0.5 m above the deck and is terminated with a right angle bend. Any exhausting steam is directed inboard towards the main working area of the platform.

This arrangement is similar to many such vent pipes. However, the design does not take into account the fact that personnel can, at times, be working on the platform.

Had the pipe been designed so that it directed the exhausting steam away from the working platform or at a height well above the height of a person standing on the platform, it is likely that the ordinary seaman would not have been injured.

The placement of the steam vent pipe, and the direction in which it exhausted, meant that any personnel on the funnel casing top platform were vulnerable when a boiler safety valve operated.

The ATSB advises the owners, operators and masters of ships to consider the implications of this safety issue and take action where it is considered appropriate.
