ATSB TRANSPORT SAFETY INVESTIGATION REPORT
Marine Occurrence Investigation No. 225
Final

Independent investigation into the crew member fatality
on board the Bahamas registered passenger ship

Pacific Sun

5 February 2006

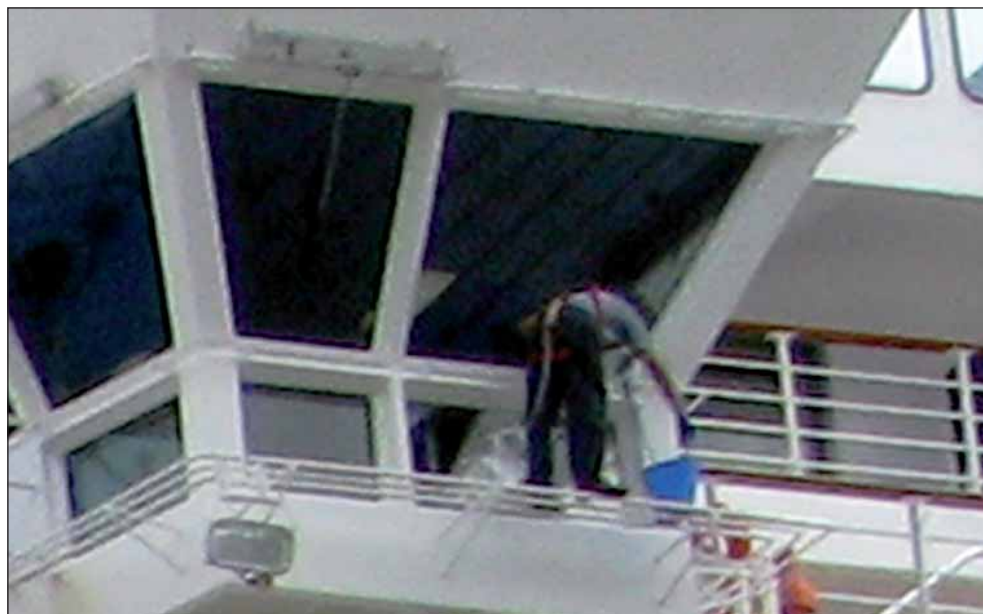
Figure 3: The quartermaster's foot extending beyond the edge of the catwalk

Normally, a person standing on such a catwalk would have their weight slightly forward when cleaning windows but because of the outward slope of the bridge wing windows, it is not always possible. There are times when the person must lean out and thereby have their centre of mass suspended over clear air and so the security of the harness is critical under these circumstances.

The quartermaster was wearing lace-up steel capped working shoes at the time of the incident. An examination of the shoes after the incident found that they were not laced up tightly, possibly to allow them to be slipped on and off when moving through passenger areas of the ship. These loosely laced shoes may have been insecure and unstable on his feet when working on the catwalk, a fact which, combined with the catwalk construction, may have led to him losing his footing.

3. The quartermaster probably lost his footing on the catwalk, possibly partly the result of having very loosely tied work shoes, while moving his harness lanyard past a grab rail bracket.

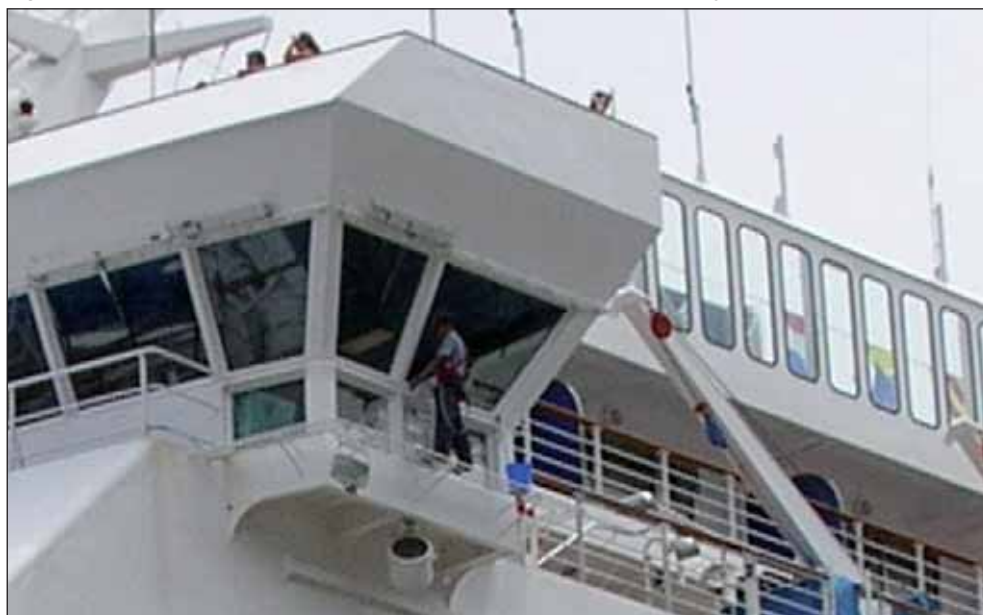
Figure 4: The quartermaster near the middle bracket immediately before the incident

From the time stamps on the witness photographs it was possible to construct a sequence of events which showed that the quartermaster had progressed all the way along the port side to the limit of the harness lanyard before returning to the grab rail bracket in the middle. The last photograph in the sequence shows the quartermaster standing on the catwalk adjacent to the middle bracket with both of his hands at the grab rail near the bracket (Figure 4). Considering his movement pattern, it is probable that he was moving the lanyard past this grab rail bracket when he lost his footing and fell.

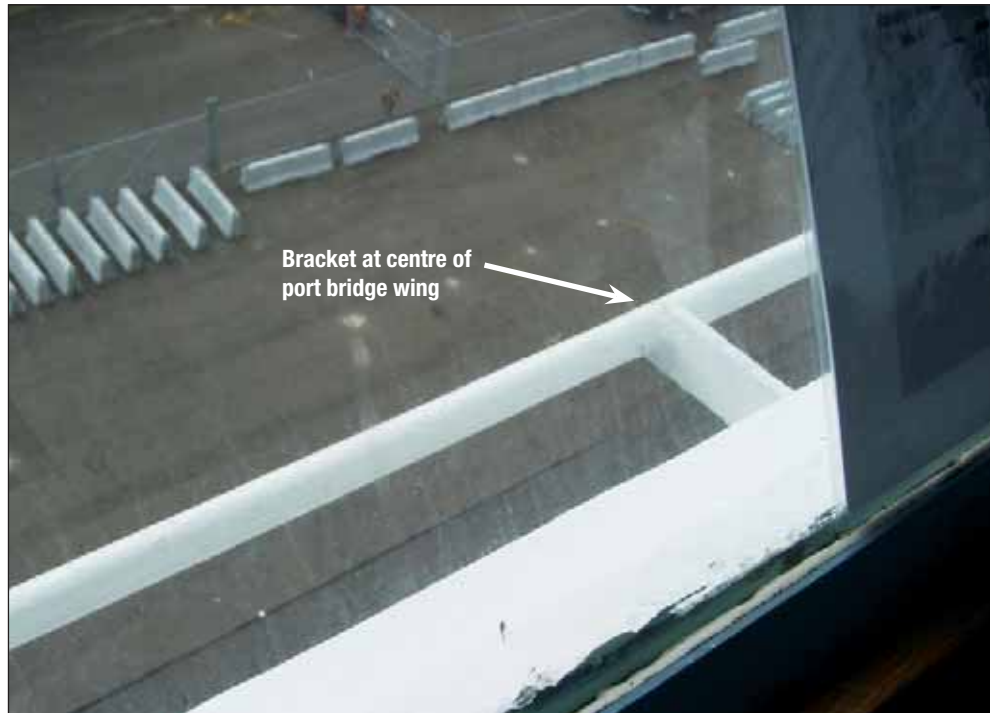
Figure 6: Grab rail bracket

Once secured, the lanyard cannot be moved past the brackets on the grab rail (Figure 6). To move along the catwalk, the wearer must disconnect the lanyard and reconnect the clip past each bracket. The fact that it is difficult to fasten the clip with one hand possibly encouraged the use of two hands to unclip, move and re-secure the lanyard. For this critical period of time it is likely that the wearer will have neither the lanyard secured nor a hand free to hold onto the grab rail.

The design of the harness with only a single lanyard did not allow the harness to be attached to the ship in any way while the lanyard was being moved past a bracket.

4. The single harness lanyard securing arrangement was inadequate in that it needed to be disconnected from the ship's structure in order to move it past brackets without having a secondary method of securing the quartermaster.
