AUSTRALIAN TRANSPORT SAFETY INVESTIGATION REPORT
 Marine Occurrence Investigation No. 230

Crew member fatality on board *Probo Bear*

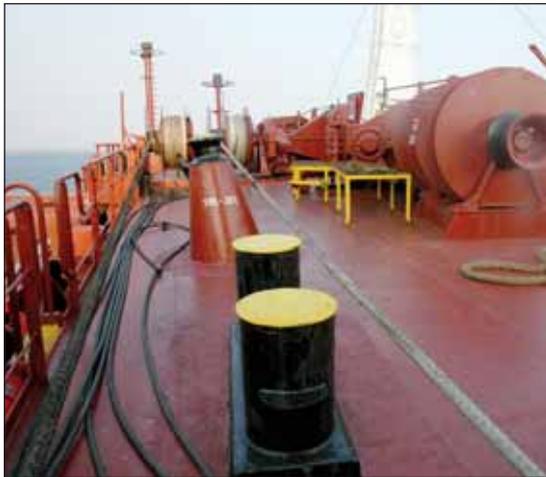
Figure 2: Aft end of forecastle

The aft end of the ship's forecastle is a very congested area. It contains two large windlasses, a double drum winch, the foremast and a small deckhouse to protect the ladder access down to the forecastle store (Figure 2).

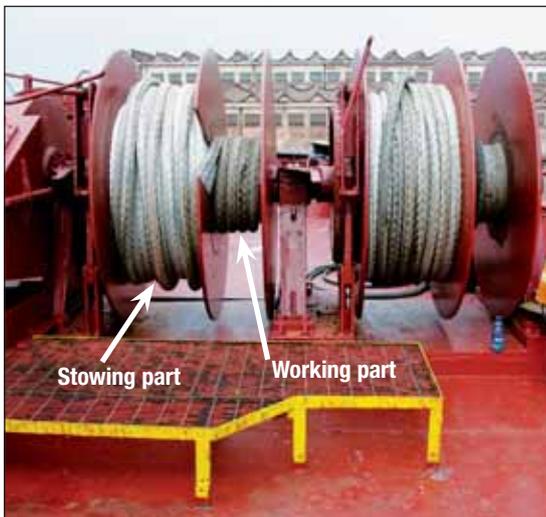
Figure 3: Forward mooring winch

The two drum winch for the forward spring lines is positioned on the ship's centreline, with the mooring lines leading from the top of the drums when the ship is starboard side alongside. The two drums are in line on a common axle, and are powered using the same hydraulic motor. Each of the two drums is divided into two sections, the stowing part and the working part (Figure 3).

The working platform for the winch is in two parts. A higher section behind the winch motor controls and a lower part behind the winch drums that gives access to the winch brakes (Figure 3). The platform extends aft as far as the mid-section of the stowing part of the aft drum, and thus does not provide adequate support for those accessing the aft brake handle.

It is possible that the AB may have lost his footing while reaching for the winch brake handle, overbalanced, and fell forward, putting his head in close proximity to the winch drum.

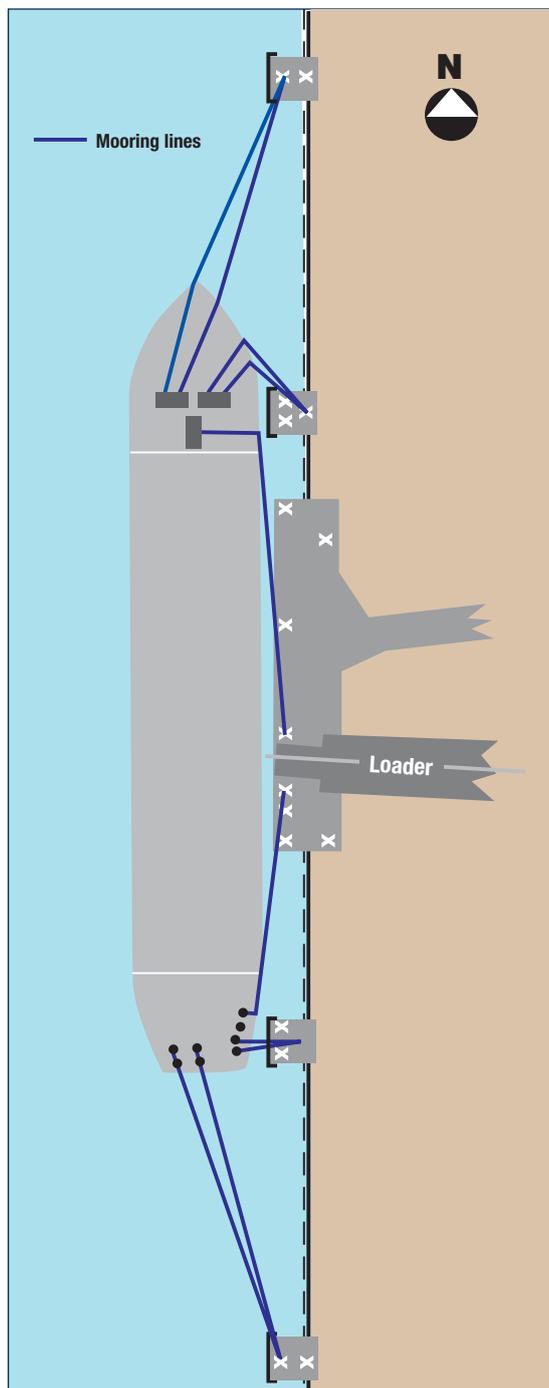
Figure 4: Initial mooring arrangement

Two head lines had been made fast on the northern mooring dolphin, two forward and two aft breast lines on the two dolphins adjacent to the jetty, and the stern lines on the southern dolphin. The forward spring line was made fast on the jetty to a quick release hook under the loading boom. The aft spring line was made fast on the jetty to one of three bollards south of the loading boom (Figure 4).
