ATSB TRANSPORT SAFETY INVESTIGATION REPORT
Marine Occurrence Investigation No. 218
Final

Independent investigation into the engine room workshop
fire on board the Thailand registered bulk carrier

Opal Naree

at Dampier, Western Australia
15 September 2005

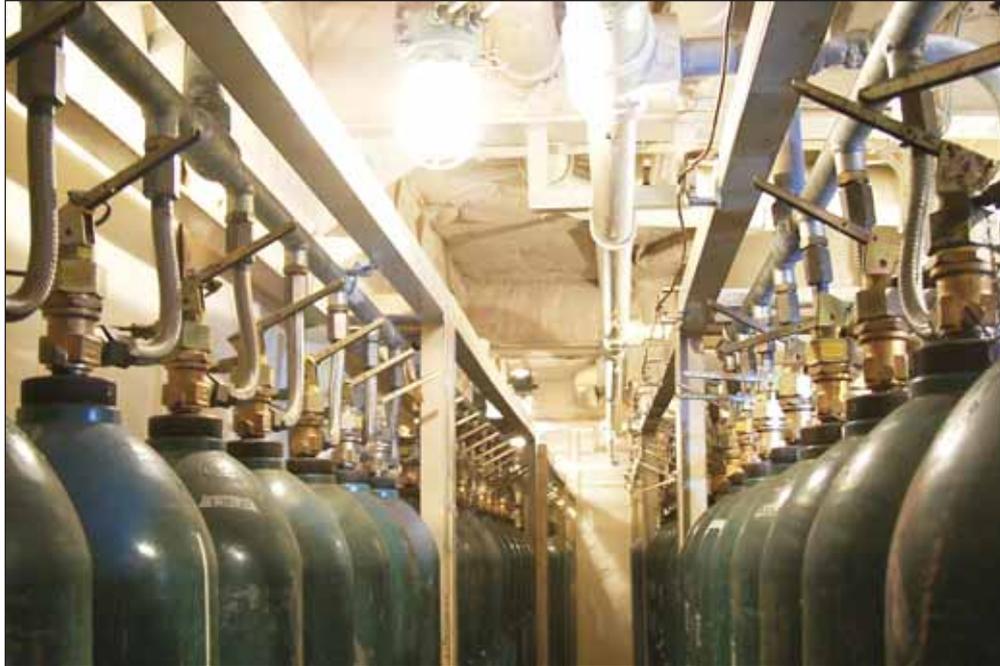
Figure 2: CO₂ system

Opal Naree's machinery spaces are not fitted with a fixed fire detection and alarm system. The ship was fitted with a fixed carbon dioxide (CO₂) fire extinguishing system that consisted of 101 gas cylinders, each cylinder containing 45 kilograms of CO₂. The cylinders were connected to a common distribution manifold that supplied CO₂ to the engine room or the cargo holds (Figure 2).

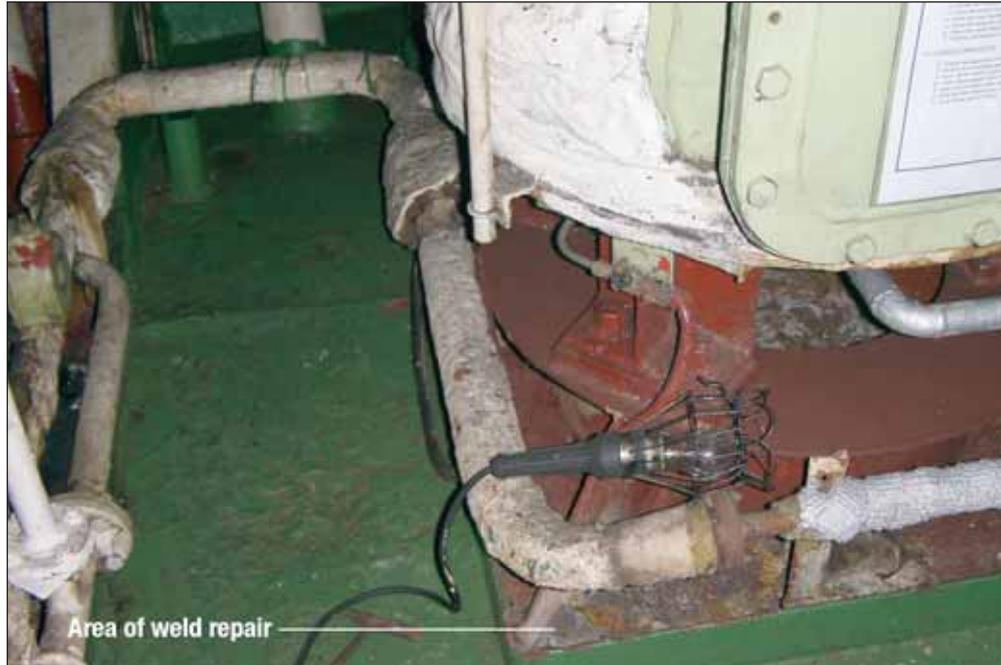
Figure 3: Sewage system save-all

Following the PSC inspection the crew attended to the deficiencies found during the inspection and carried out a number of other routine maintenance tasks. One of the maintenance tasks was a weld repair on the base of the sewage tank save-all (Figure 3). The sewage system is located on the compressor deck, one deck above the engine room workshop. Consequently, the save-all base forms part of the workshop deck head.

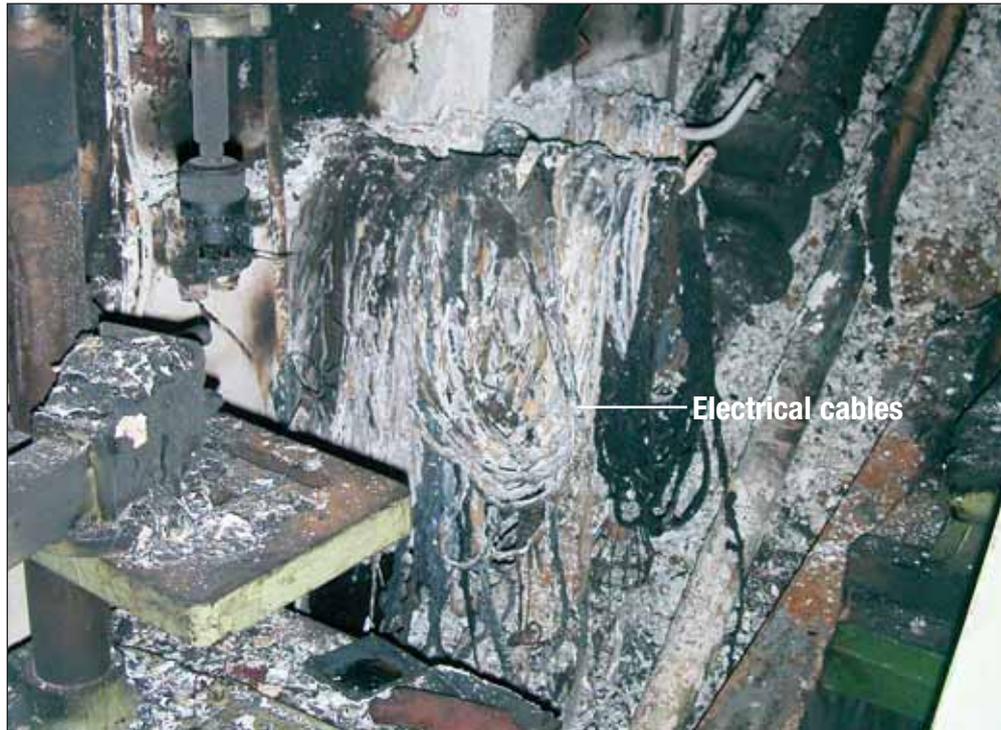
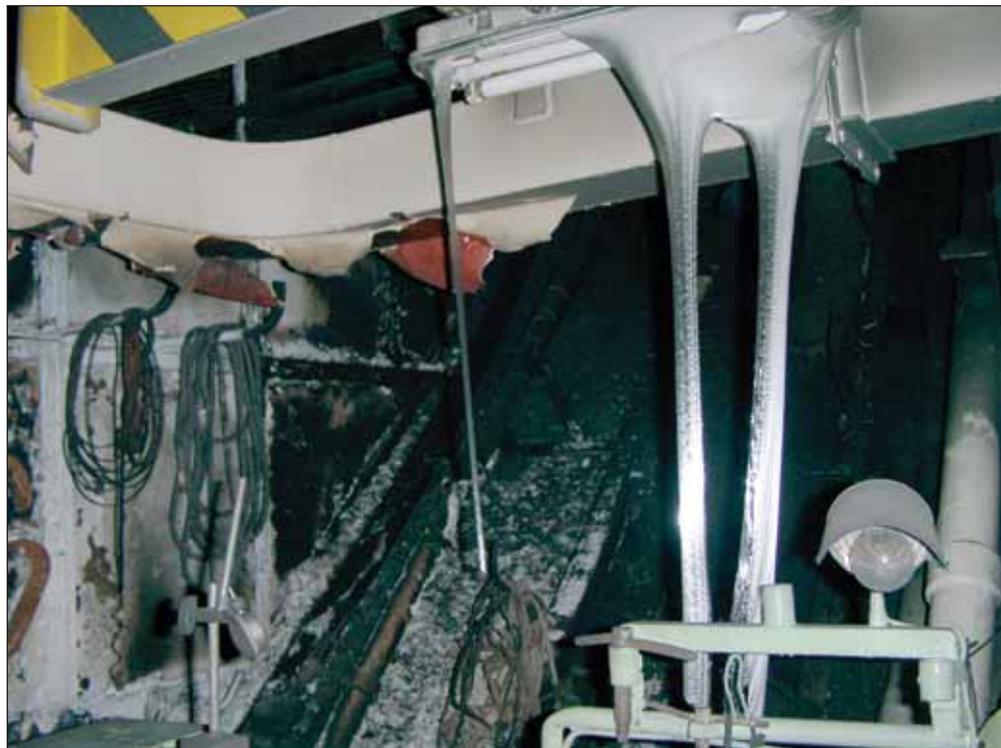
Figure 4: Fire damage to engine room workshop

At 0230 on 16 September, the master and chief engineer checked the oxygen content at the engine room entrance. After determining that it was safe to enter, they then made their way into the engine room and inspected the workshop (Figures 4 and 5).

The holes in the save-all base that required repair were only about 2 mm in diameter. However, the plate surrounding the holes was wasted. Inspection of the area after the fire revealed that the hole in the deck plating had increased in size to about 20 mm in diameter.

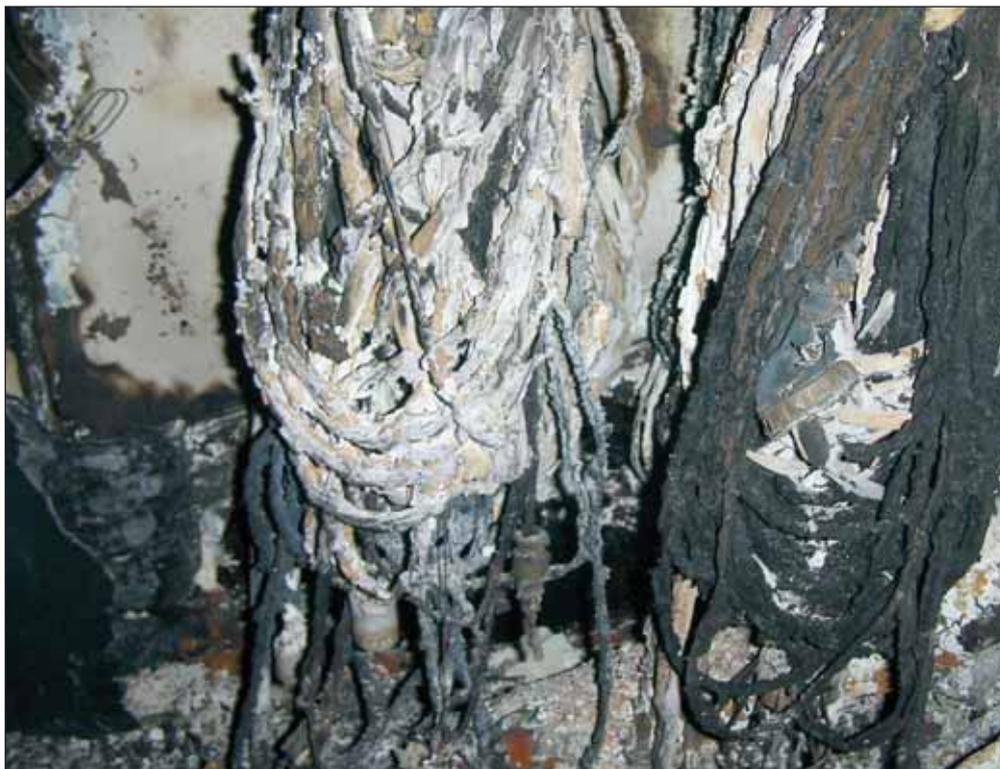
Figure 6: Burnt coils of electrical cables

It is probable that the force of the electric arc blew a hole in the plate during the welding process. This resulted in free molten metal falling into the workshop below. Located in the workshop directly below the area where the welding was taking place were coiled electrical cables. The molten metal probably landed on these cables causing the insulation to ignite (Figure 6).
