Fatality aboard *Golden Bell*, Dampier WA

16 May 2005

Fatality following fall in engine room

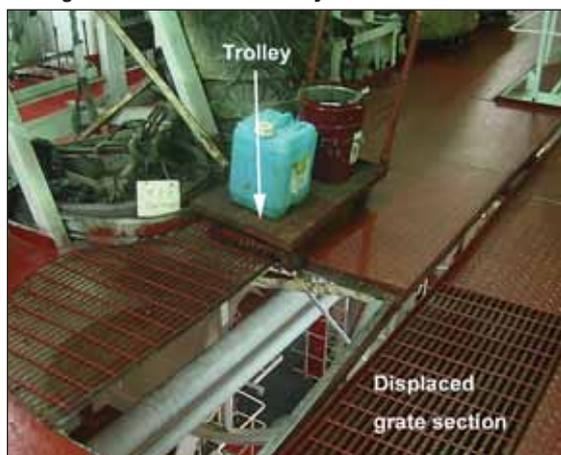
FIGURE 2:
Deck grate and hole immediately after the accident

The second engineer pushed the trolley from the drains condenser around the forward side of the main engine towards the port side of the engine room (Figure 3). As he was approaching the lift, the trolley came to a sudden stop. Looking down, he saw that one of the front wheels of the trolley had dropped into the open section of deck grating (Figure 2).

Almost immediately, the second engineer saw a movement out of side of his left eye. This was the engineer cadet who had followed him from the drains condenser and was in the process of passing him. According to the second engineer, the cadet did not appear to see the open section of grating and had stepped into the hole.

A number of sensible preventative measures were available to *Golden Bell's* crew. These included placing the removed section of grating over the hole created (90 degrees opposed), roping off the area, putting up some other form of barrier or placing a man on guard.

Ship owners, managers and masters should revise operational procedures to reflect the need to ensure that open deck areas on board their ships are adequately safeguarded.

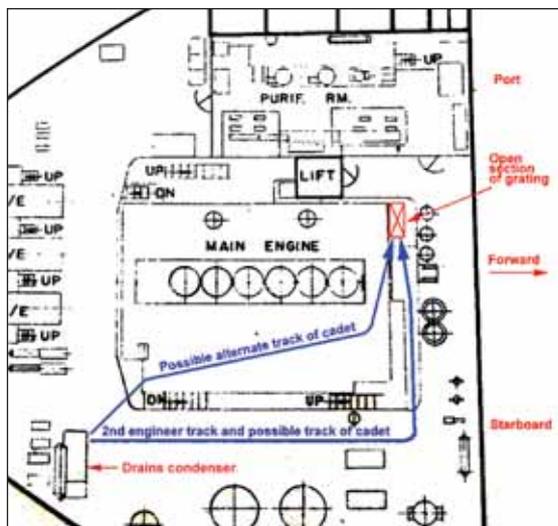
FIGURE 3:
Engine room plan section (third deck)

At about 0900, in order to gain access to the steam valve, the oiler removed a section of deck grating from the third deck, forward and to port of the main engine (figure 3). He placed a danger sign near the open section of grating as a warning to crew using the area. The oiler then passed a long aluminium extension ladder through the hole to the third engineer standing on the intermediate deck below. The ladder was to be used to stand on while repairing the valve, with its feet on the bottom deck plates.

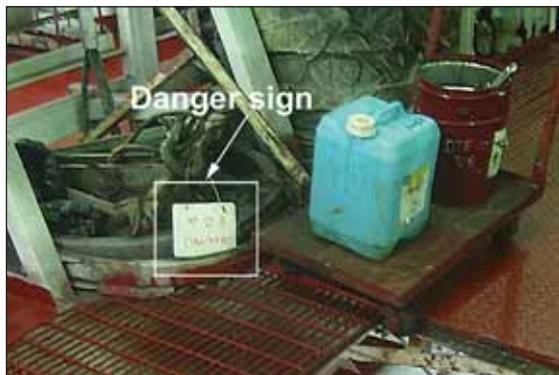
FIGURE 5:
Posting of danger sign

However, the sign was placed at deck level and not at eye level, and it was facing the port quarter of the engine room. The sign's placement made it difficult to be seen by anyone approaching the area from the forward section of the engine room's starboard side.

It would appear that the second engineer was also unaware of the open section of grating as he only stopped walking when his trolley came to a stop. While he was stopped, the sign's visibility was further compromised.

The placement of the danger sign alone (as shown in Figure 5) was manifestly inadequate in the circumstances, given the degree of hazard created by the removal of the grating.
