Independent investigation into the collision  
between the Liberian flag bulk cargo vessel

# Silver Bin

# Chinderah Star

Report No 156

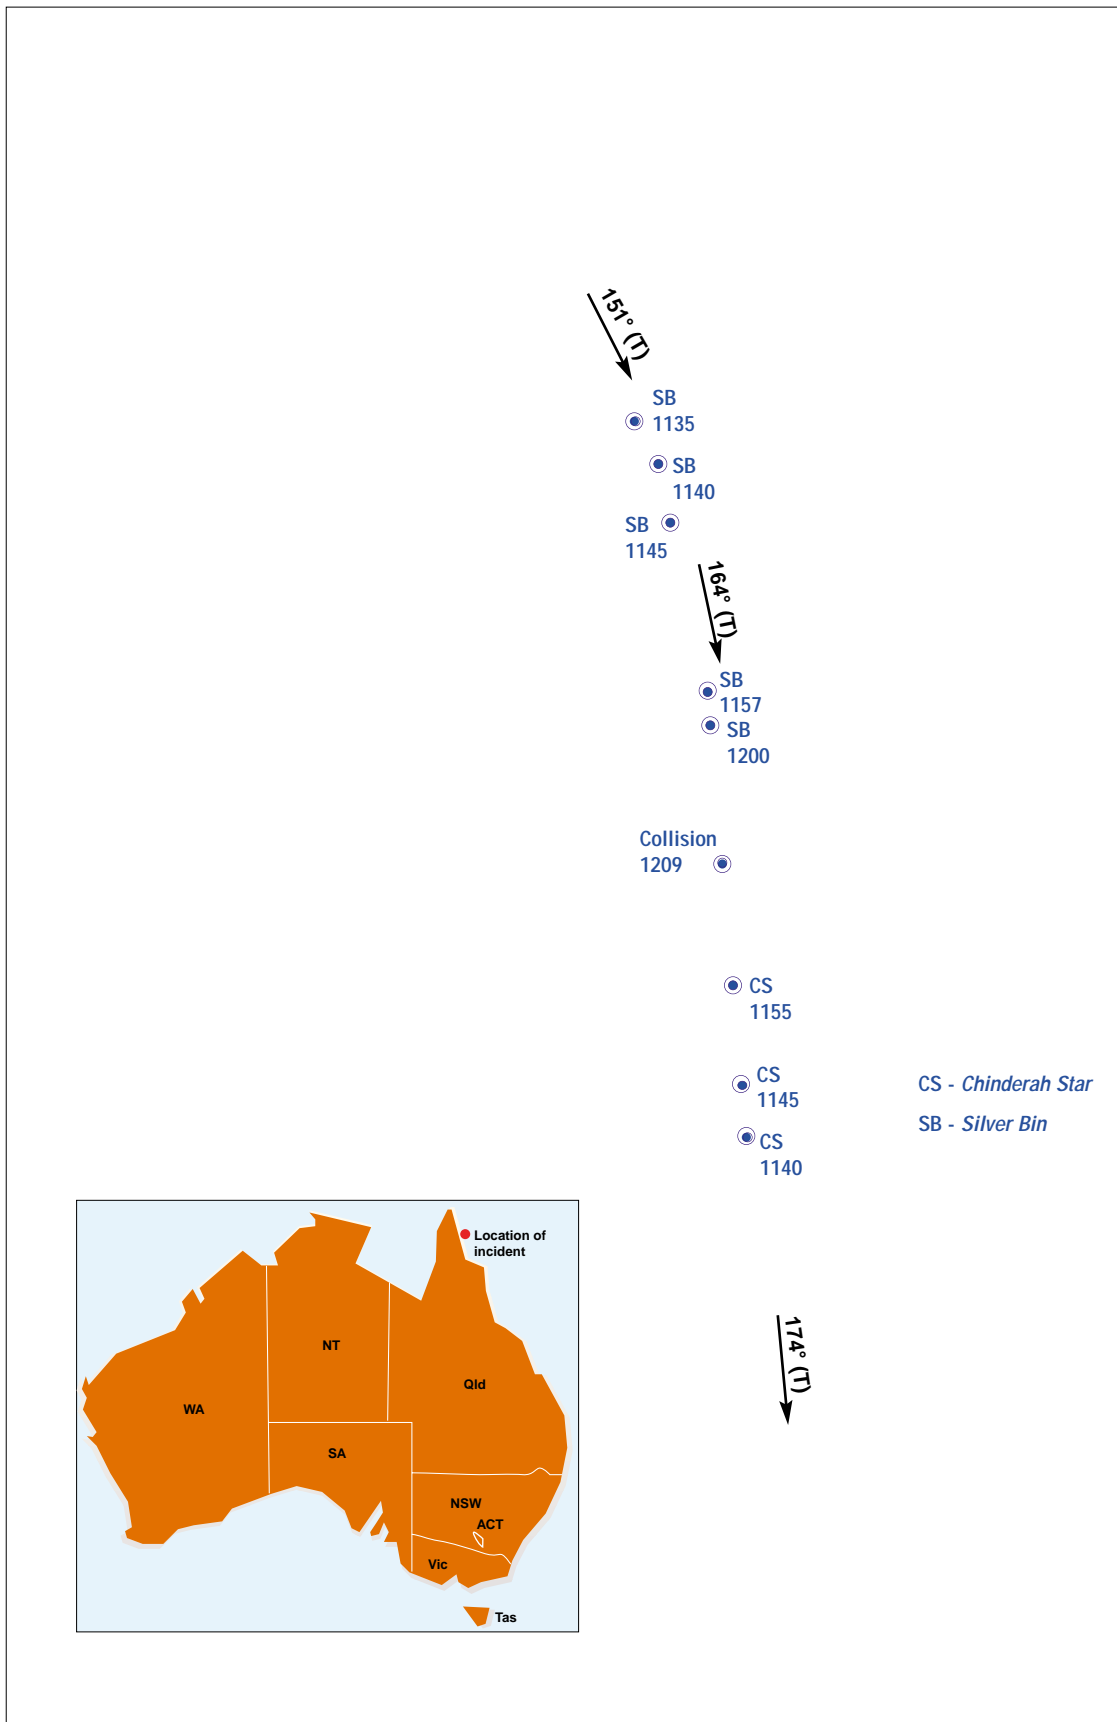
**FIGURE 4:**  
**Portion of chart Aus 834 showing area of collision and vessel's track**

*Silver Bin* and *Chinderah Star* collided at approximately 1209 on 25 March 2000, at a position of 12° 53.0' S, 143° 35.2' E, 0.6 miles from Chapman Island light on a bearing of 284° (T) (figure 4). This was the time and GPS position provided by the pilot and master of *Silver Bin*. The position was confirmed by the skipper of *Chinderah Star*.

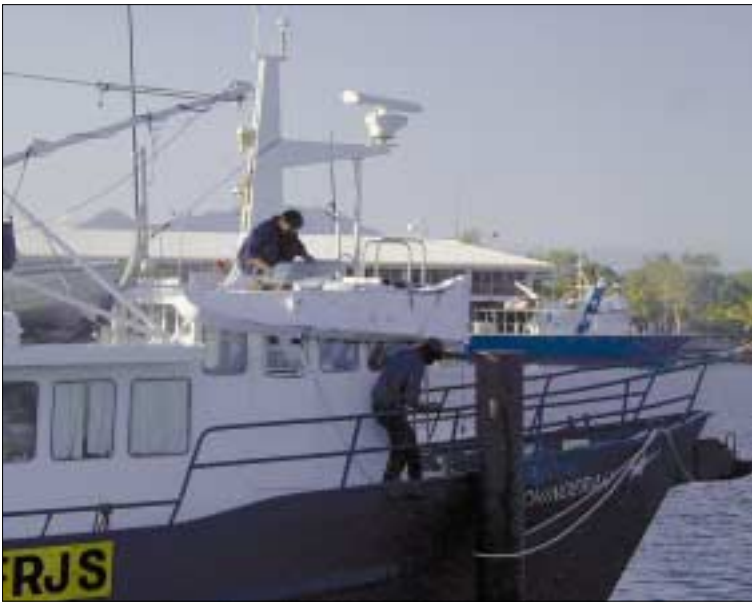
*Chinderah Star* presented as a well-maintained and well-equipped vessel. Damage was noted to the starboard forward handrails and bulwark alongside the wheelhouse (figures 5 and 6). The handrails and bulwark had been deformed and set-in. The wheelhouse visor had also been deformed and bent downwards on the starboard side of the wheelhouse, with the starboard forward wheelhouse window broken in the process. The starboard trawl boom had already been removed and cut to salvage the top rigged section. It was bent in a number of places including one bend of about 90° adjacent to the net spreader block. This cast brass block had also been cracked in the collision.

The deformed hand rails and wheelhouse visor both showed evidence of contact and light green/gray paint scrapes and flakes were found around these areas and lying on the trawler's foredeck.

**FIGURE 5:**  
Damage to starboard side of  
*Chinderah Star*

that the two vessels collided almost head on. The point of impact on the ship was on the starboard shoulder under the flare of the bow. First contact would have been the trawler's starboard trawl boom, which was in the stowed position with its top approximately 6 m above the water and 1 m or so outside the line of the starboard bulwark. The damage to the *Chinderah Star*'s wheelhouse visor would indicate that the trawler might have rolled towards the ship at the time of the impact, as the visor is inside the line of the starboard handrails and bulwark which were also damaged in the collision.

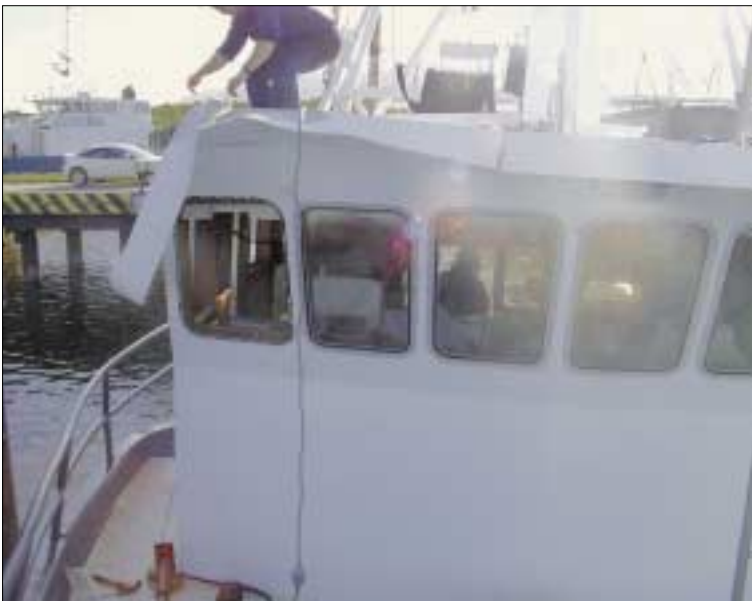
**FIGURE 6:**  
Damage to *Chinderah Star's*  
wheelhouse

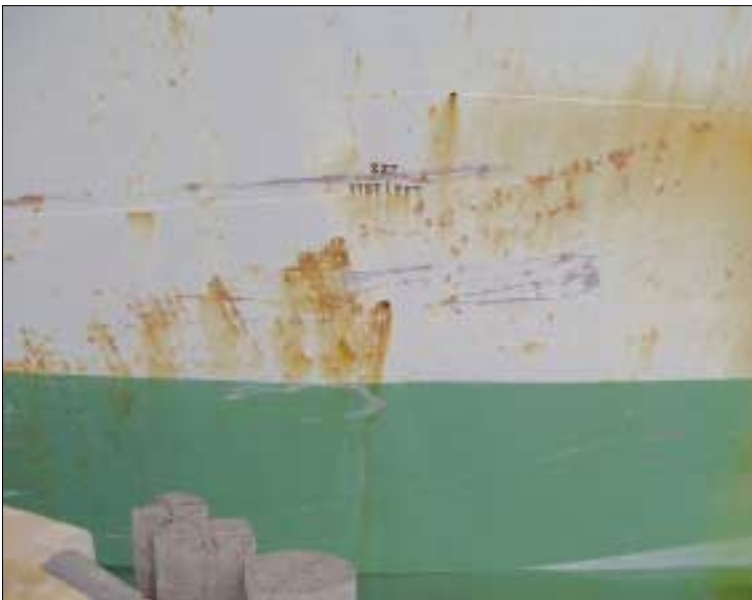
At 1225, the pilot made a call to Reef Centre on VHF channel 18 to report the collision, while the crew inspected *Silver Bin* for damage. The hull paint was found to be scraped at the point of impact under the flare of the starboard bow but there was no structural damage.

obtained including copies of the ship's navigation charts, log books, movement book, passage plan, course recorder trace and radar details. The master and third mate were interviewed and the ship inspected. Some fresh scoring was evident in the hull paint on the ship's starboard shoulder (figure 7) but there was no structural damage to framing or hull plating.

**FIGURE 7:**  
Starboard bow of *Silver Bin*,  
showing damage to paintwork  
at point of impact.
