MARINE SAFETY INVESTIGATION

Independent investigation into the  
collision between the British flag motor vessel

# Ariake

# Redcliffe

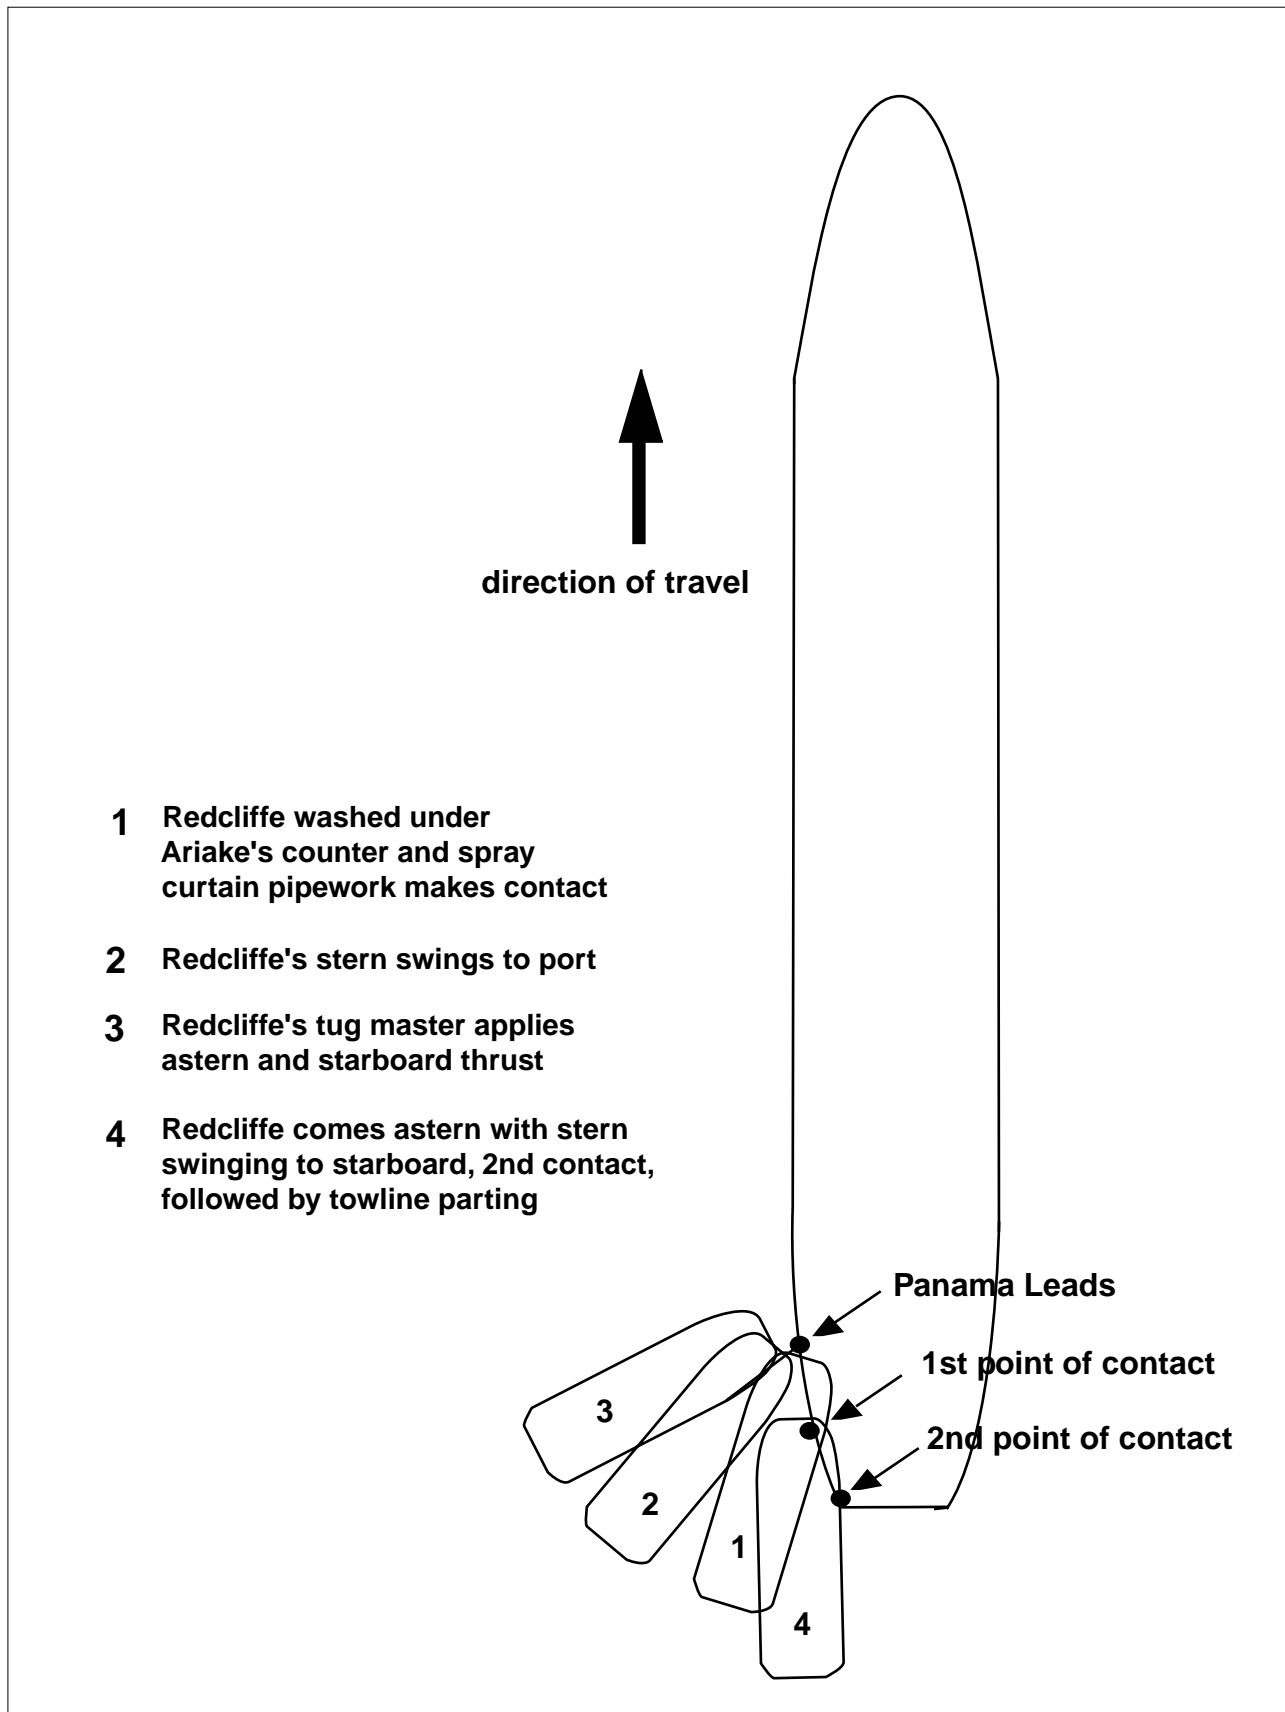
**FIGURE 4**  
**Ariake/Redcliffe collision reconstruction**

Once the crucifix bollards had made contact, they acted as a pivot point with most of the tug's length overhanging *Ariake*'s stern and the bow tethered by the towline. For a short time, *Redcliffe* continued to swing on the crucifix bollards, increasing the weight on the bollards and towline. With the increasing weight, the bollards were forced into the ship's side causing scoring, an indentation and a tear, approximately 400 mm in length, in the shell plating. *Redcliffe*'s crucifix bollards were set in and deformed in the process. The

weight on the towline was sufficient for the bit on *Ariake*'s deck to be 'strangled' (deformed around its circumference). With a little more swing and increasing weight, the towline parted between the tug's fairlead and the ship's panama lead (see fig. 4).

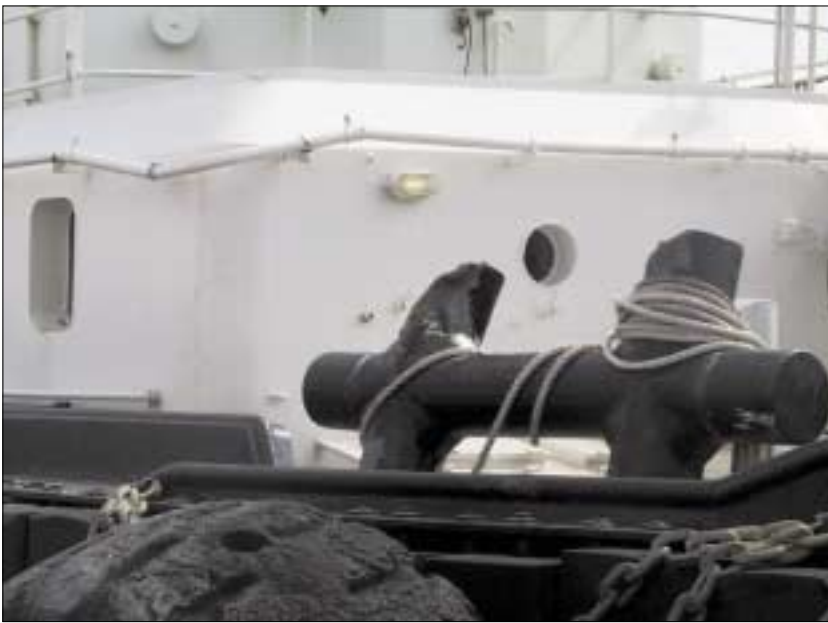
**FIGURE 5**  
Damage to *Redcliffe*

*Redcliffe* was inspected and damage was noted to the fire curtain pipe-work at the starboard forward corner of the deckhouse and also damage to the crucifix bollards located on the starboard shoulder (fig. 5). The tug is not equipped with any form of course recorder or engine manoeuvre recording equipment that may have assisted with the analysis of the incident. The tug master was the only member of the crew present on the bridge at the time of the incident and thus the investigation is reliant on his recollection of his actions and events at the time of the incident.

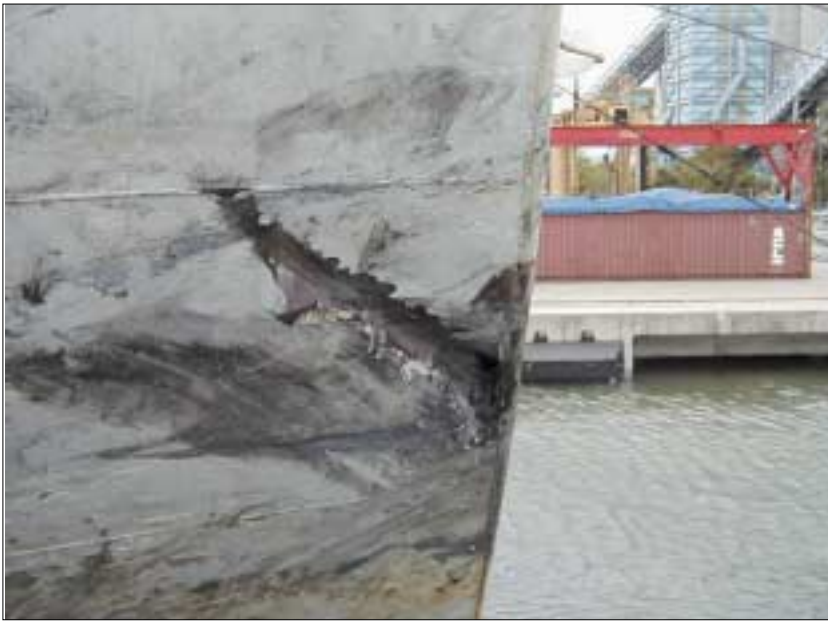
**FIGURE 6**  
Damage to *Ariake's* hull plating

*Ariake* was inspected and damage was noted to the shell plating at the port quarter just forward of the transom bar strake including the hole (fig. 6). The mooring bit on the port quarter was inspected and showed a deformation around most of its circumference consistent with the diameter and position of the tug's towline (fig. 7). The vessel was equipped with a course recorder and an engine movement recorder. The times for the engine movements and the ship's heading at the time of the incident can be verified from these records. At the time of the incident the second mate was standing on the poop deck with some other members of the ship's crew in preparation for the mooring operation and witnessed the movements of the tug at the time of the incident.

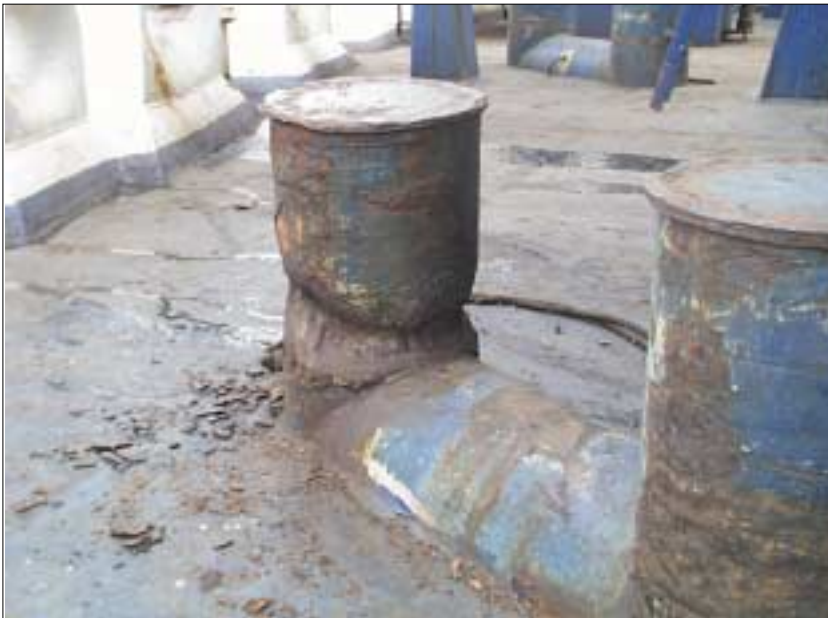
**FIGURE 7**  
Damage to *Ariake's* mooring bits

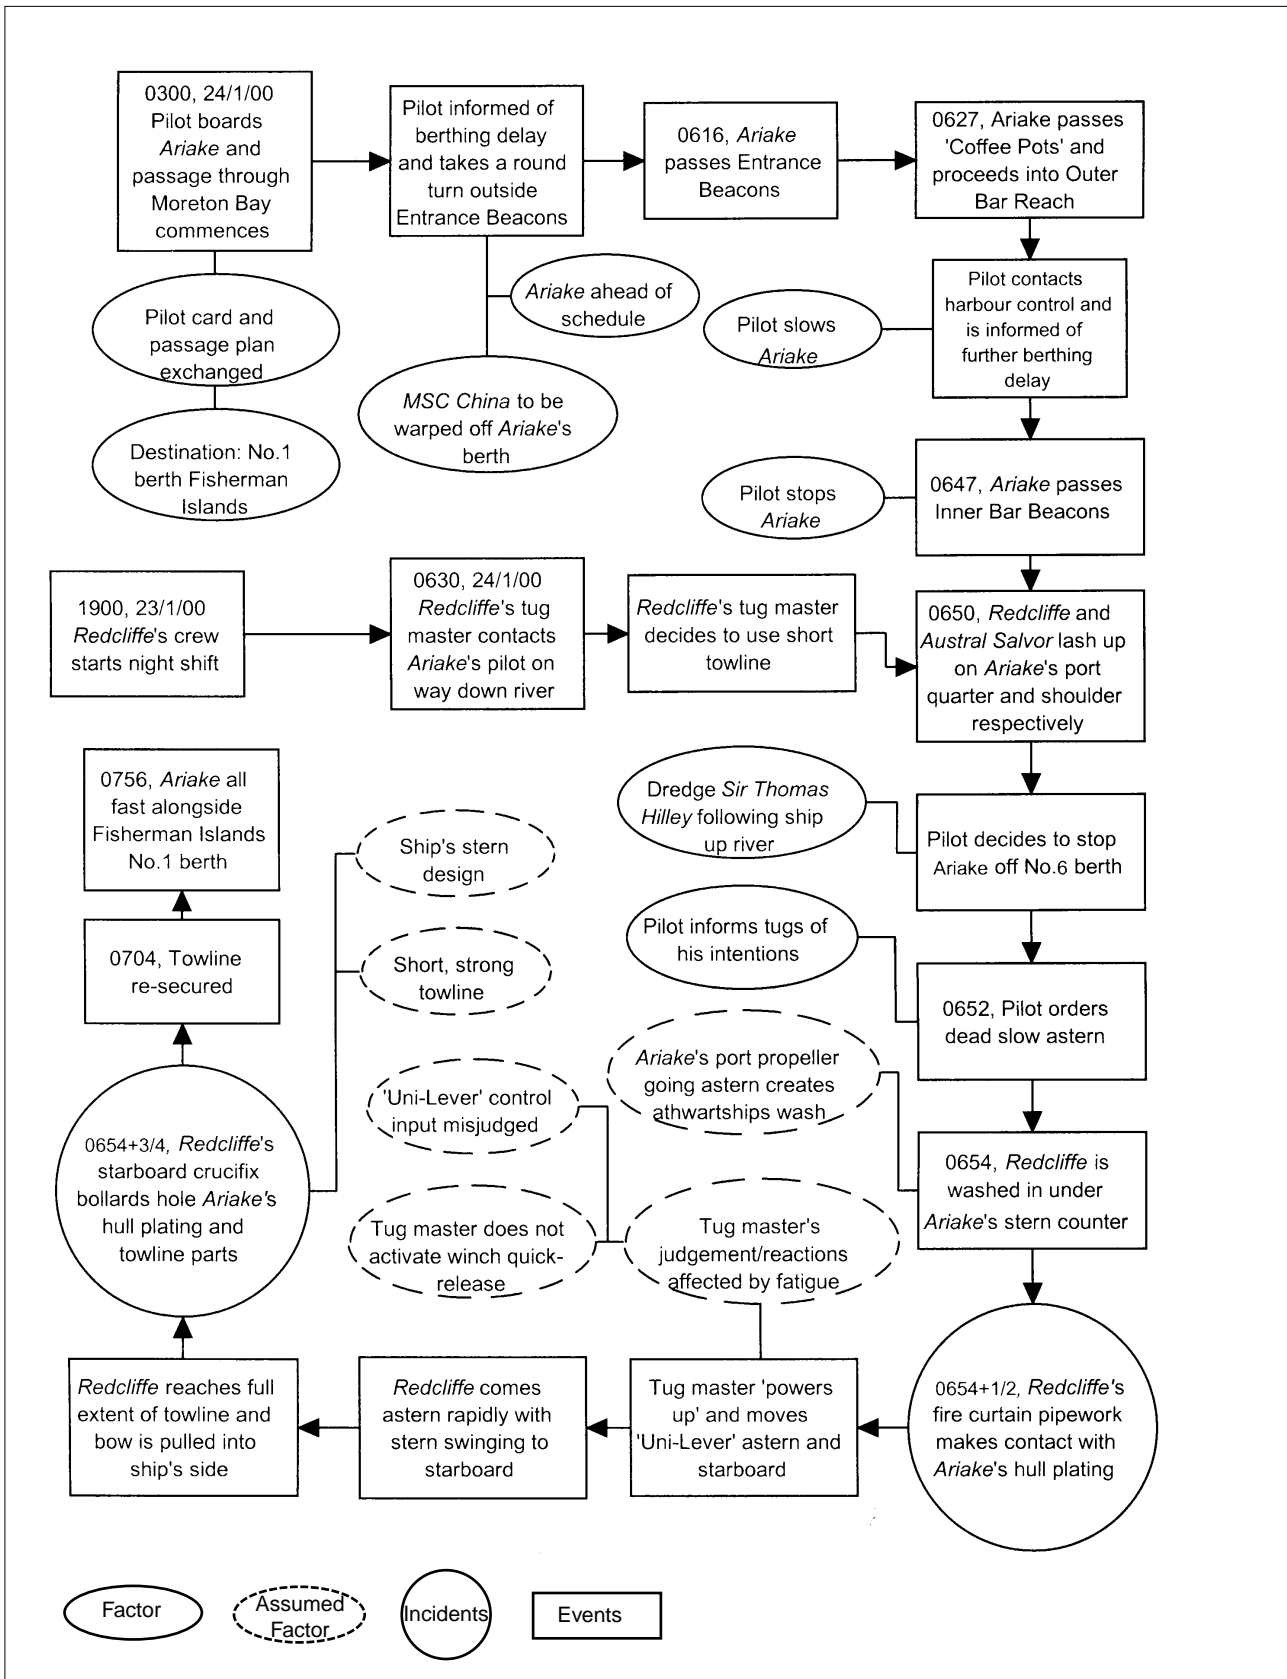
**FIGURE 8**  
**Ariake/Redcliffe collision events and causal factor chart**

2. The tug master misjudged his response to the initial impact of the spray curtain pipe-work which resulted in the second impact when most of the damage to the tug and ship occurred.

7. There are still some apparent ‘human factors’ issues with the control of the large ‘Duckpeller’ tugs in Brisbane and further training is indicated for tug masters in emergency procedures.
