Grounding of the bulk carrier *Shen Neng 1* at Douglas Shoal, Queensland

3 April 2010

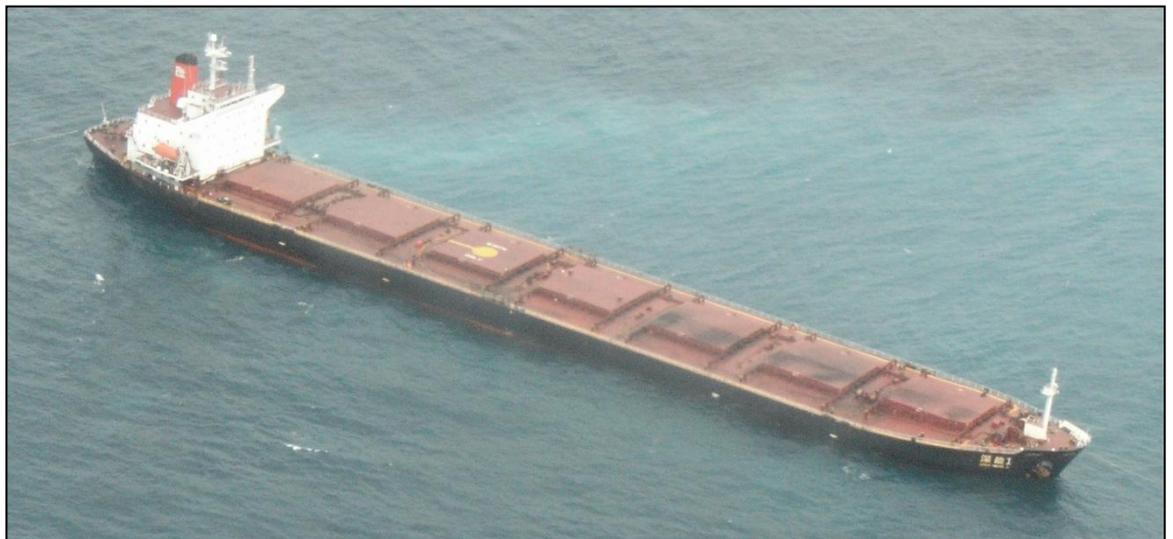
Shen Neng 1 aground at Douglas Shoal

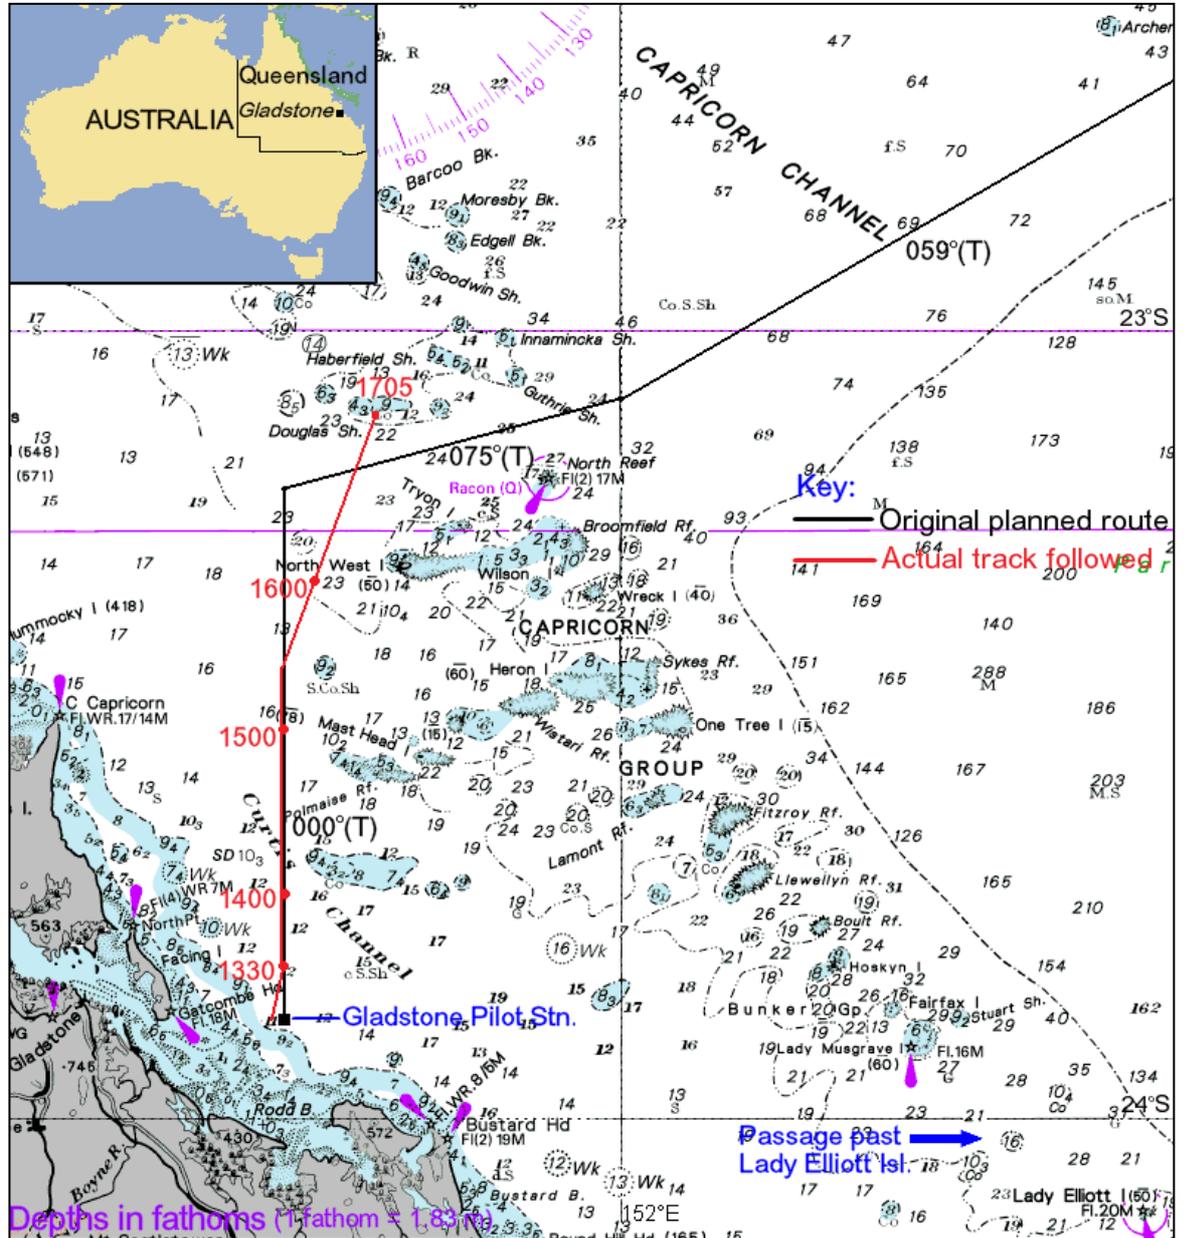
Figure 1: Section of navigational chart Aus 426 showing area off Gladstone and Shen Neng 1's original planned route, its actual track and positions plotted by the ship's crew

Ships can pass either to the north or the south of Lady Elliott Island, east-southeast of Gladstone. The island has a lighthouse and other islands in the vicinity are also fitted with lights (Figure 1).

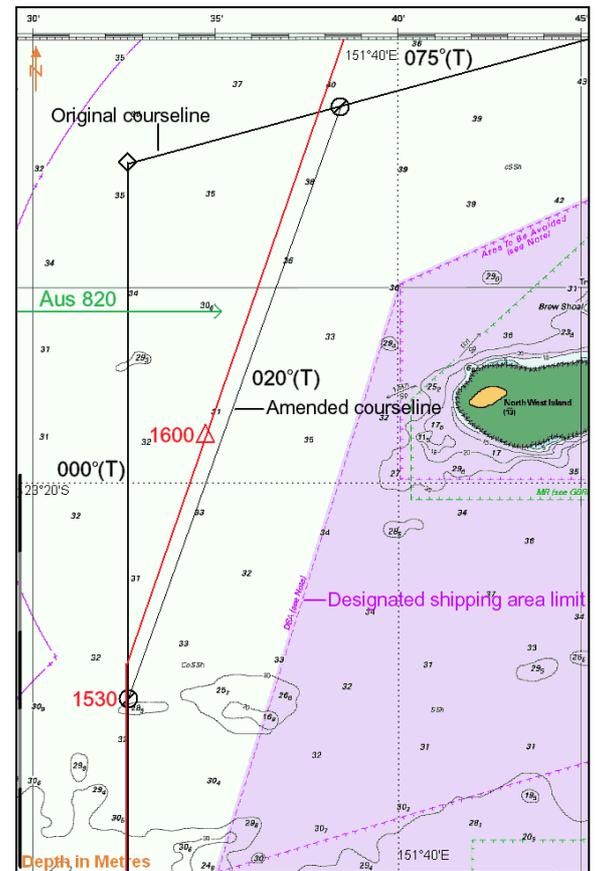
Figure 2: Annotated section of chart Aus 819

After *Shen Neng 1* had settled on the 000° (T) course in auto-pilot, the second mate asked the master if he could adjust the planned route to slightly reduce the passage distance. He indicated the proposed amendment on the chart. The master agreed and the second mate marked the amended 020° (T) track, about 3 miles from and parallel to, the DSA limit on chart Aus 819 and the next chart Aus 820. A line with the notation 'Aus 820' to indicate a change of chart was also marked on chart Aus 819 (Figure 2). The original route marked on chart Aus 819 was not erased.

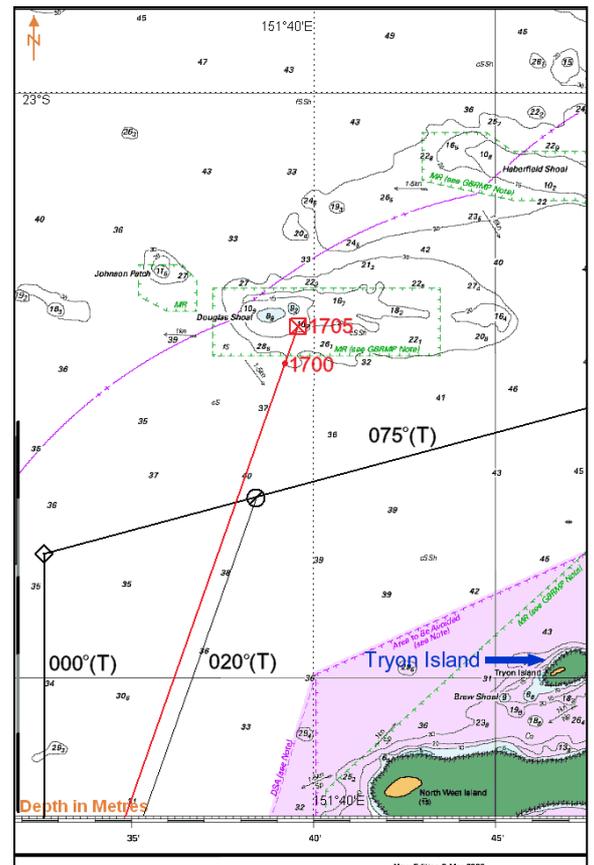
Figure 3: Annotated section of chart Aus 820

At about 1700, the chief mate recorded the coordinates 23°07.0'S 151°39.2'E in the GPS position log book. This position is not on chart Aus 819 so he took out chart Aus 820 from the chart table drawer. As he placed the chart on the chart table, he noticed that the ship's speed had decreased to about 8 knots. He also saw the 'no go area' marked on the chart around Douglas Shoal and realised the ship was closing on the shoal (Figure 3). He immediately ordered the duty seaman to engage hand steering and quickly alter course to starboard.

Just as hand steering mode was engaged, the chief mate saw the speed rapidly decreasing to zero and the ship began to shudder. The starboard helm applied had no effect and at 1705, *Shen Neng 1* grounded on a heading of 020° (T) and came to a shuddering stop. The GPS unit indicated the position 23°06.0'S 151°39.6'E, close to a charted depth of 10.7 m at Douglas Shoal where the sea-bed is composed of coarse sand, shells and coral. At Tryon Island nearby, a low water of 0.8 m was predicted at 1706 and a high water of 2.8 m was expected at 0002 the next day.
