TECHNICAL ANALYSIS REPORT No: 05/02

**Examination of failed components
from a Garrett TPE331-11U
turboprop engine**

**Fairchild Industries Inc. SA227-AC
VH-VEH**

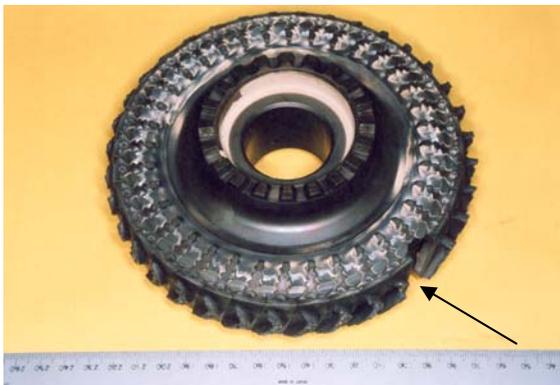
The stage-one turbine assembly comprised thirty-six air-cooled blades, retained within the disk by a tapered firtree connection (figures 1 & 2). While most of the turbine blades showed severe mechanical breakage immediately above the base platform, a single blade had broken away from beneath the platform (figure 3). Occurring at the top of the firtree root, the blade fracture was characterised by a stained and discoloured surface that presented several distinct regions (figure 4). The most dominant of these was a zone of fatigue crack progression-marks extending into the section from a small region on the outer surface of the root (concave blade side, figure 5). The total area of fatigue cracking represented around half of the total cross-section at the point of failure; the remainder showing features consistent with ductile overload fracture.

Fig. 1. Forward face of the stage-one turbine wheel – missing blade indicated.

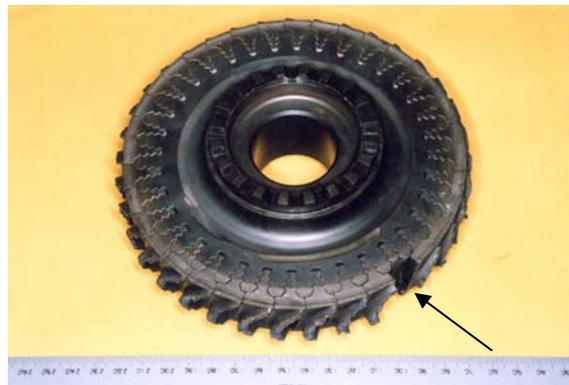
Fig. 2. Rear face of the stage-one turbine wheel – missing blade indicated.

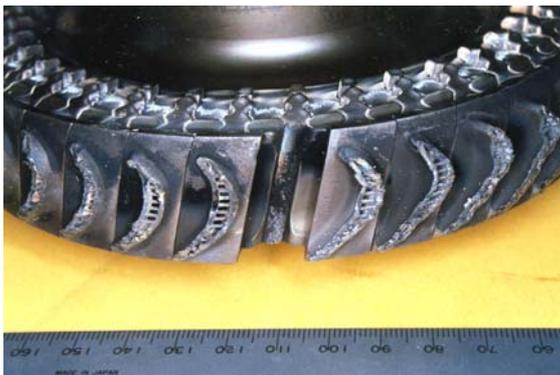
Fig. 3 (Top left). Failure of the turbine blade from beneath the platform base.

From the results of the investigation, it was evident that the failure of a stage-one turbine blade within the engine assembly was the principal cause of the engine malfunction observed by the aircraft crew. The blade had failed by bending fatigue cracking that had initiated at the top of the firtree root connection. By design, this location was the area of maximum centrifugal and aerodynamic stresses within the blade. Numerous regular arrest marks within the zone of fatigue cracking attested to the propagation of the cracking over multiple flight cycles. Final overload failure of the remaining section occurred after growth of the fatigue cracking to around half of the total root cross-section. The examination found no evidence of pre-existing defects or conditions that could have predisposed the blade to premature failure. The nature of the fatigue damage, with a large area of faceted Stage-I cracking was consistent with high frequency, low-magnitude driving stresses^[1].

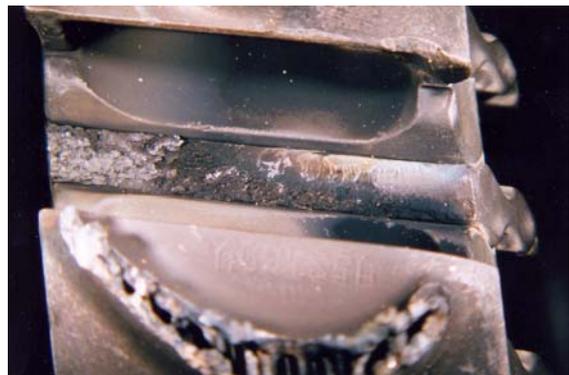
Fig. 4 (Above). Blade fracture surface (as-received).

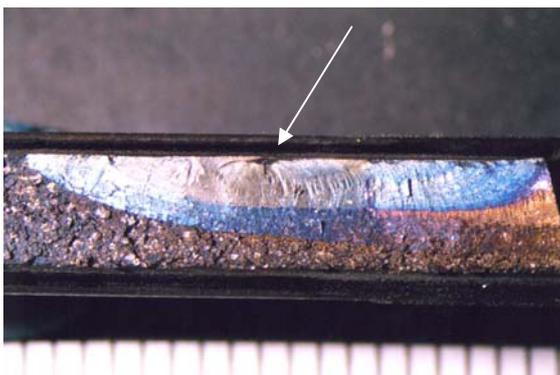
Fig. 5 (Left). Blade fracture surface following cleaning – area of fatigue progression markings clearly visible. Fatigue origin indicated at arrow.

Inspection at low magnification (approx 40X) found the fatigue cracking had initiated from the surface of the root section on the high-pressure (concave) side of the blade. The initial areas of fatigue propagation were characterised as featureless, faceted areas with no visible progression markings and fracture following defined crystallographic planes (figures 6 & 7). Such areas are typical of Stage-I fatigue cracking in nickel alloys. Similar features were observed for some distance along the edge of the fracture (figures 8 & 9). Located at 9.5 millimetres from the forward edge of the blade, the largest faceted area formed the base of several characteristic ‘ratchet’ marks often associated with fatigue crack origins (figure 10). At the higher resolution offered by the scanning electron microscope, the progression of Stage-II fatigue cracking from the base of the faceted area was clearly observed, with regular arrest marks identified (figure 11).

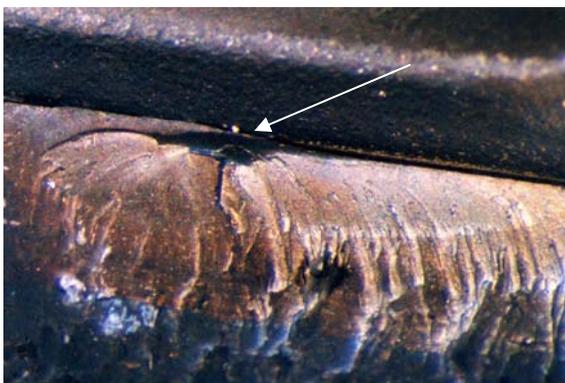
Fig. 6. Close optical view of the fatigue origin (arrowed).

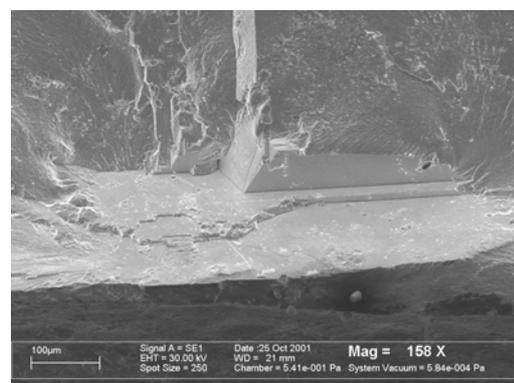
Fig. 7. Faceted appearance of the fatigue origin – typical of Stage-I fatigue crack propagation.

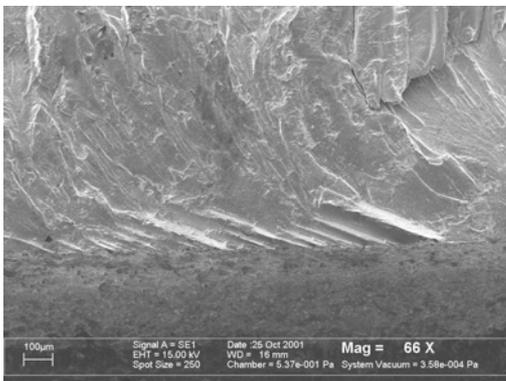
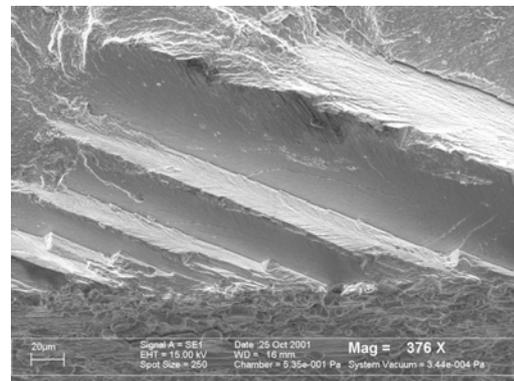
Figures 8 & 9. Other regions of faceted crack formation – again typical of Stage-I fatigue.

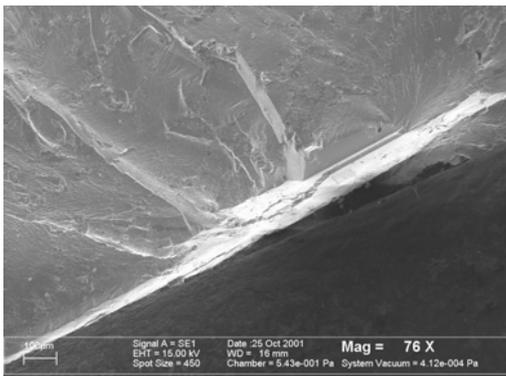
Fig. 10. Electron microscope image of the transition from Stage-I to Stage-II fatigue cracking.

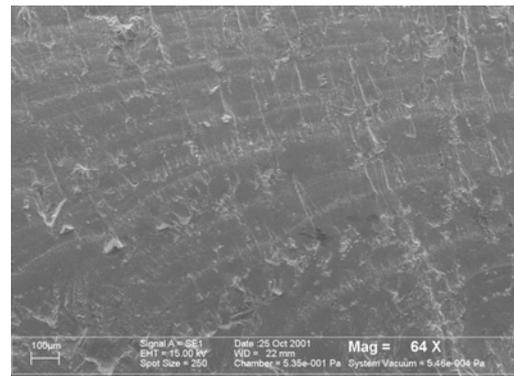
Fig. 11. Electron microscope image of the outer regions of fatigue cracking – regular arrest marks clearly shown.

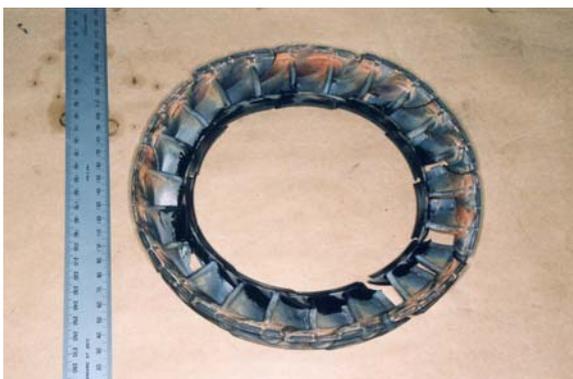
The TPE331-11U turbine inlet guide vane (IGV) assembly comprised of eleven discrete circumferential segments, each containing two guide vanes (figures 12 & 13). As an assembly, the IGV had sustained appreciable mechanical damage during the engine failure – mostly on the outlet side adjacent to the first-stage turbine wheel (figure 14). Many of the guide vanes contained transverse cracking within the leading edge and in some cases, this cracking had developed into appreciable wide-mouthed notching (figure 15). In most areas, cracking of this nature remained confined to a band between six to eight millimetres from the inside platform edge. In the most severe cases, the notching had penetrated the internal air cooling galleries (figure 16).

Fig. 12. Turbine inlet guide vane segments – forward faces.

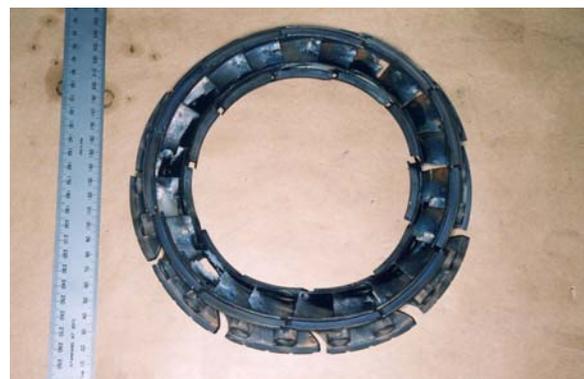
Fig. 13. Turbine inlet guide vane segments – rear faces.

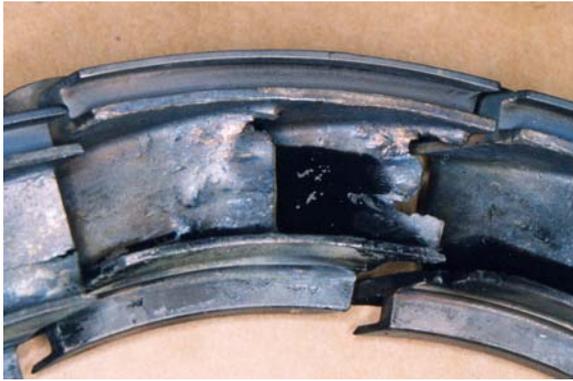
Fig. 14. Mechanical damage to the trailing edges of the inlet guide vanes (typical).

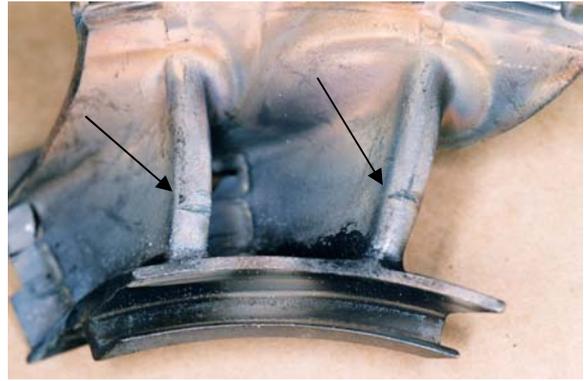
Fig. 15. Thermal fatigue cracking within the leading edges of the guide vanes (arrowed).

The damage to the aerofoil sections of the stage-one IGV assembly was consistent with the effects of thermal fatigue cracking. Expansion and contraction associated with engine temperature changes produces alternating axial stresses in the vanes, which subsequently leads to fatigue crack initiation once sufficient cycles have accumulated.

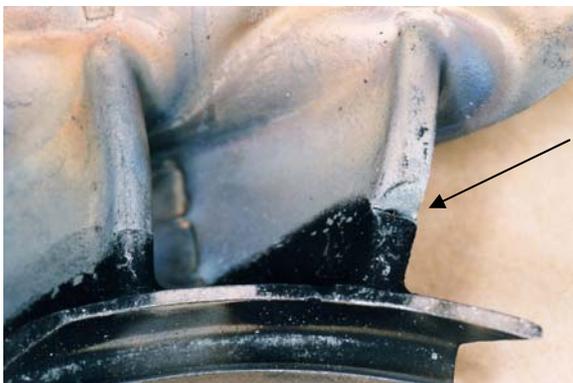
Fig. 16. Advanced thermal fatigue cracking, developed into notches that penetrated the vane cooling galleries.

Growth of these cracks into the aerofoil body leads to the perforation of the internal cooling galleries and the disruption of the circulating airflow. Deprived of cooling, the vanes rapidly overheat, oxidise and fail in the manner observed.

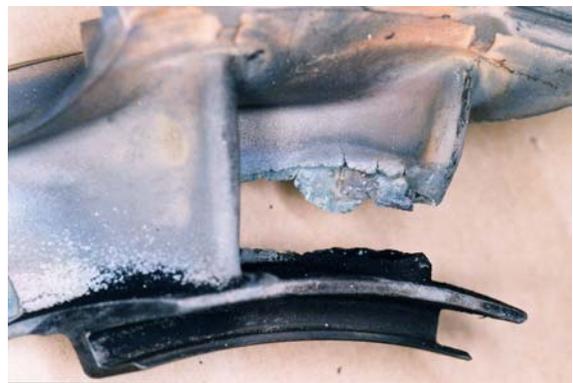
It was apparent from early inspections that one of the eleven IGV segments had sustained the complete ‘burn-through’ failure of a single vane (figure 17). The centre of the affected area was coincident with the location of the leading edge notches found on the other vanes. Consistent with overheating and oxidation, the edges of the affected area were thinned and friable and showed a pronounced discolouration of the surface oxide. The failed segment carried the following identification:

Fig. 17. Destruction of a guide vane from the effects of overheating and oxidation.

The damage and loss of an inlet guide vane would disturb the flow of high-pressure combustion gasses through the assembly. Given that the stage-one turbine is driven by gas flow through the guide vanes, each turbine blade would experience a once-per-revolution impulse on passing the damaged vane. In this situation, the excitation of resonance or vibration is likely, producing the type of high-cycle, low-magnitude stresses necessary for fatigue crack initiation and growth. The nature of the fatigue cracking experienced and the absence of cracking in any of the other blades suggests the stress level was only marginally above the threshold necessary for fatigue development.
