ATSB TRANSPORT SAFETY REPORT
Aviation Occurrence Investigation A0-2010-019
Preliminary

Collision with terrain, VH-ANB

Darwin Aerodrome, Northern Territory

22 March 2010

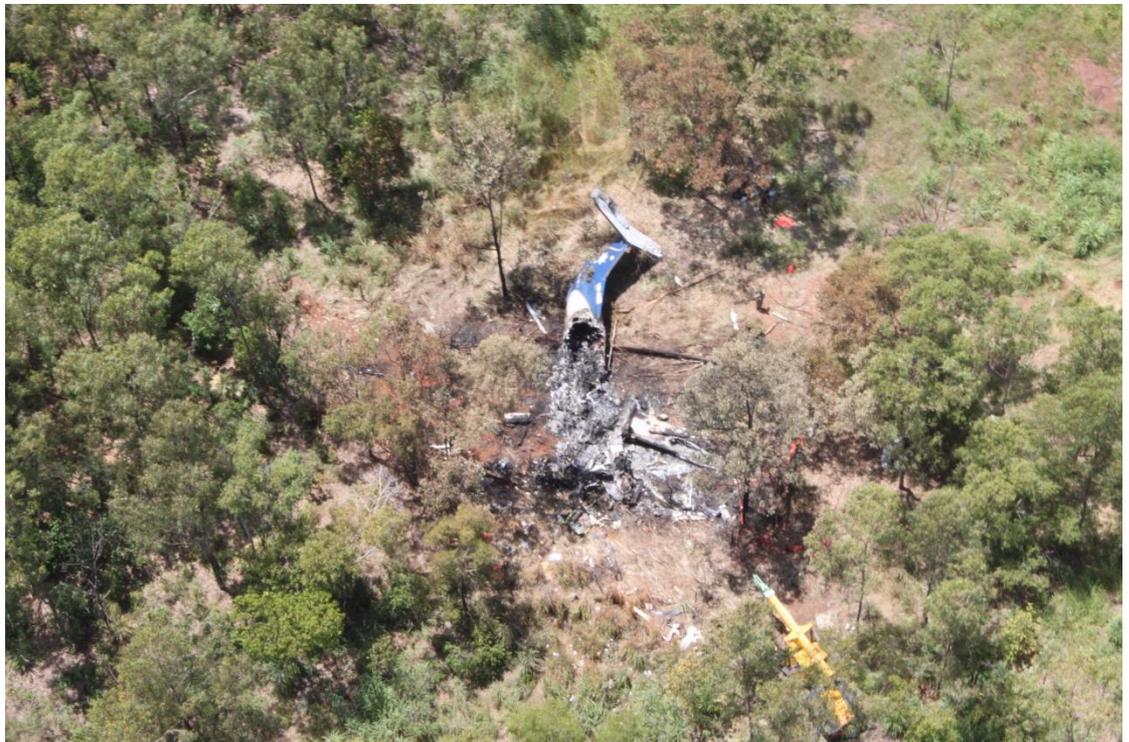
Figure 1: Aerial view of wreckage

Aerodrome rescue and fire fighting services were in attendance very shortly thereafter and extinguished the fire. Both pilots were fatally injured and the aircraft was seriously damaged² due to impact forces and an intense post-impact fire (Figure 1).

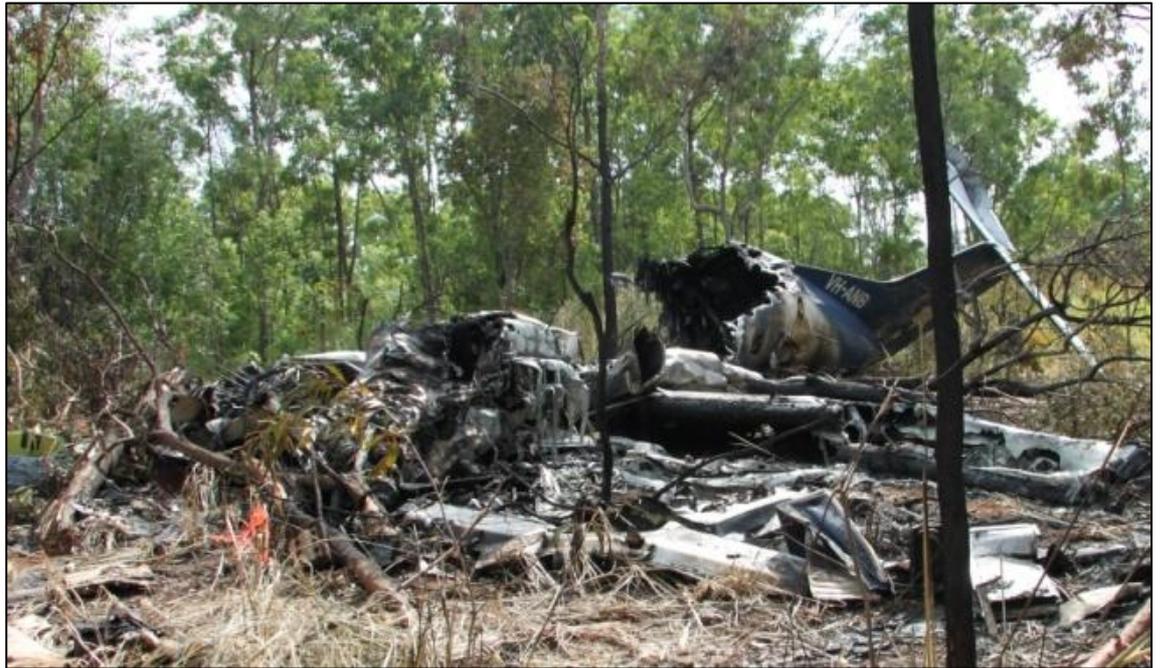
Figure 3: Aircraft wreckage

The wreckage was located in bush land on level ground within the aerodrome boundary. Damage to foliage and ground impact marks were consistent with a steep impact trajectory. Damage to the aircraft was consistent with a relatively low forward speed at impact, and the aircraft being in a right wing-low, nose-down attitude of about 65°.

A high intensity, fuel-fed fire that followed the collision with the ground destroyed most of the fuselage and cabin, the right wing and the inboard section of the left wing (Figure 3).

The cockpit, apart from the overhead panel, was destroyed by impact forces and by fire. Both the left and right engines and propeller assemblies were also severely damaged by impact forces and by fire. The landing gear was in the retracted position and the flaps were extended to 15° at the time of impact. All flight control surfaces were accounted for on the accident site.
