Engine cooling fan fracture, VH-IDU Rolleston, Queensland - 3 May 2009

May10/ATSB84

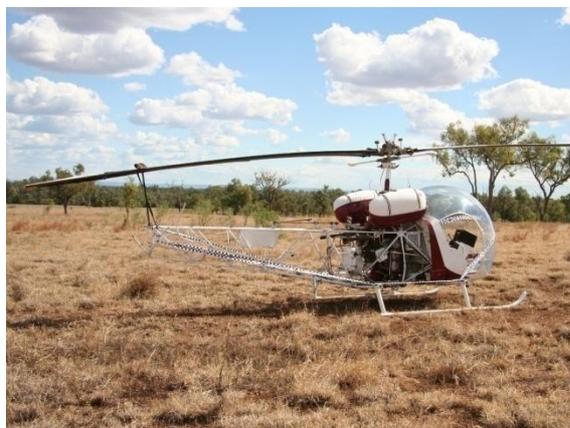
Figure 1: VH-IDU

The tail of the helicopter was severed by the main rotor blades and damage was sustained by the airframe as a result of the hard landing (Figure 1). The engine cooling fan had fractured and three of the 16 blades were missing (Figure 2). The fan shroud support was fractured and showed evidence of contact with the rotating fan. Damage was also sustained by the flight controls located forward of the engine cooling fan, including chafing of the control rods and fracture of the lower control rod connected to the fore/aft cyclic servo unit (Figure 3).

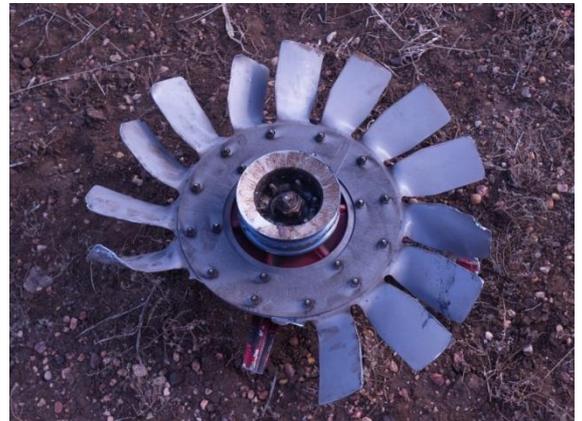
Figure 2: Cooling fan assembly

Three blades were separated from the fan (Figure 2) as examined after the accident. Separation of two of the blades was associated with a fracture running through the blade disc, whereas the third blade had fractured through the blade root, with the section remaining on the disc being heavily plastically deformed. The separated blades were not recovered. Several of the remaining blades showed deformation consistent with rotational contact. Corresponding damage was observed on the fan shroud support.

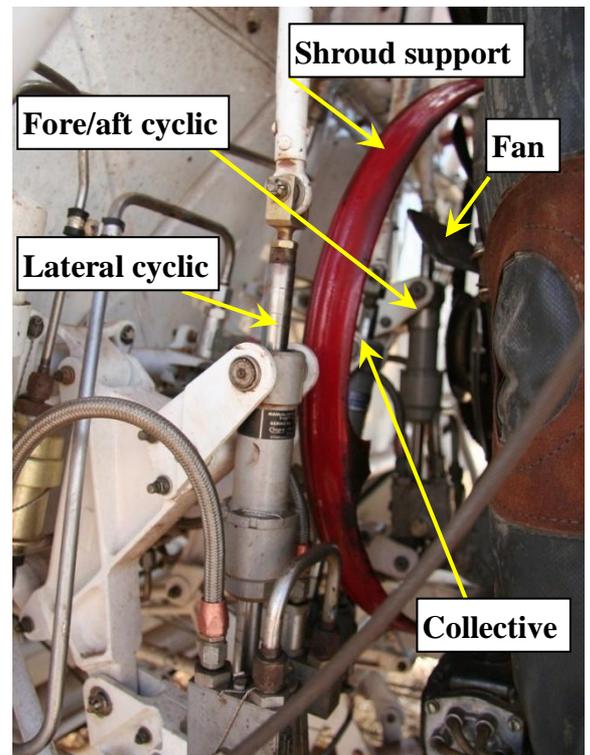
Figure 3: Fractured cooling fan and shroud support adjacent to the flight controls

The loud noise and jolt reported by the pilot was as a result of the high-cycle fatigue cracking, failure and release of a two-bladed segment from the engine cooling fan, as well as the secondary fracture of the third fan blade and of the fan shroud support. It was likely that the subsequent jamming of the fore/aft cyclic control was a result of interference between the failed components and the flight controls.

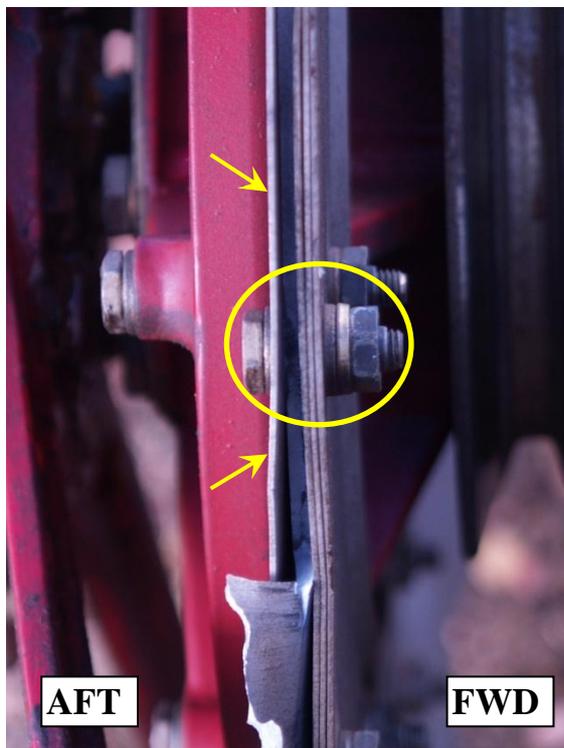
Figure 4: Cooling fan assembly (side). Additional fan ring arrowed

Examination of the fan assembly found three fan rings on the forward side and a single fan ring on the aft side (Figure 4). This differed from the maintenance manual specification of three fan rings on the forward side and a *fan spacer* on the aft side (Figure 5).

The fatigue crack originated on the aft side of the fan, adjacent to the bolt circled in Figure 4, and progressed predominantly in an anticlockwise direction as viewed from the front - opposite to the direction of fan rotation. The bolt at the location of the fatigue origin had an extra washer under the nut - presumably for the purpose of static balancing.

In this occurrence, the substitution of the fan ring for the fan spacer on the aft side of the fan assembly would probably have affected the relative stiffness of the assembly, as well as slightly altering the distance between the blades and surrounding structures, such as the shroud supports. This could result in a change to the frequency and amplitude of vibrational stresses, or change the fan's inherent resonance characteristics. Experimentation in this area would need to be conducted to quantify the extent of influence on fatigue crack initiation and propagation.

As a result of this occurrence CASA released airworthiness bulletin AWB 63-007 on 20 January 2010, reminding operators and maintainers of the importance of adhering to all current manufacturer's approved data for cooling fans manufactured from sheet metal and their drive assemblies.

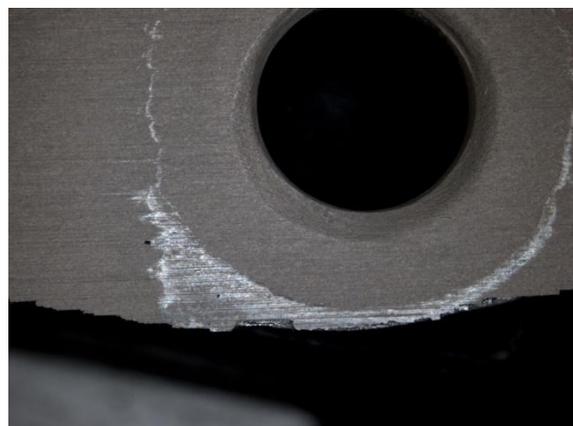
Figure 6: Abrasion marks and fretting damage at bolthole

Fretting⁶ between the fan and fan ring surfaces was evidenced by paint wear adjacent to most of the outer ring of boltholes and at discreet locations on the fan surface (Figure 6). The damage adjacent to the boltholes was at the outside (blade side) of the disc, where it was expected that fretting would most likely occur as a result of vibration of the fan blades. Bolt torque was not measured during disassembly; however the absence of fretting damage directly under the bolt bearing surfaces suggested that the torque had been sufficient to prevent relative movement between these surfaces. Superficial abrasion marks were also observed over the fan surface and may have been present as a result of the manufacturing process.

Resistance to fatigue initiation is also sensitive to surface finish. The presence of scratches in the fan surface may have acted as local stress concentrators and increased the susceptibility of the fan to fatigue cracking. The scratches were present underneath the anodised coating and were regular in appearance, despite their random orientation. This suggested they were probably present from manufacture rather than any specific maintenance action.
