Collision with terrain, VH-FXE

Pilton Valley, Queensland

29 September 2008

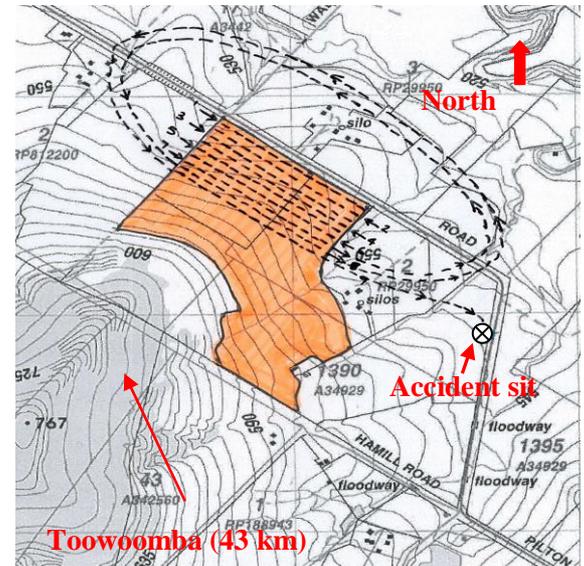
Figure 1: Baiting runs⁴

Witnesses reported that the pilot commenced the flight with seven baiting runs in a north-west to south-east direction, with a procedure turn at the completion of each run to reverse direction. The pilot was reported to have then completed two runs in an anticlockwise racetrack pattern. The last run positioned the aircraft in a direction towards the south-east, about half way across the property (Figure 1).

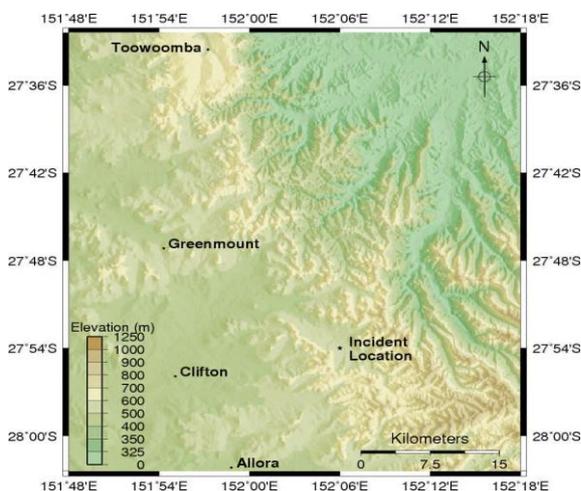
Figure 2: Topographical map of the area

The application area was in a valley adjacent to the Great Dividing Range. A number of peaks of up to 800 m (2,600 ft) above mean sea level (AMSL) lay immediately to the south-west (Figure 2).

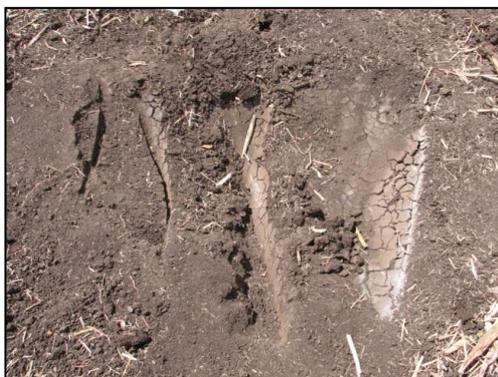
Figure 3: Propeller slash marks

Further along the wreckage trail, there were four consecutive slash marks, consistent with the propeller contacting the ground while rotating. Given a nominal engine operating speed of 2,500 RPM, from the spacing of those slash marks, it was estimated that the aircraft's speed at impact was about 88 kts (Figure 3).¹⁰

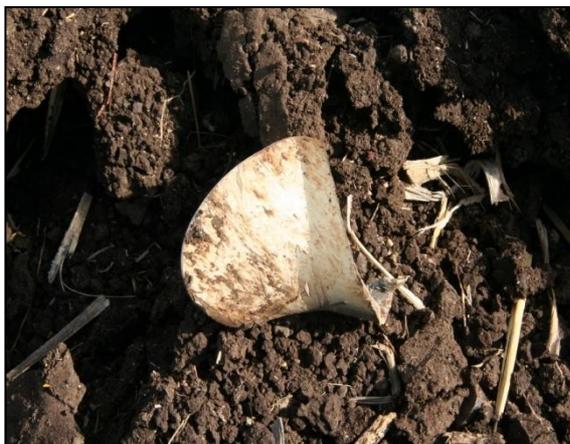
Figure 4: Section of propeller tip

A section of propeller blade tip was located adjacent to those ground marks. That section of propeller blade was bent and curled in the direction of propeller rotation and exhibited chordwise scoring across both faces. The fracture, bending and scoring of the propeller were consistent with high rotational energy at impact (Figure 4).

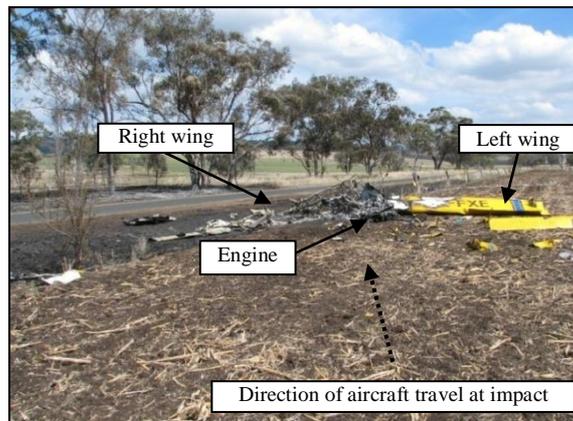
Figure 5: Aircraft wreckage

The aircraft came to rest upright and facing in the opposite direction of travel about 20 m from the initial impact point, with the left main wheel lodged under the fuselage. The fuselage, wings and engine sustained significant post-impact fire damage. The engine had separated from the airframe as a result of impact forces, and was located ahead of the airframe.

The left wing had rotated around the main spar, and was inverted and facing in the opposite direction. The left wing fuel tank had ruptured and was burnt at the wing root. The right wing was similarly oriented, and had also sustained significant fire damage (Figure 5).

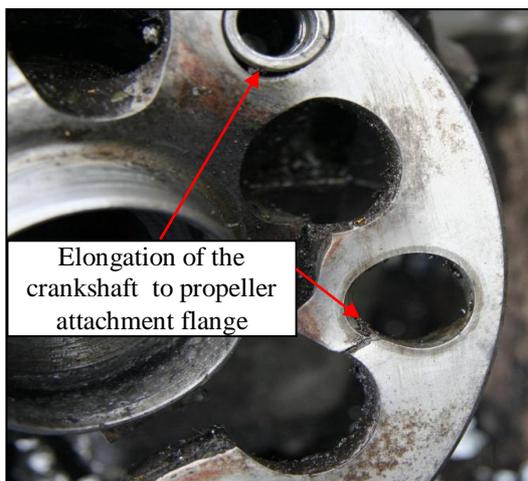
Figure 6: Engine crankshaft flange

The majority of the propeller remained attached to the engine crankshaft flange. Once the propeller was removed from the flange, elongation of the propeller attachment spigot holes was identified (Figure 6). This damage was consistent with the production of torque by the engine at impact. In addition, a section of the flange had failed in ductile overload at an angle of about 40° to the propeller's plane of rotation. That was consistent with the final phase of the impact with the ground, and the aircraft pivoting on the propeller.
