# **Derailment of Train 1MA6Q**

**near Pura Pura, Vic.**  
**30 March 2008**

INFRA-08533

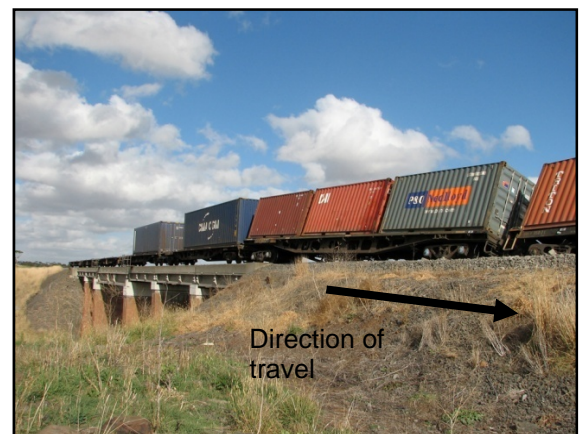
**Figure 1: Point of derailment on bridge**

Mount Emu Creek bridge is constructed of brick piers and concrete spans with an encapsulated top (Figure 1).

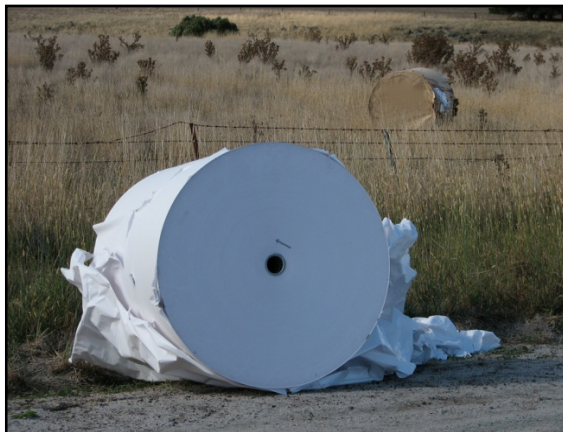
**Figure 2: Large paper rolls thrown from train**

smoke, but dust. At this point, the driver observed that the brake pipe pressure gauge was indicating a 'loss of air'. The driver left the throttle in the 8th notch until the train was nearly stopped to avoid the wagons bunching up. After stopping, the train brakes and locomotive handbrakes were applied to secure the train. Both drivers then walked back to the 21st wagon, RQKY2063, which had both bogies derailed. The driver called train control and the shift support officer and advised them of the occurrence before returning to the front of the train. The co-driver continued to walk further back to assess the other damage. Closer to the bridge the co-driver noticed a motor vehicle had stopped on the adjacent Vite Vite Road because the road had been blocked by large paper rolls thrown off the train during the derailment (Figure 2).

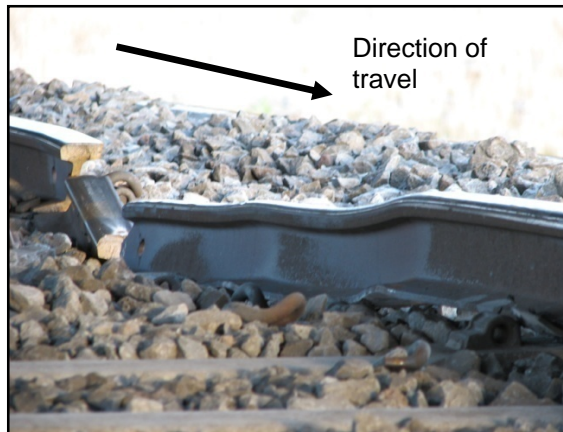
**Figure 3: The fractured rail in-situ**

Further examination of the site revealed a fractured rail on the Mount Emu Creek bridge, under the 43rd position in the consist (Figure 3).

Of note was the deformation of the rail in the trailing section caused by the wheels 'landing' after traversing the fracture.

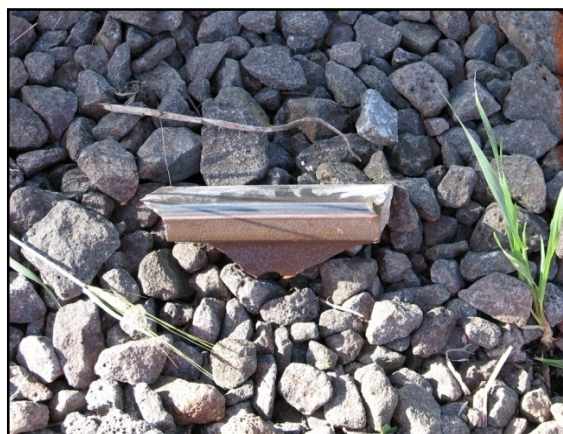
**Figure 4: The ejected rail piece in-situ**

A large piece of rail head (Figure 4) was found directly below the fractured rail on the earth embankment beneath the bridge. It was determined to be the matching piece which had been ejected from the fractured rail above.

- The passage of the previous train 5PM5 may have dislodged the portion of rail (Figure 4).
- The locomotives of train 1MA6Q travelled over the fractured rail and probably ejected the piece of rail head.

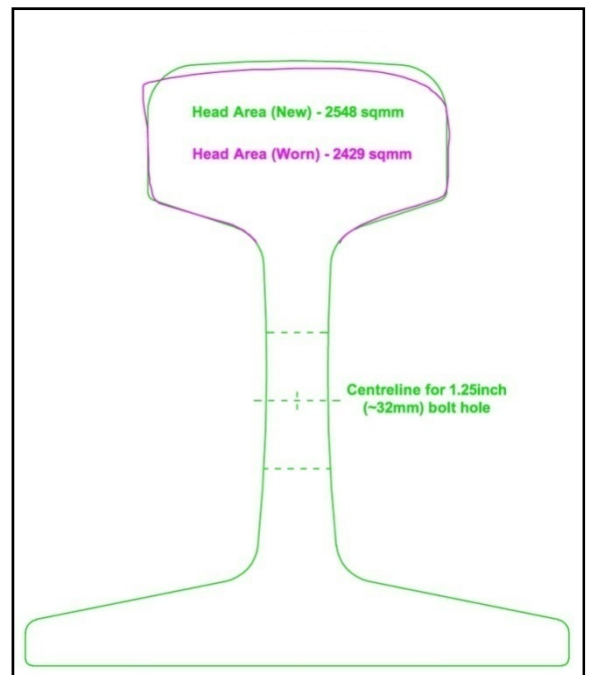
**Figure 5: Rail profiles (actual versus new)**

The rail was profiled and compared to a new rail profile (Figure 5). The total loss of head area was calculated to be 4.7 per cent. Given the age of the rail, the amount of head wear is well within the maximum specified limit of 35 per cent.

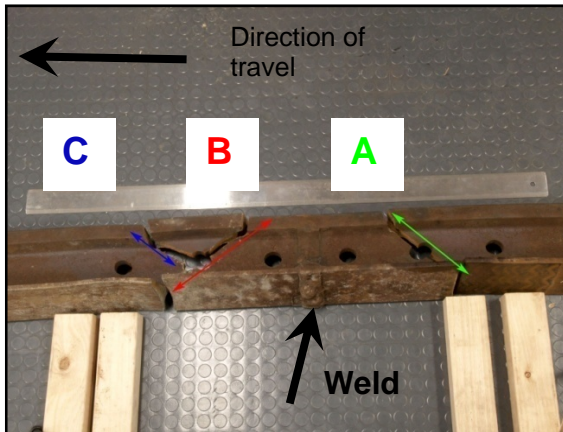
Figure 6: Fractured rail sections

The fractured section of rail contained an aluminothermic weld joint in between two sets of three fishplate bolt-holes. The rail had fractured through the middle bolt-hole on each rail section.

For the purpose of the investigation, the fractures were labelled 'A' to 'C' in the direction of train travel (Figure 6).

the bolt-hole, at an angle of approximately 45° from the vertical. This is consistent with the bolt-hole cracks observed in the rail recovered from the derailment site (Figure 6). The magnitude of the calculated stresses was almost three times greater than the stresses calculated in the web of the rail that did not have bolt-holes. It is evident that a bolt-hole in the web of a rail introduces a stress concentrating effect under cyclic loading typical of actual rail traffic.

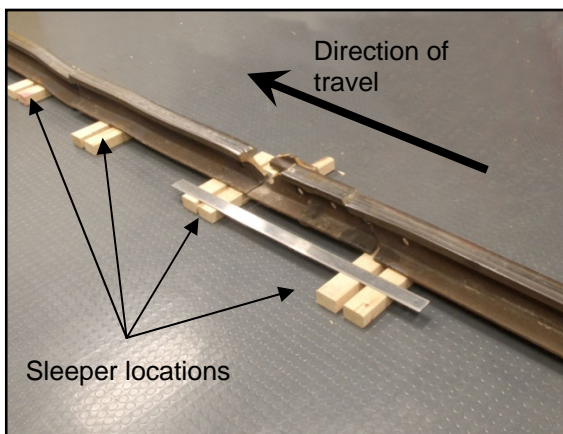
Figure 7: Assembly of rail sections

The sections of track were laid out and the train direction identified (Figure 7). Pad marks on the base of the rail indicated the approximate location of the concrete sleepers.

The rail had completely fractured in two locations, effectively between two sleeper locations. The fractures at A and B were at a 45 degree angle, to the rail head, through the bolt-holes. Evidence of fatigue cracking was observed on the fracture surface at both bolt-holes. The surface of these cracks had oxidised to an extent that resembled the exterior rail surface and had therefore been open to atmosphere for a period of time prior to the derailment.

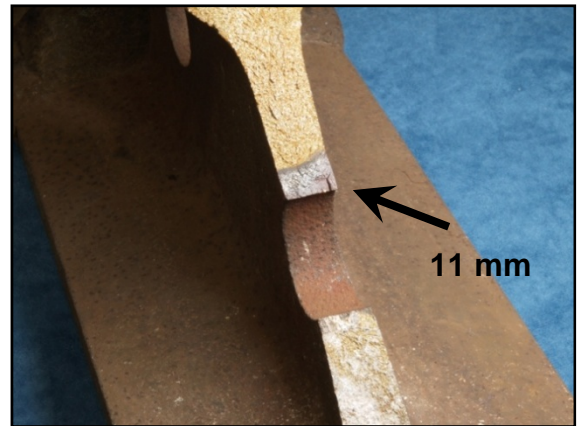
Figure 8: Bolt-hole and fracture at 'B'

The largest fatigue crack extended 11 mm towards the head of the rail from the bolt-hole at fracture B (Figure 8).

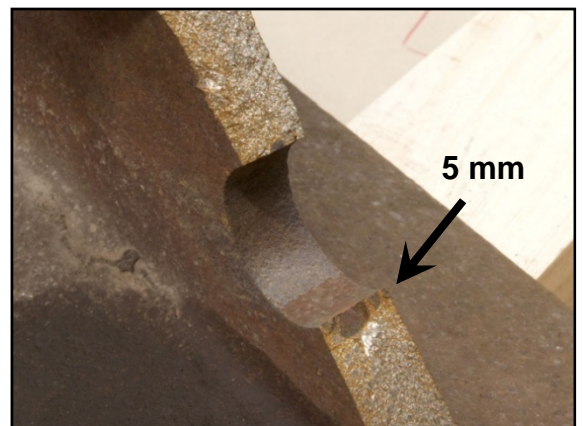
Figure 9: Bolt-hole and fracture at 'A'

The major fatigue crack at fracture A extended 5 mm towards the foot of the rail (Figure 9). No evidence of pre-existing cracking was observed on the fracture face at C.

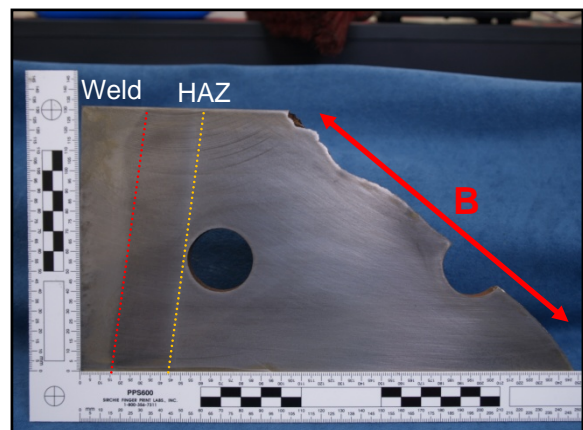
Figure 10: Section of the heat affected zone

The weld was sectioned and etched using 5 per cent nital solution (Figure 10).

The heat affected zone (HAZ) extended about 30 mm from the weld up to the first bolt-hole. The second bolt-hole, with the fatigue crack origin, was about 130 mm outside the heat affected zone. The heat affected zone of the weld was not contributory to the initiation, propagation, or failure of the rail.

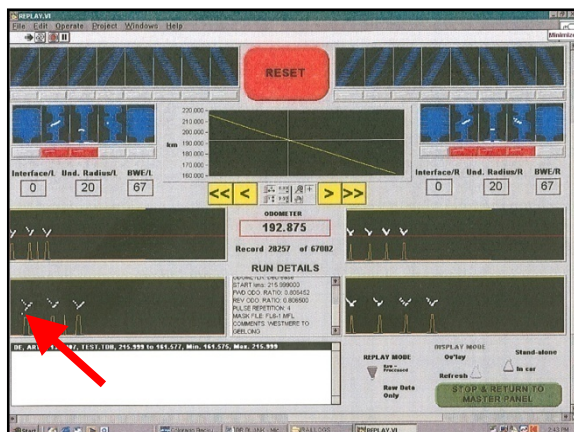
Figure 11: Extra pulse echo in replay

Prior to the derailment, the section of track across Mount Emu Creek was last ultrasonically tested on 13 July 2007, about 9 months before the derailment. A replay of the test data from that run, undertaken by Speno, showed no loss of bottom signal and one extra pulse echo very near the bolt-holes at location 192.875 km (Figure 11 and Figure 12).

On the day of the testing, the operator detected this anomaly and requested that the hand tester following the Speno car conduct a closer examination with a handheld ultrasonic testing device. A defect report automatically generated by this inspection concluded that No Sizable Defect (NSD)<sup>9</sup> was detected, meaning that no further action was required even though the evidence suggests that the fatigue cracks probably existed (to some degree) at the time of the ultrasonic testing
