AUSTRALIAN TRANSPORT SAFETY INVESTIGATION REPORT
Rail Occurrence Investigation No. 2007/004
Final

Derailment of Train 6MP9 – Bates, SA, 10 June 2007

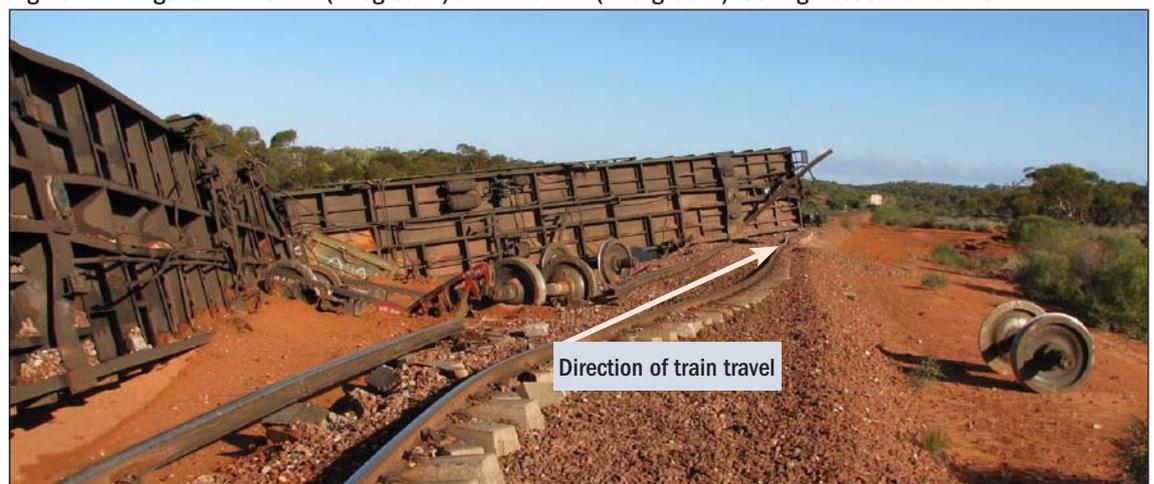
There were no injuries as a result of the derailment, however, there was significant damage to the track and rollingstock. Of 10 wagons that separated from the train, four overturned.

Figure 1: Wagons ABFY 3111 (foreground) and PBGY 54 (background) looking west towards Perth.

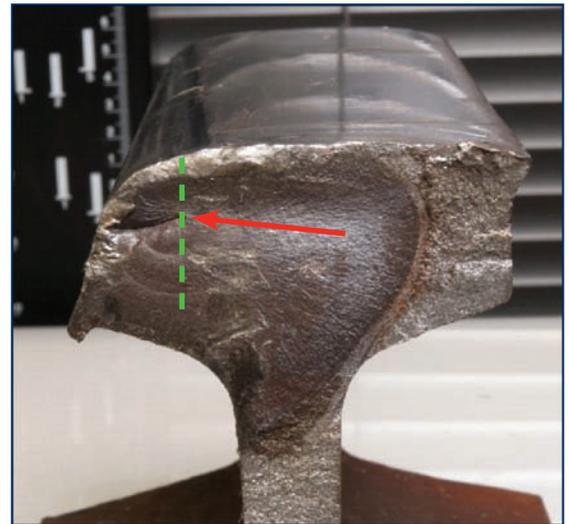
An examination of the track at the ‘point of derailment’ uncovered several broken rail segments with signs of a transverse defect³ type known as a ‘detail fracture’. In one case, (Fig. 2) the defect appears to have originated from a horizontal crack beneath the gauge corner and has propagated across approximately 65 percent of the railhead breaking through the lower/non-visible part of the rail near the web. The defect was not new as there were signs of corrosion at the fracture face. The derailment occurred during a cold part of the evening when the rail would have been under significant tensile stress and therefore more likely to break under the dynamic load of the train. It is probable that the rail initially failed at this defect when 6MP9 passed over it.

Figure 2: Primary break exhibiting transverse defect with horizontal crack (red arrow), and showing orientation of metallographic sample (green line).

The analysis determined that the chemical composition was consistent with the requirements of AS E22 – 1964 Steel Rails, the applicable Australian Standard at the time of manufacture. The analysis further determined that there was no evidence of any underlying microstructure anomaly. A further review of the rail properties in comparison with the current Australian Standard AS 1085.1 – 2002 determined that the rail largely complied with the requirements of the current standard. Based on the analysis it was

concluded that the failure was probably initiated by a hydrogen-induced crack. With the additional material and product testing requirements of AS 1085.1 – 2002 it is likely that rail manufactured to the current standard would contain fewer defects with less likelihood of premature failure when compared with the older AS E22 – 1964.

- A review of the frequency of ultrasonic testing of track on the Trans-Australian Railway to include a mid period inspection.
- A review of the ARTC Code of Practice to ensure that it considers the age of the asset, exposure to significant temperature variations, increases in axle loading and transit speed.

- A review of current practices in relation to the selection and testing of rail to be used as inserts.
- A review of data gathered by ultrasonic test vehicles to identify and prioritise reportable sized flaws.

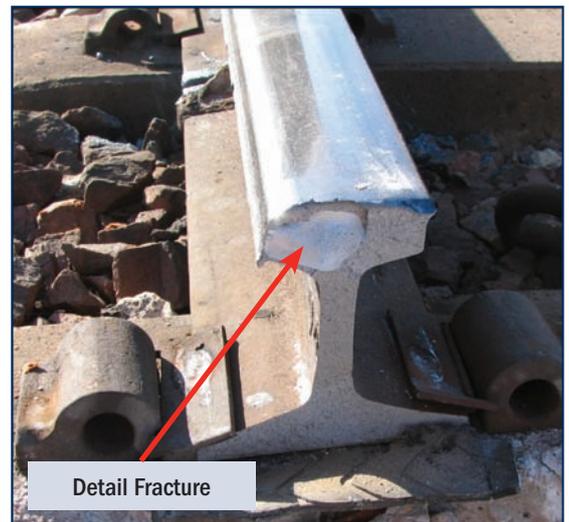
A further secondary defect, (Fig. 3) 170 mm before the primary break probably caused a section of rail, about 0.5 m in length, to break away from the rail under the train. Once this had occurred, the derailment was almost inevitable. Two pieces of recovered rail showed significant evidence of wheel batter on their leading face indicating that wheels had probably travelled over these broken sections of rail after it failed.

Figure 3: Secondary break exhibiting a transverse defect 170 mm before the point of derailment.
