ATSB TRANSPORT SAFETY REPORT
Aviation Occurrence Investigation A0-2010-042
Preliminary

Collision with terrain, VH-RPN

257 km ENE of Derby, Western Australia

13 June 2010

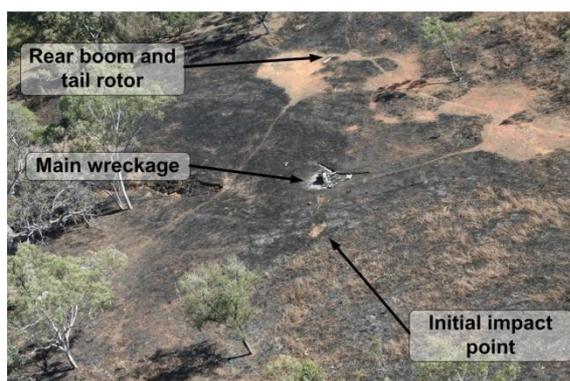
Figure 1: Aerial view of the accident site

The accident site was located on flat, clear terrain close to a small creek (Figure 1). The terrain surrounding the accident site was slightly undulating with numerous trees and saplings. There was no evidence to indicate that the helicopter struck any of those trees or saplings prior to the impact with the ground.

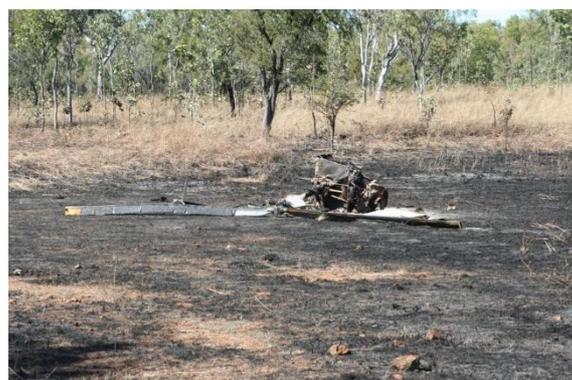
Figure 2: Helicopter main wreckage

The helicopter had collided heavily with the ground, collapsing the skid landing gear and destroying the lower of the engine components, including the carburettor and induction manifold. Associated ground contact marks were consistent with the helicopter's tail boom also striking the ground. The main wreckage was about 10 m from the initial ground contact. An intense post-impact fire consumed the main wreckage; the intensity of

The helicopter's main rotor blades were intact, securely attached to the main rotor hub and were situated with the main wreckage (Figure 2). Damage to both blades was consistent with impact forces and the effects of the post-impact fire. There was no evidence of the main rotor blades striking any foliage, terrain or other objects prior to the accident, or of pre-accident skin delamination on either of the main rotor blades.
