Turbulence event, VH-QPI 58km N of Kota Kinabalu, Malaysia 22 June 2009

Abstract

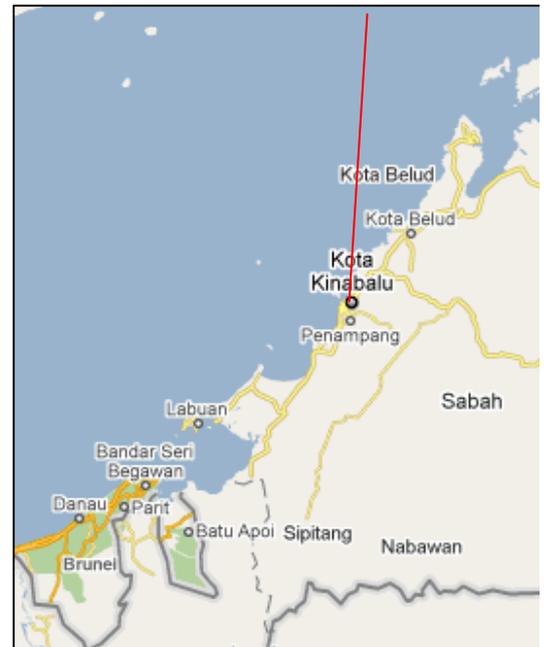
Figure 1: Malaysian Borneo with inbound track to Kota Kinabalu in red.

206 passengers and 13 crew, departed Hong Kong on a scheduled flight to Perth, Western Australia. Two hours and 10 minutes after takeoff, while tracking towards Kota Kinabalu at flight level (FL)² 380, the aircraft encountered an area of severe turbulence (Figure 1).

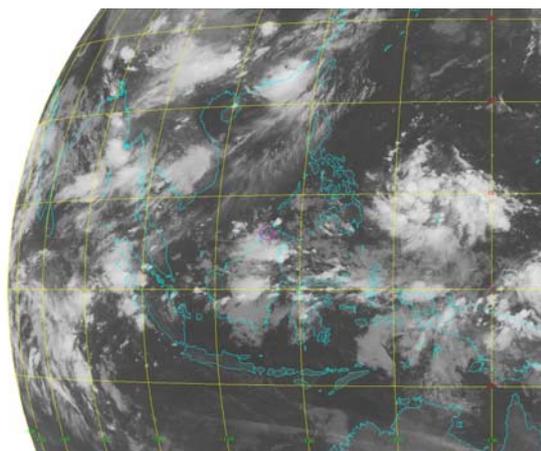
Figure 3: Infra-red satellite image at 0230 of the South-east Asia region.⁸

Infrared satellite photography from 0030 to 0230 on 22 June 2009 showed the presence of convective activity covering the majority of the north-eastern part of the island of Borneo, including the approaches to Kota Kinabalu (Figure 3).

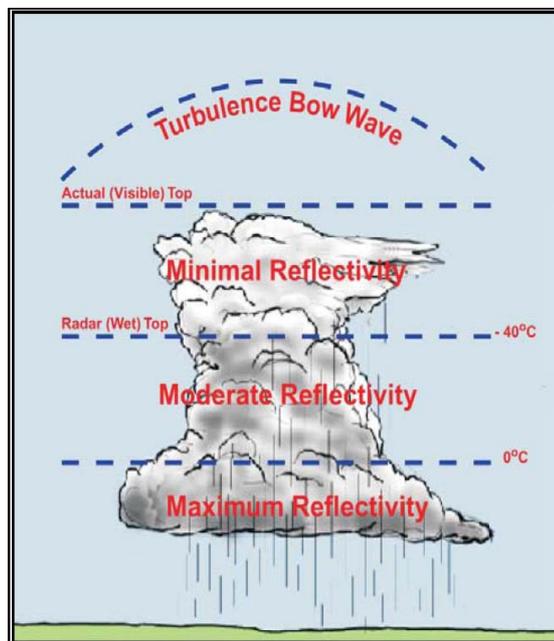
Figure 4: Thunderstorm Reflectivity Levels.¹²

In the case of a cumuliform cloud, with its potentially extensive turbulence as a result of associated up and downdrafts, water droplets can be in different states, sizes and amounts depending on their location in the cloud (Figure 4). In that context, the radar reflectivity of cumuliform cloud is:

- greatest in the lower portion, where there is a significant proportion of moisture in the liquid state
- moderate in the middle section, between the freezing level and around -40 °C, where water exists as either supercooled droplets¹¹ or ice crystals – the presence of ice crystals reducing the radar reflectivity
- minimal in the top layer, above the height consistent with a temperature of -40 °C, where water exists entirely as ice crystals.

Jet transport aircraft normally operate at altitudes associated with temperatures below -40 °C.
