**ATSB TRANSPORT SAFETY INVESTIGATION REPORT**

Aviation Occurrence Investigation – AO-2007-047

**Collision with terrain  
255 km south-west of Warburton, WA  
17 October 2007**

**VH-WXC  
Cessna Aircraft Company C210**

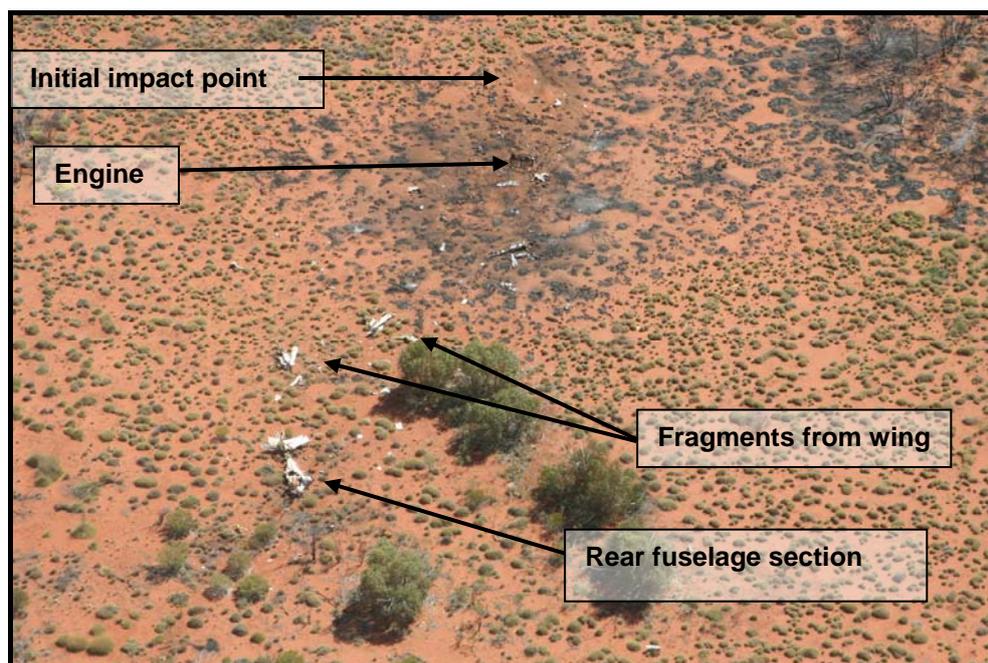
**Figure 1: Photograph overhead accident site**

The aircraft impacted sandy, desert-type terrain (Figure 1) at high speed and was destroyed by impact forces. The fuel tanks ruptured on impact and there was a post-impact fire. The accident was not survivable.

The impact trajectory of the aircraft was approximately 217 degrees magnetic and the rear fuselage came to rest approximately 50 m in the direction of travel beyond the initial impact point.
