TECHNICAL ANALYSIS INVESTIGATION REPORT

Report No. 24/05

**Examination of failed thrust bearings from a
Teledyne Continental Motors GTSIO520M engine**

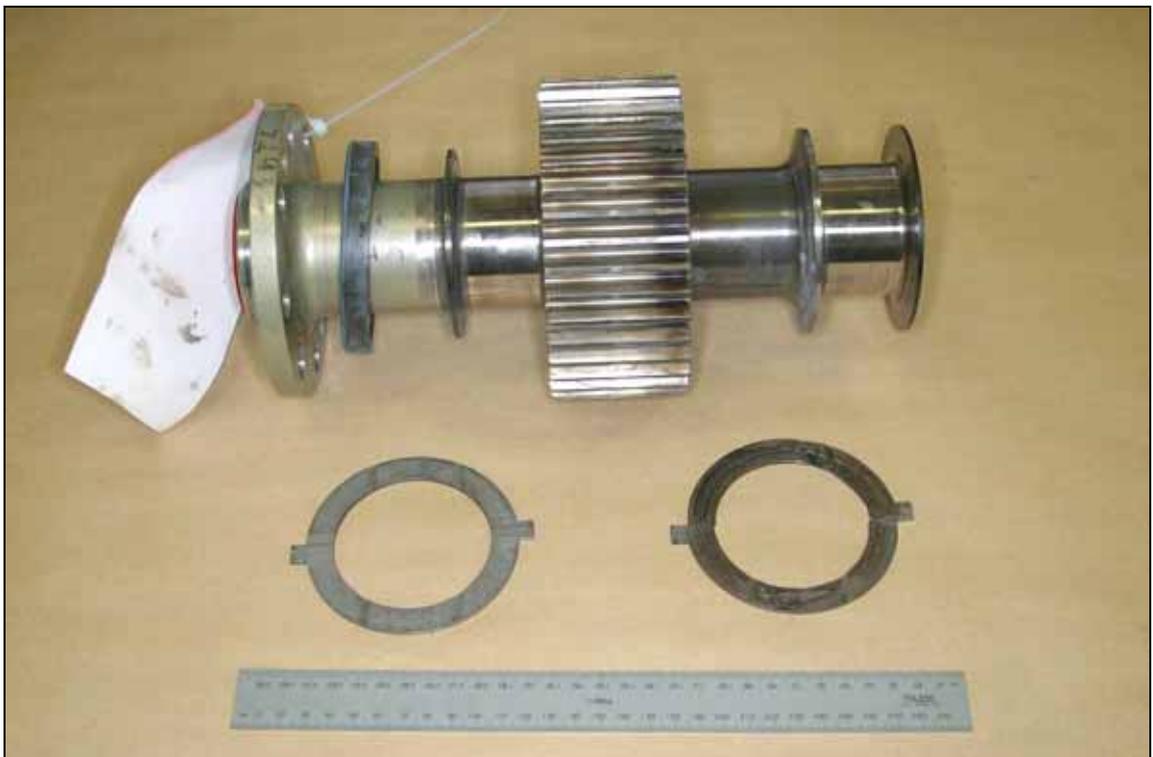
Figure 1. Propeller shaft and thrust bearings from engine serial number 810712.

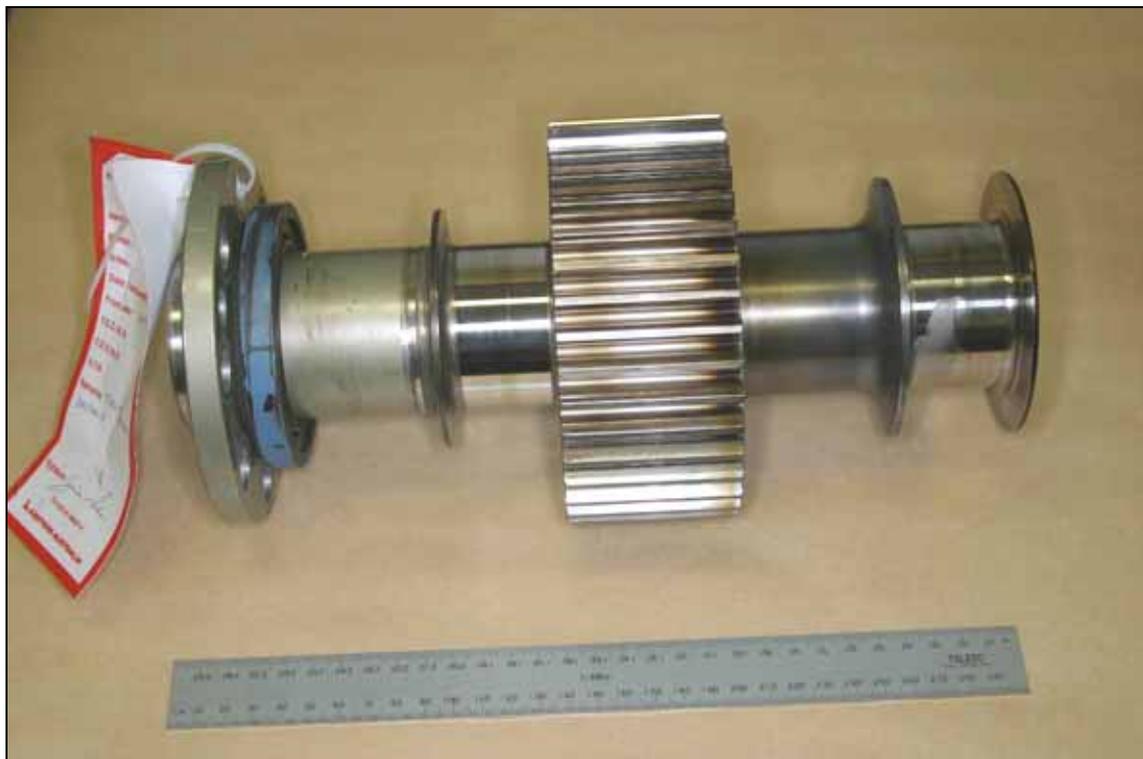
Figure 2. Propeller shaft from engine serial number 239168R.

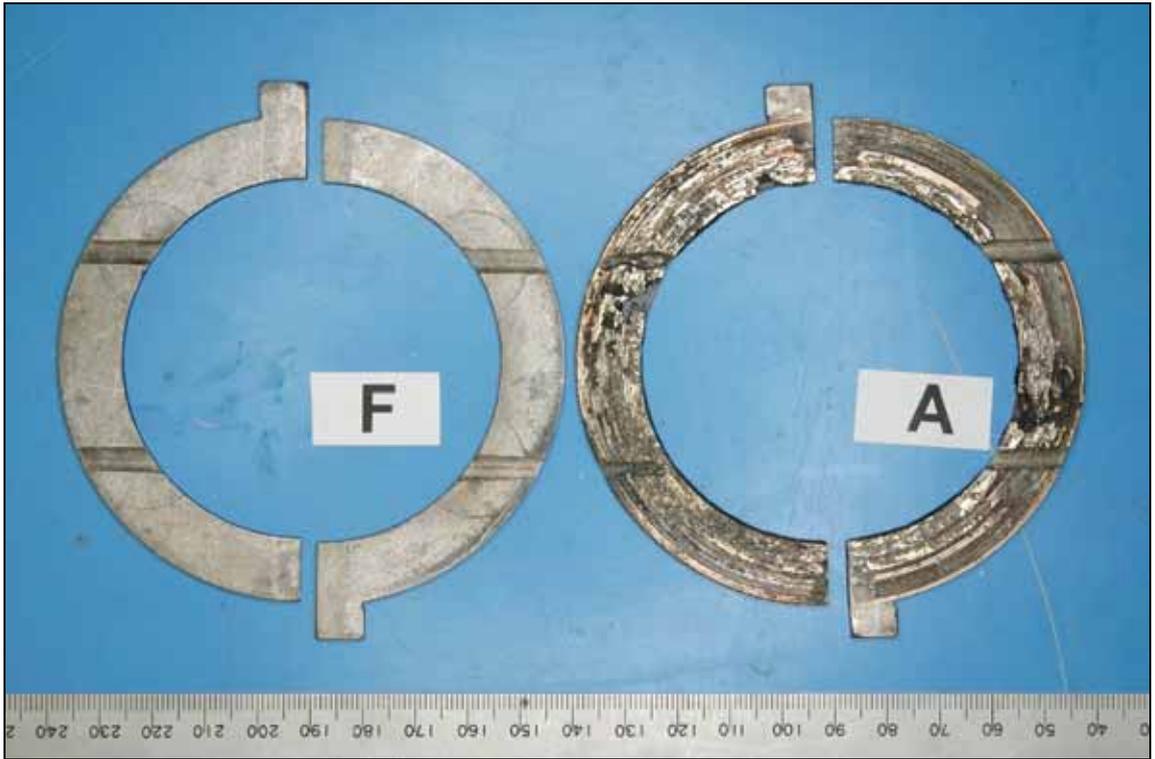
As installed, the thrust bearings comprised two sets of semicircular opposing plates, located against flange elements at the rear of the propeller shaft (figure 3¹). The rear bearings, carrying the primary propeller thrust loads, had sustained extensive mechanical and thermal damage, whereas the forward bearings showed little evidence of abnormal service and were visibly sound (figures 4, 5). The undamaged (forward) bearing set carried the rear surface identification '646260 G'. Damage to the rear bearings prevented the recognition of any similar markings on those items.

Figure 4. Contact (bearing) surfaces of thrust bearings as-received.

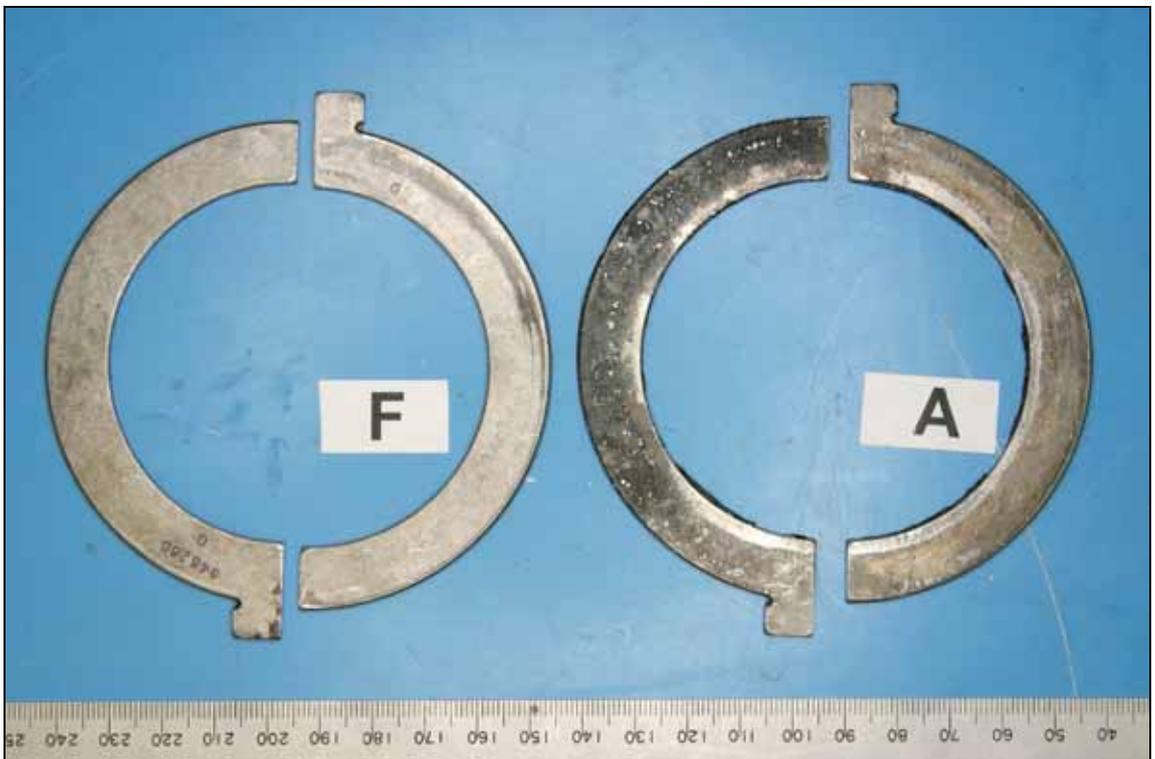
Figure 5. Rear (backing) surfaces of thrust bearings as-received.

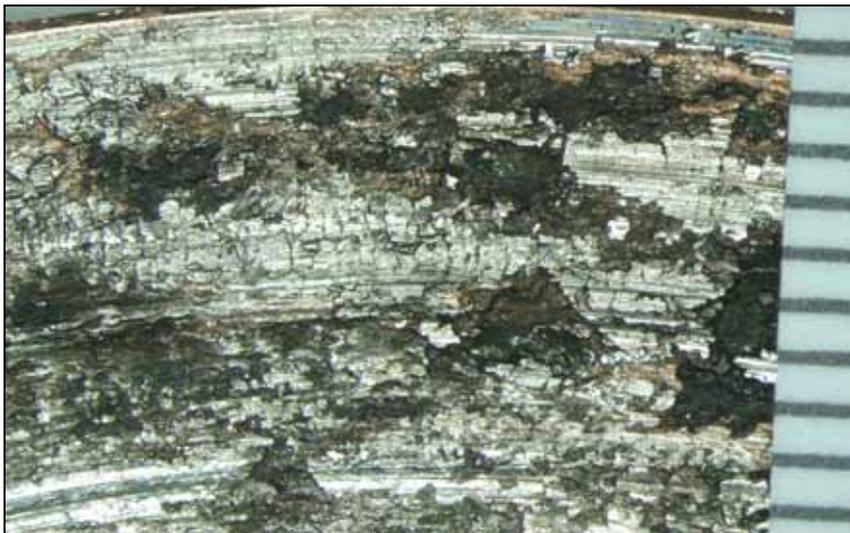
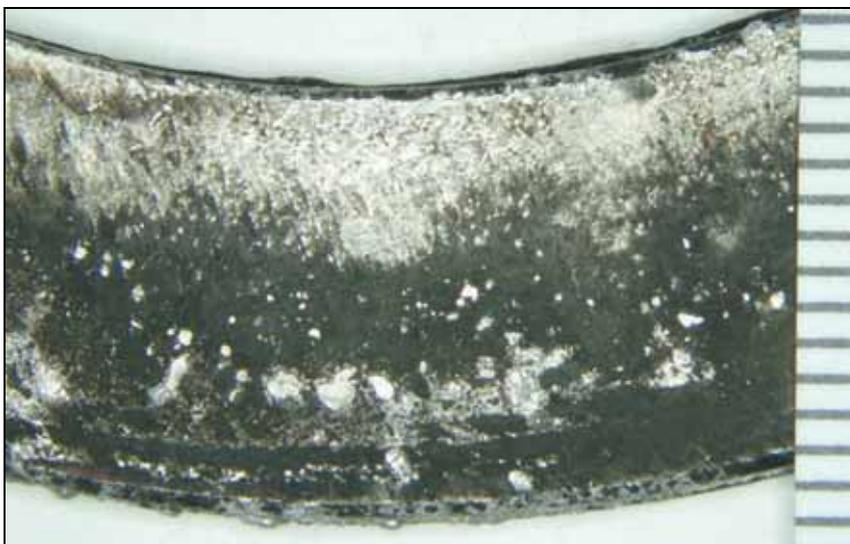
Close visual examination of the set of failed bearings (attachments A – D) showed heavy scoring, gross disruption and partial loss of the bearing alloy from the bearing running (contact) surfaces (figure 6). Partial melting of the surface alloys and other evidence of elevated temperatures was prevalent, as was the blackening and discolouration of the surfaces where alloy loss had occurred. The rear (back) faces of the bearings also showed blackening and the accumulation of melted alloy (figure 7). The lubrication channels on one bearing were partially filled with transferred material that had been melted and dislodged from adjacent areas.

Figures 6 and 7. Low-power microscopic view of a damaged area on the contact and backing surfaces of a damaged thrust bearing.

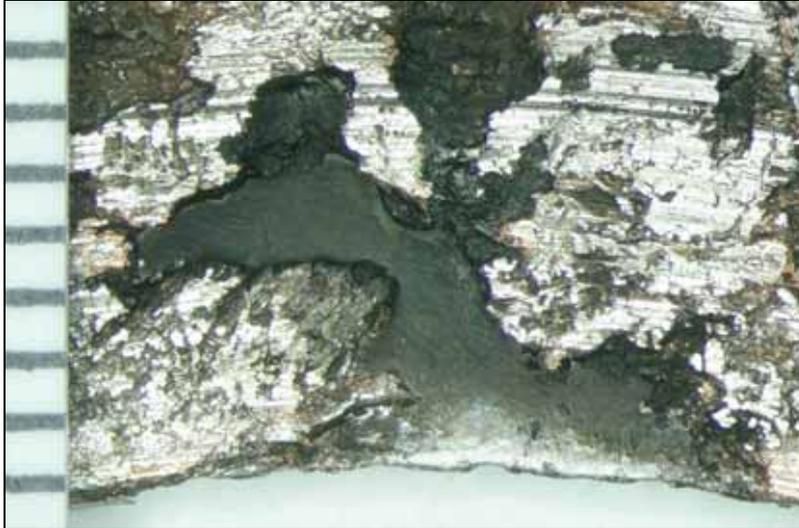
In isolated regions, the bearing alloy had completely separated from the steel backing, with the affected areas characterised by exposure of the comparatively flat, featureless interfacial surfaces (figure 8).

Figure 8. Area on a damaged bearing showing complete separation of the bearing alloy from the steel backing.

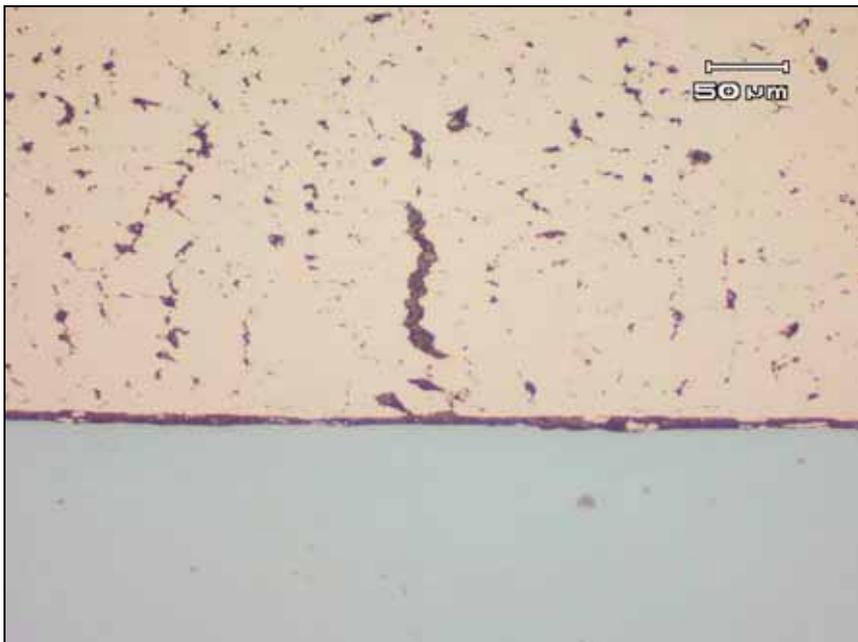
Several metallographic sections taken transversely through one bearing confirmed the basic tri-metal construction, with the intermediate layer presenting as a coarse intermittent network of lead within a copper alloy matrix. In numerous areas, the lead network had interconnected, creating filled fissures (figure 9), the larger of such breaching the external surface. Evidence of lead migration to the steel backing interface was observed at and adjacent to the areas of alloy separation, creating a continuous lead boundary layer approximately 5-10 μm thick.

Figure 9. Cross-sectional microstructure of a damage bearing, showing the agglomeration of lead (dark phase) within the copper bearing alloy and along the backing interface. Unetched.

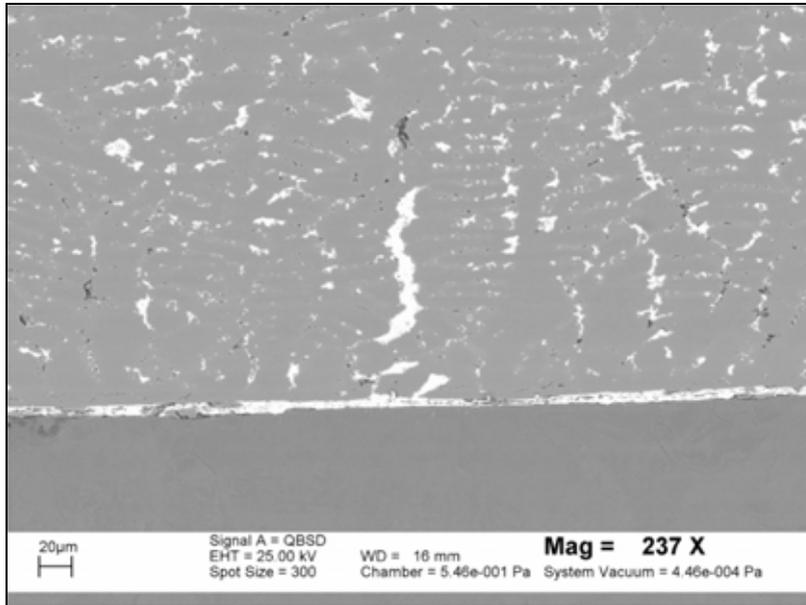
Scanning electron microscopy of the prepared sections confirmed the metallographic observations, with back-scattered electron imaging (figure 10) and x-ray dot mapping (figure 11) graphically illustrating the lead agglomeration and migration to the backing interface.

Figure 10. SEM image of the metallographic section, illustrating the lead migration.

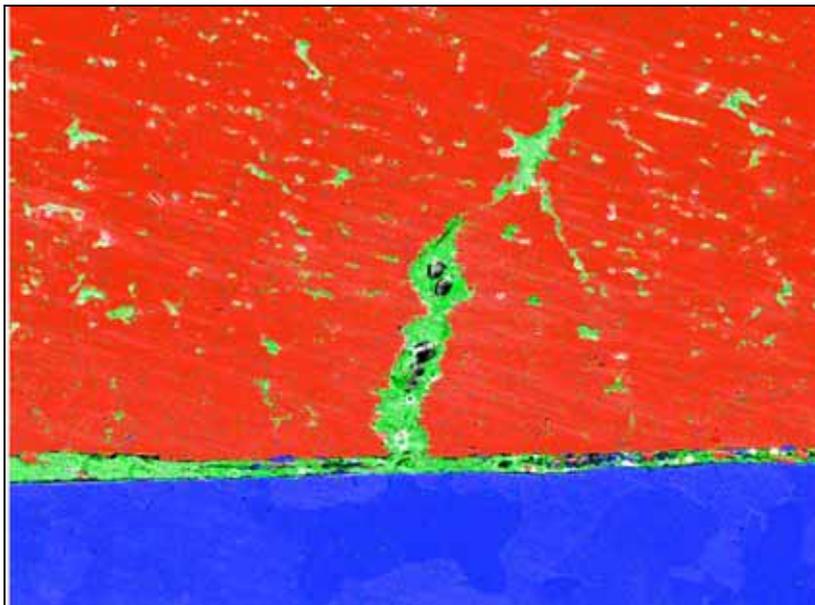
Figure 11. SEM X-ray map confirming the lead migration (green phase) within the copper alloy (red phase) and at the steel (blue phase) interface.

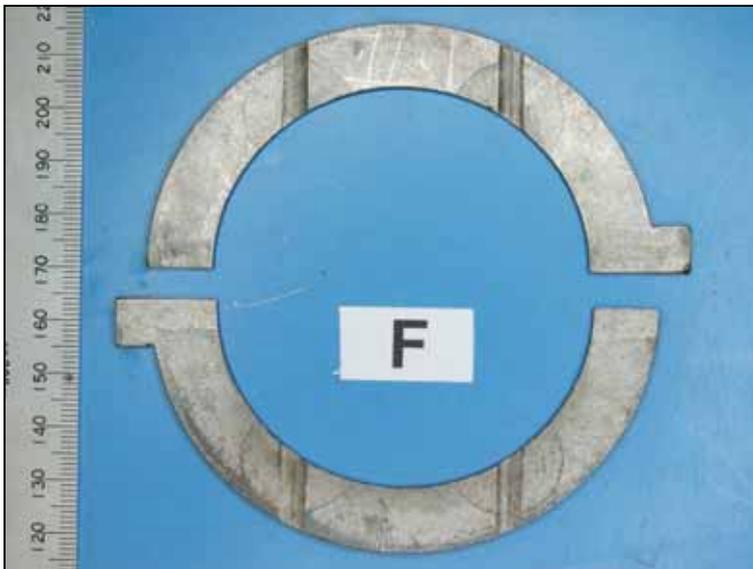
In contrast with the rear elements, the forward bearings presented in an essentially undamaged condition (figure 12), with very little evidence of metal-to-metal surface

contact and no evidence of thermal distress, overheating or physical degradation. The rear surfaces were not fretted or rubbed to any significant extent and showed no indication of improper seating, movement or miss-installation.

Figure 12. Undamaged running surfaces of the forward bearing set.

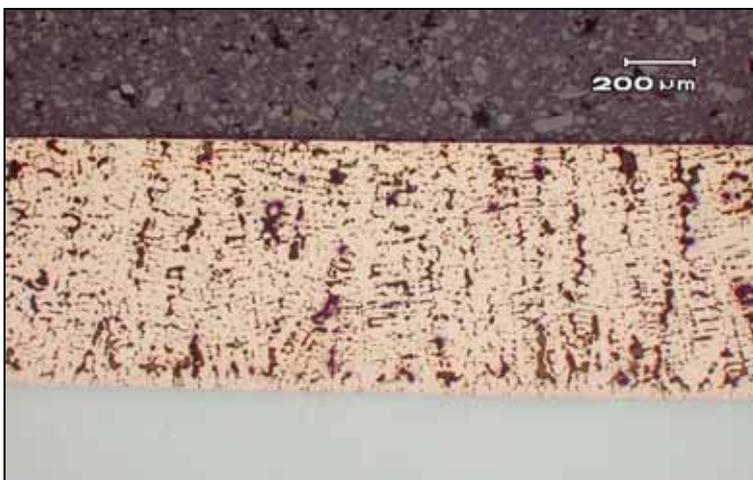
Several metallographic sections, taken in a similar sense to those from the rear bearings, presented a similar general microstructure, with the intermediary alloy layer showing a distinct as-cast (dendritic) distribution of lead within the copper alloy matrix (figure 13). No evidence of fissuring or lead migration to the backing interface was observed within the cross-sections studied.

Figure 13. Metallographic cross-section through an undamaged bearing – no lead migration to the alloy interface.

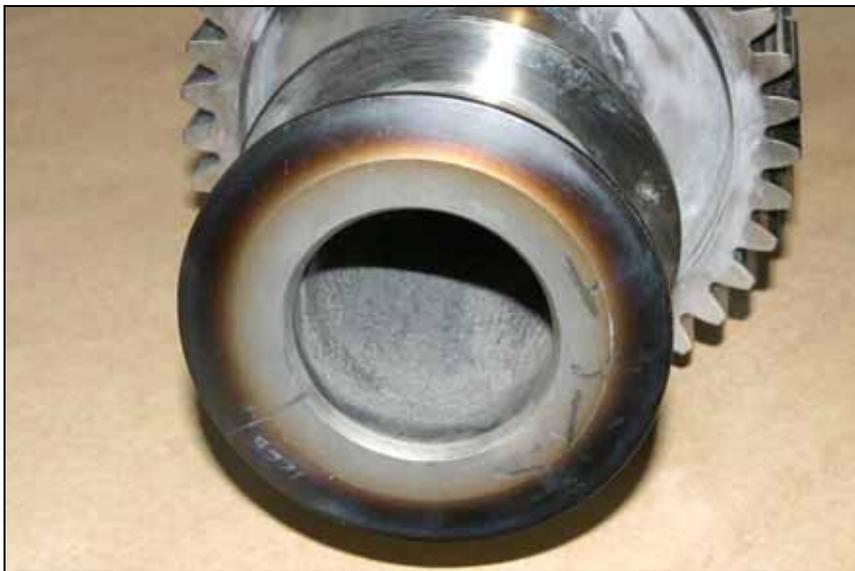
Both propeller shafts showed distinct discolouration and evidence of localised heating in a band around the back face of the rear thrust flange (figure 14). Similar discolouration was also noted in a band around the rearmost ends of the reduction gear teeth (figure 15), however the tooth contact surfaces themselves showed no evidence of distress, uneven wear or excessive localised friction.

Figure 14. Discolouration of the rear thrust flange surface typifying the localised overheating.

The rear propeller shaft thrust bearings from ESN 810712 had failed as a result of gross localised overheating. The local discolouration of the shaft flanges and adjacent surfaces and the partial melting and microstructural changes within the bearing alloy attested to the excursion in temperatures to a level well above the normal component operating range. The physical loss of sections of bearing alloy from the backing material was a direct manifestation of the overheating, with the elevated temperatures causing the lower melting point lead alloy to agglomerate and migrate to the steel interface, where it weakened the normal bond and allowed the break-up and separation of the bearing material. There was no evidence of a deficiency within the construction or make-up of the bearings examined, nor was there any evidence that the bearings had been improperly installed.

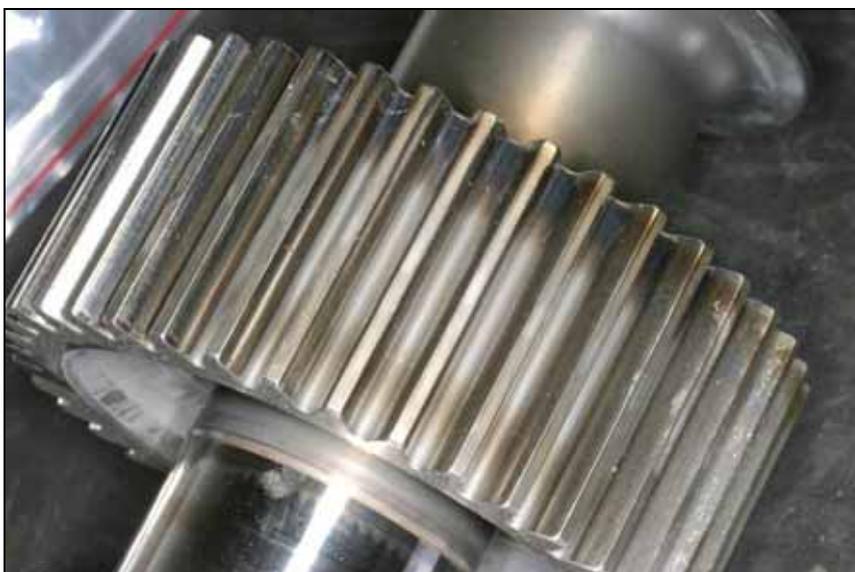
Figure 15. Discolouration (similar to figure 12) evident on the ends of the reduction gear teeth.

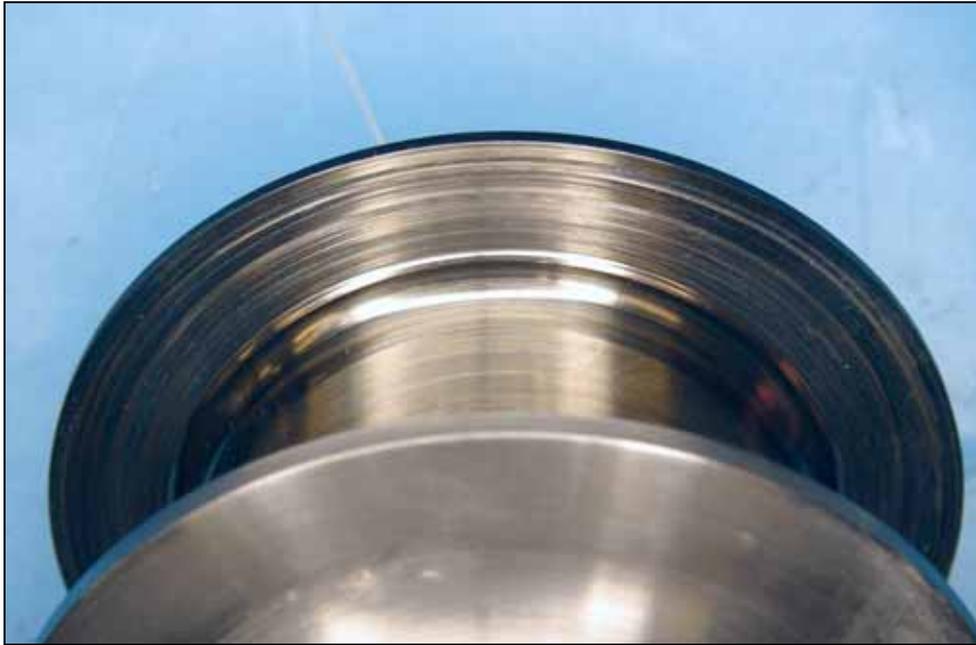
The inside (bearing) surfaces of the rear shaft flanges (those working against the failed bearing elements) showed heavy wear and circumferential scoring around the contact path (figure 16). In contrast, the opposite flange faces (figure 17) showed little if any physical manifestation of service – abnormal or otherwise.

Figure 16. Appearance and extent of scoring and wear sustained by the propeller shaft rear thrust flange contact surface.

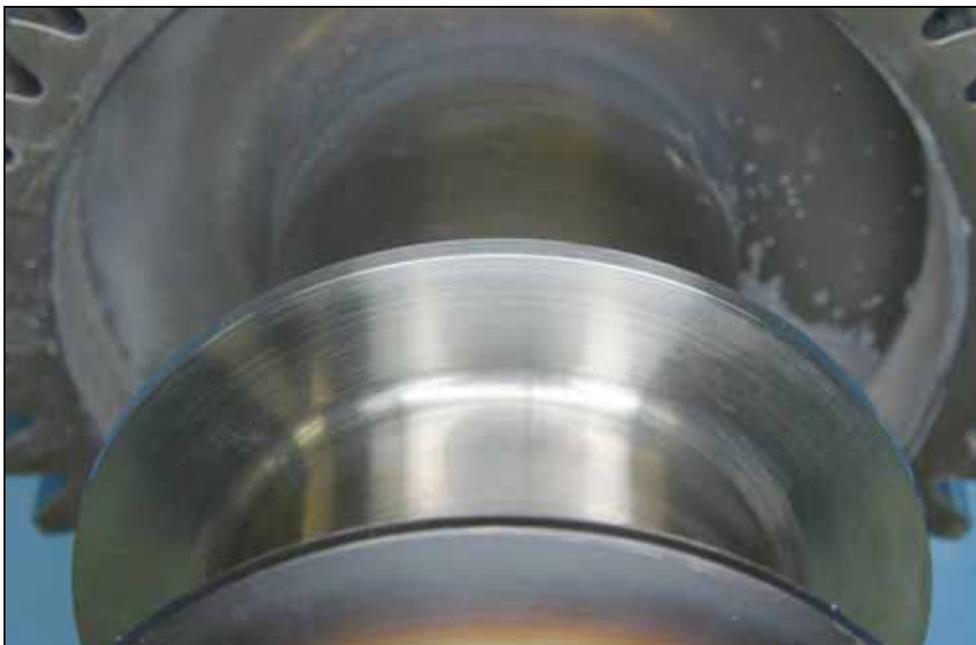
Figure 17. Forward thrust flange (opposite that shown above), presenting in sound condition.
