ATSB TRANSPORT SAFETY REPORT
Rail Occurrence Investigation R0-2010-004
Preliminary

Collision between XPT passenger train WT27 and a track-mounted excavator near Newbridge, New South Wales 5 May 2010

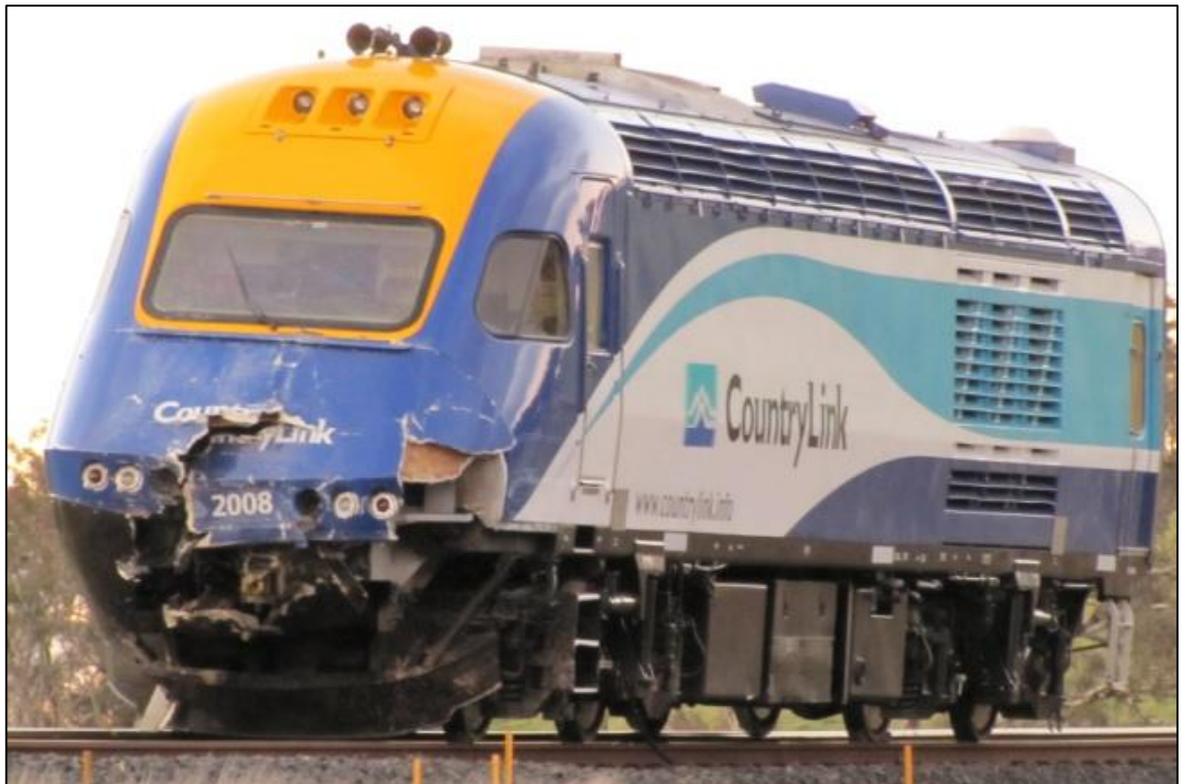
Figure 1: Leading power car XP2008

The excavator and a utility vehicle were severely damaged; the leading power car of the train received moderate damage.

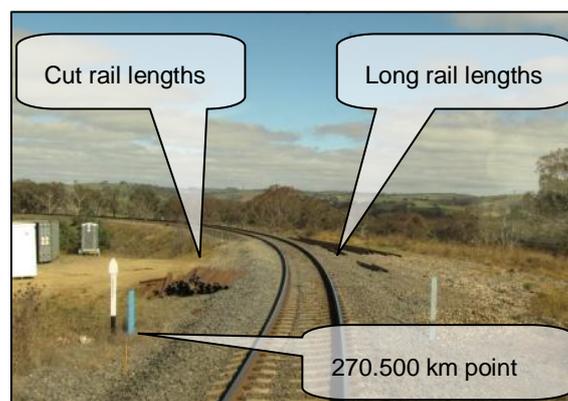
Figure 2: Worksite layout

Due to wet weather conditions affecting planned work on the day of the collision, the ARTC work group manager at Bathurst had arranged for ad-hoc work to be undertaken at the 270.512 km mark. Work comprised reclamation of used rail by oxyacetylene cutting into manageable lengths, then transferring the sections to the other side of the track for collection and removal by truck (see Figure 2). The workgroup consisted of an ARTC Protection Officer (PO) and two private contractors engaged by ARTC as labourers. One contractor was the operator of a track-mounted excavator and the second contractor was responsible for cutting the rail lengths.

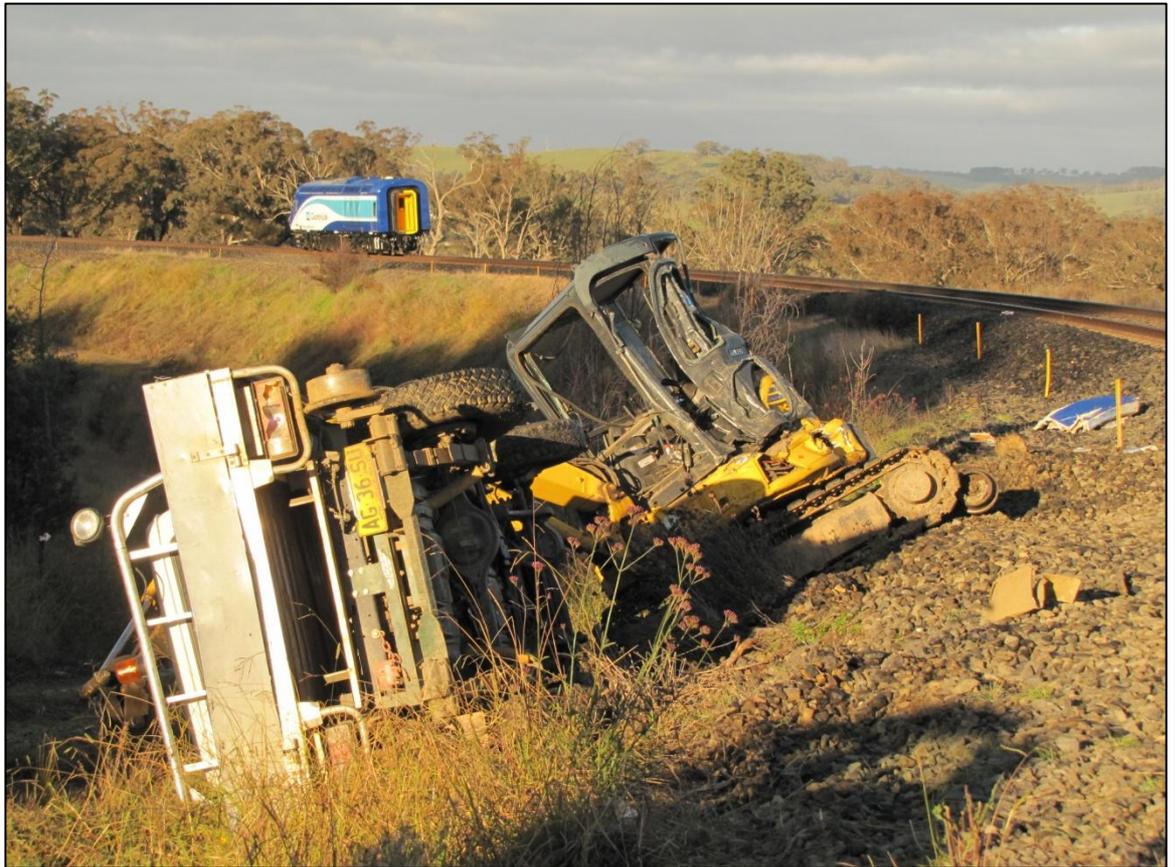
Figure 3: Resting point of excavator, utility vehicle, and lead power car

The excavator was propelled along the track for a distance of 20 m until the extended boom struck a utility vehicle parked alongside the track. On impact, the excavator derailed and came to rest on the formed embankment. The operator of the excavator was ejected from the cab during the collision sequence and was fatally injured. The excavator finally came to rest about 38 m from the point of impact. Train WT27 came to a stand about 194 m from the point of impact (Figure 3). First aid was rendered to the excavator operator by the other ARTC team members, an off-duty train driver, and two off-duty nurses, but to no avail.
