ATSB TRANSPORT SAFETY REPORT
Aviation Occurrence Investigation A0-2010-069
Preliminary

Collision with terrain, VH-KZF 25 km east of Geraldton Aerodrome, Western Australia 14 September 2010

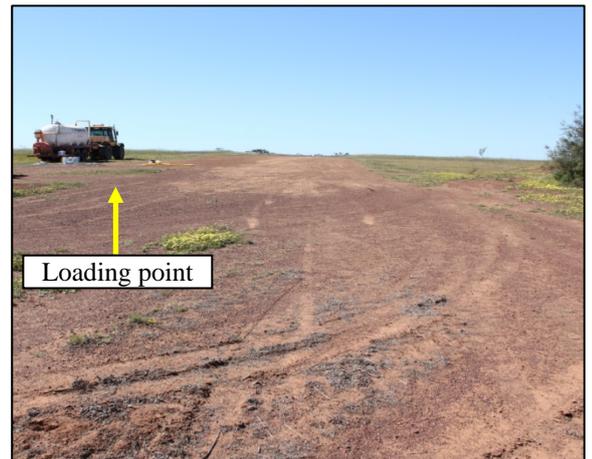
Figure 1: Loading point viewed from the take-off end of runway 13

The loader reported that during the course of the day, 12 flights were planned to be flown. Each flight required the aircraft's spray tank (hopper) to be loaded with a combined 600 L of water and chemical from the load truck. The load truck was located at a loading point about 50 m along the runway from the take-off threshold (Figure 1).

After loading, the pilot commenced take off from the loading point in a south-easterly direction as the loading point was close to the threshold of runway 13 (Figure 1). Nine subsequent flights were successfully completed using the same runway and procedures.

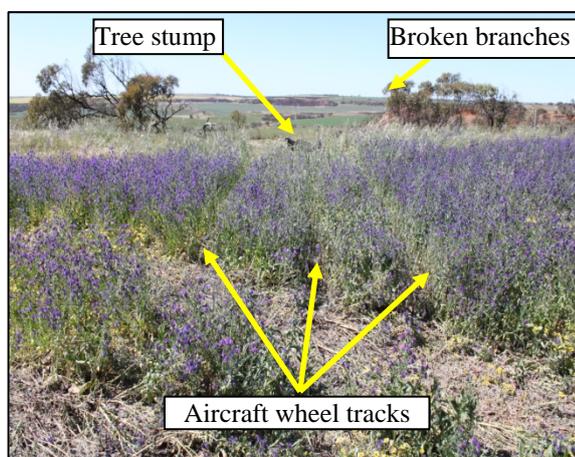
Figure 2: Overshoot area at the departure end of runway 13

The overshoot area at the departure end of runway 13 was an unprepared surface that showed evidence of wheel tracks, a shattered tree stump and trees at the end of the plateau (Figure 2). The tree to the right of the wheel tracks showed evidence of broken branches with red paint transfer that was consistent with the red paint markings on the aircraft.

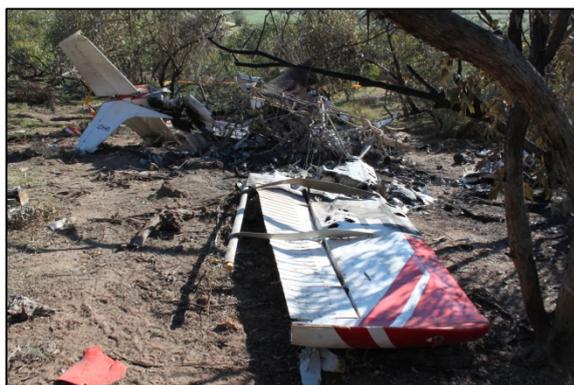
Figure 3: Accident site

The wreckage was located in a treed area about 100 m from the departure end of runway 13 and 25° to the right of the extended runway centreline.

An intense fuel-fed fire that followed the collision with the ground destroyed the fuselage and the inboard sections of the left and right wings. The tailplane, which included the vertical and horizontal stabilisers, sustained minimal damage (Figure 3).
