RAIL INVESTIGATION REPORT

Australian Transport Safety Bureau

**Collision between the passenger
train 5AL8 and vehicles at the
Salisbury Interchange level crossing,
Salisbury, South Australia**

24 October 2002

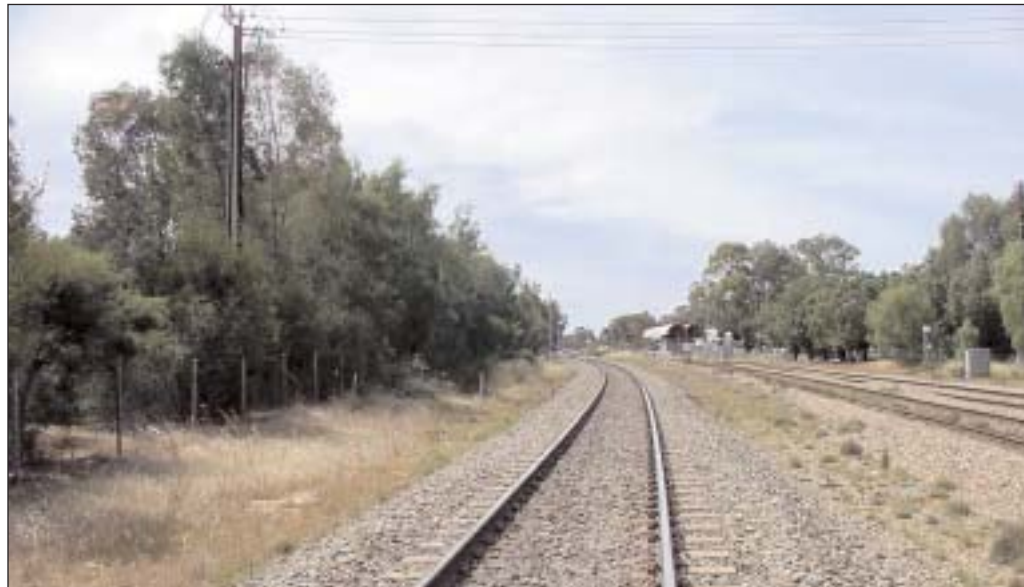
FIGURE 7:
Park Terrace at about 250 m

The real effect of limiting the train speed to 50 km/h is that a road vehicle or pedestrian has more time to clear the line than if a train is travelling at 80 km/h. A sighting distance of 250 m provides an extra seven seconds for road vehicles and pedestrians to clear the tracks. This time would be greater if the approaching train applied full emergency braking.
