ATSB TRANSPORT SAFETY INVESTIGATION REPORT
Marine Occurrence Investigation No. 237
Final

**Independent investigation into the collision
between the Australian recreational vessel**

Norma Jean

Seatow 61

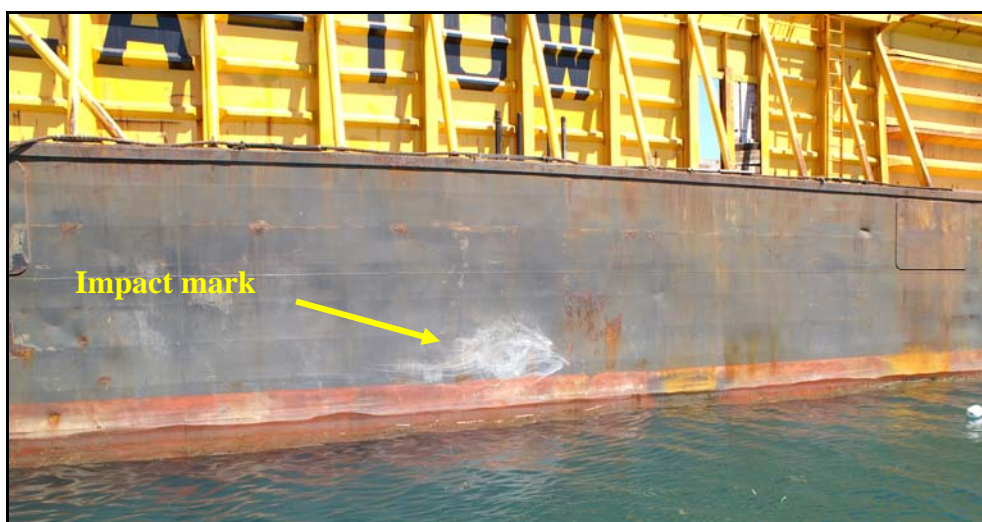
Figure 10: Impact mark on the hull of *Seatow 61*

At 1610, *Kurutai* stood by the barge, about one cable away, and the crew was able to see a previously unknown impact mark on the barge's port side (Figure 10).

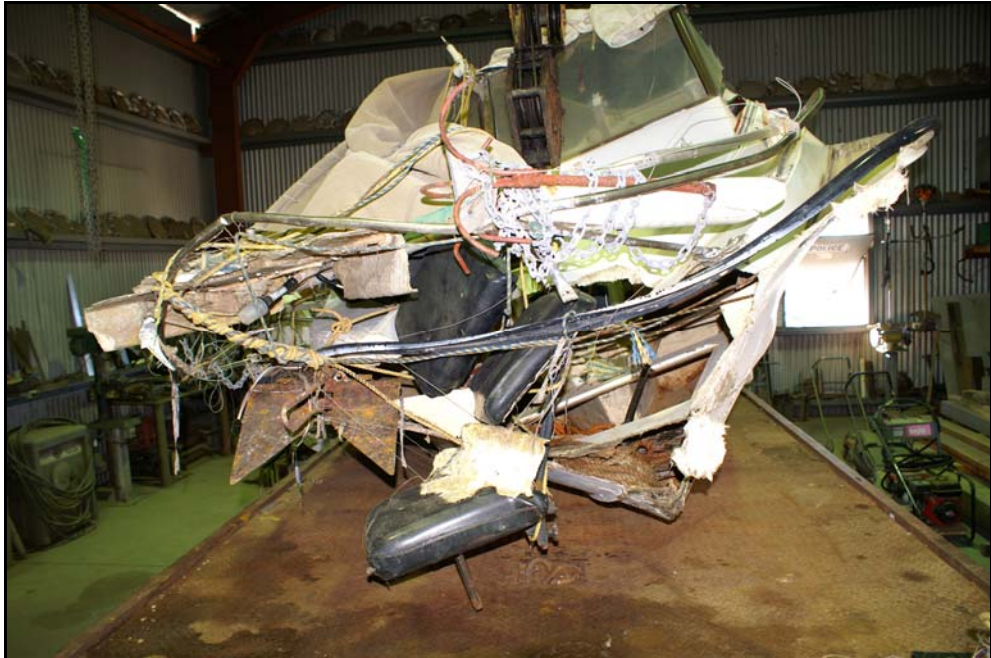
Figure 12: *Norma Jean*'s damaged bow

30 knots when the collision occurred. The impact damage on the bow of the boat was consistent with the boat colliding with the barge at high speed.

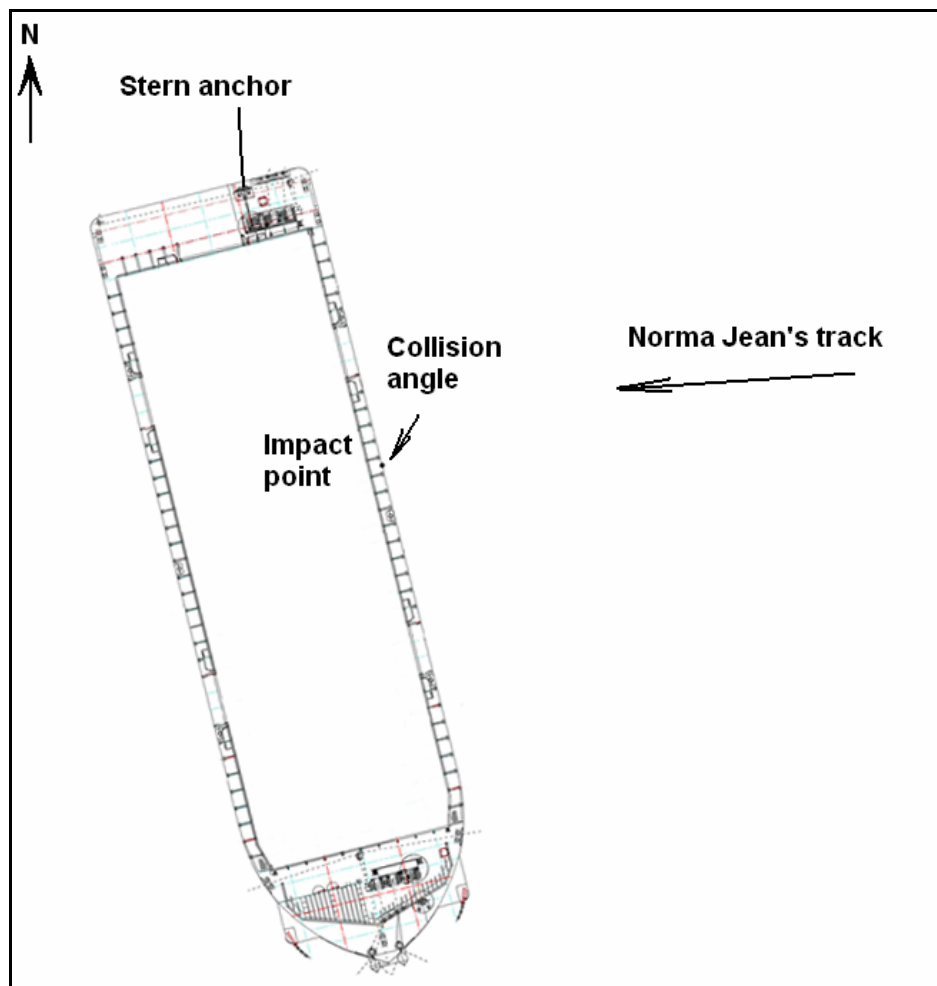
Figure 13: Diagrammatic representation of the collision

At 0625 on 18 March 2007, the tide had started to flood and the tidal flow past Carnarvon would have been from almost due north at up to about 1.25 knots. There was almost no wind. The flooding tide would have caused the barge to lie at an angle to its stern anchor cable (Figure 13). Therefore, at about 0600 on 18 March, the barge's stern would have been to the north and its port side would have been facing Carnarvon.

Norma Jean's course towards 'The Gap' would have been about 261° (T). The most severe impact damage was on *Norma Jean's* starboard bow, indicating that it collided at an oblique angle to the barge's centreline. While it is possible that the barge was lying at a different angle, an analysis of the most probable angle of the barge and *Norma Jean's* probable course (Figure 13) indicates that it is likely that *Norma Jean* changed course immediately before the collision occurred. This

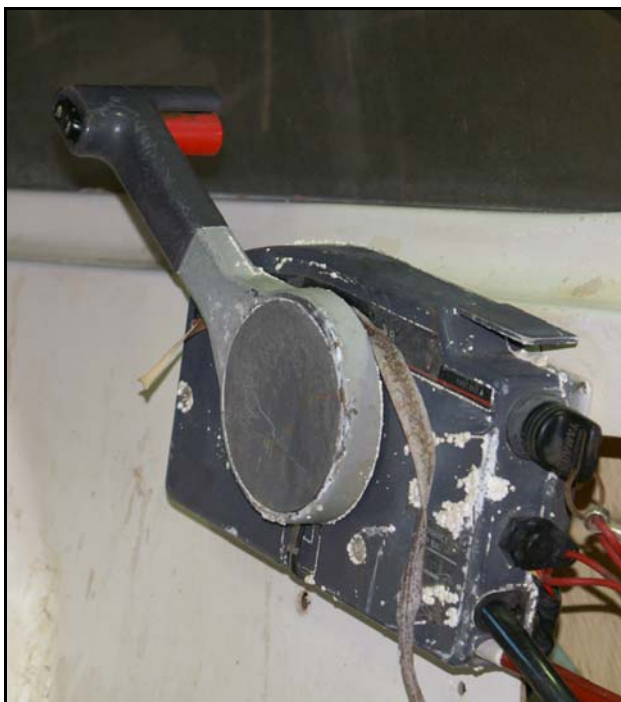
Figure 14: Throttle lever

The examination of *Norma Jean*'s wreckage revealed that the outboard motor's throttle lever was in the full forward position for maximum speed (Figure 14). While the throttle lever may have been knocked forward during the collision, it is more likely, as suggested by the damage and estimated time of collision, that *Norma Jean* was travelling at or close to its maximum speed when the collision occurred.

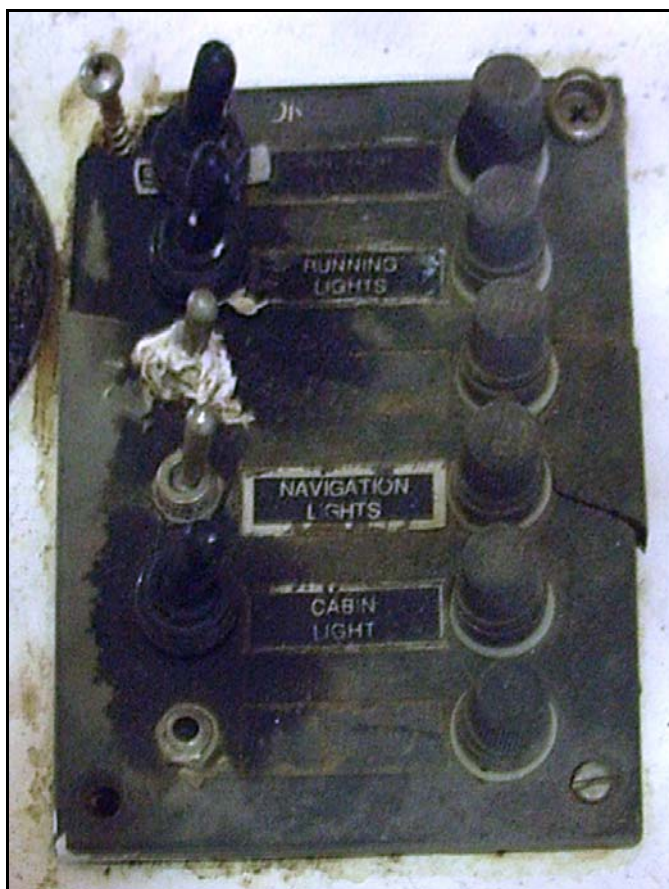
Figure 15: Switch panel

The reflections from the GPS, the cabin light and of the boats occupants on the inside of the windscreen would have stimulated the skipper's eyes to relax and focus on the reflections at the expense of his focus on objects outside the boat.

It took *Norma Jean* about 15 minutes to travel from the comparatively well lit harbour area to the barge. This brief time and the use of the boat's interior light would have limited the skipper's visual adaptation to the dark. Dark adaptation occurs when the human visual system is adjusted for efficient response in dim illumination¹⁹. Pupils in the eyes dilate and the light receptors in retinas increase their sensitivity so that the threshold of vision improves with an increase in time spent in the dark.

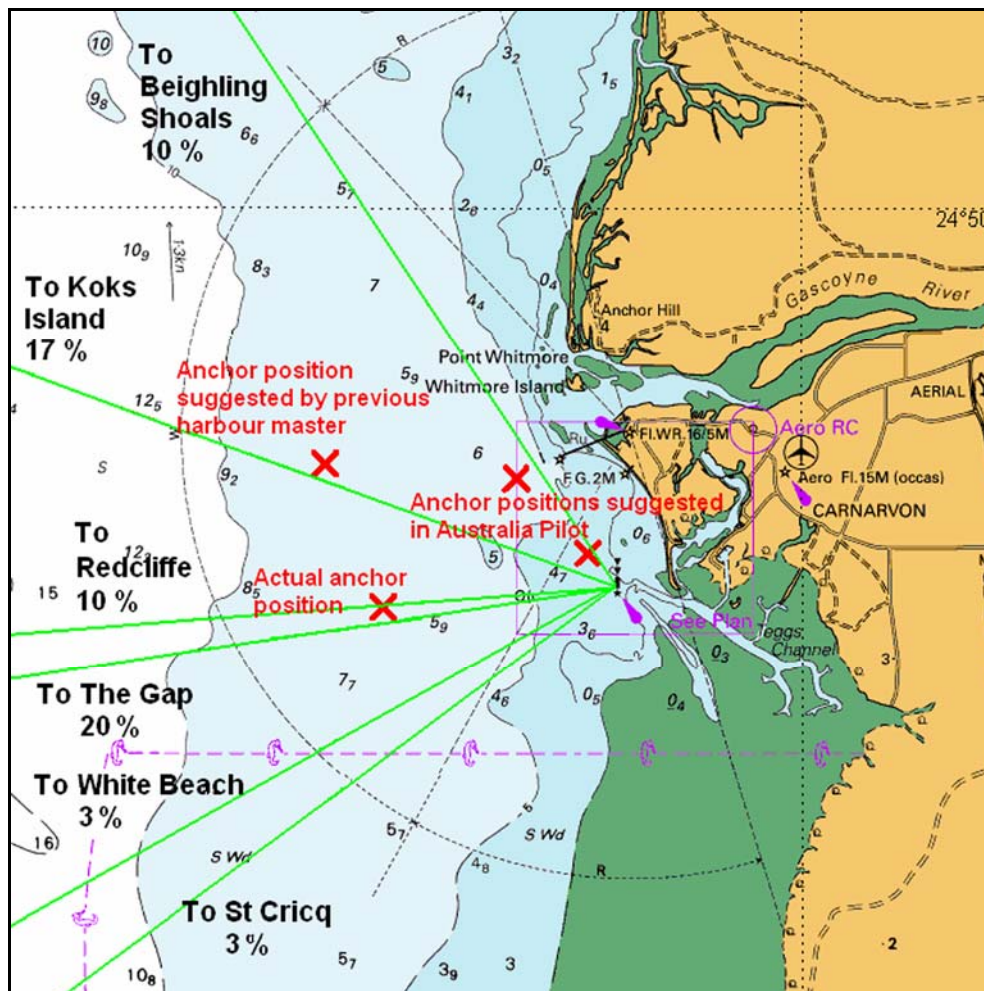
Figure 16: Section of chart Aus 747 showing different anchor positions and popularity for different fishing destinations and approximate headings to reach them

There were about 50 recreational vessels operating out of Carnarvon on 18 March because of the good weather. About 30 of these boats had notified CVSR of their departure and their estimated return time. Of these boats, 30 per cent were heading across the bay to either 'The Gap' or 'Redcliffe' (Figure 16). The course to both of these destinations passed through the area in which *Seatow 61* was anchored. Therefore, based on the traffic patterns observed on 18 March, the barge's anchored

position exposed it to the risk of collision with about 30 per cent of the recreational traffic that departed from the Carnarvon boat harbour.

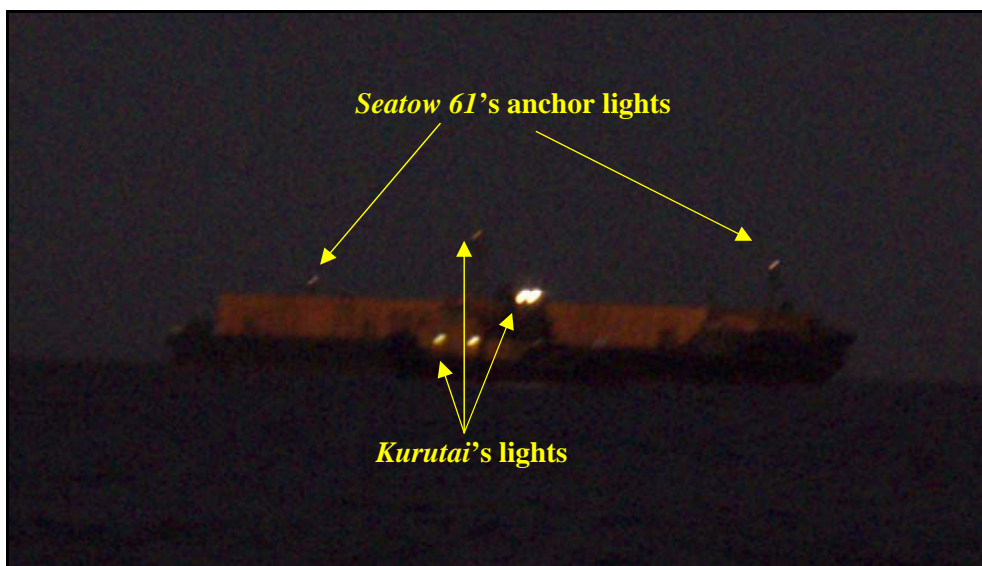
Figure 17: Tug and barge at 0711 on 13 March

At 0711 on 13 March, five days before the accident, the barge's anchor lights were photographed by the RTO while illuminated (Figure 17). No maintenance or repair work was undertaken on the barge's electrical systems between that time and the time that the system was tested on 24 March. The evidence suggests that the barge's anchor lights were probably illuminated at the time of the accident, as required by the COLREGS.
