# Fatality on board the chemical tanker *Bow De Jin* at sea off New South Wales

## 24 November 2009

On 24 November 2009, the chief mate on board the Hong Kong registered chemical tanker *Bow De Jin* died after entering a cargo tank which contained hydrocarbon vapours and was deficient in oxygen.

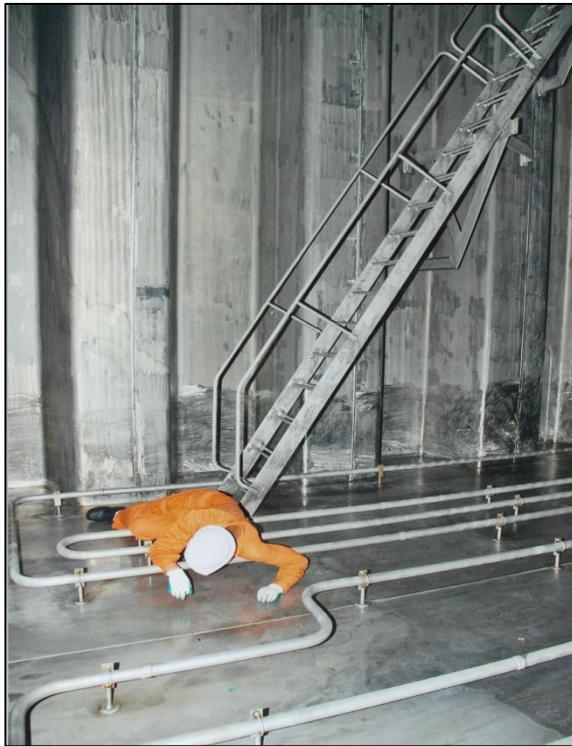
**Figure 3: Re-enactment of the chief mate's position in the tank**

When the bosun got to 5P, he looked down the open hatch and saw the chief mate at the bottom of the tank, near the base of the ladder (Figure 3). He immediately called the master who came over. The master noted that the chief mate was lying face down and was not moving.

Before the BA-equipped team entered the tank to rescue the chief mate, they checked the atmosphere in the tank, noting that it contained 16% oxygen in the bottom section and 12% in the middle section.

The evidence indicates that the chief mate collapsed at the bottom of the tank due to the lack of oxygen in the atmosphere; becoming unconscious and, consequently, was unable to help himself. He also breathed in a quantity of Hexene-1 vapours. This may have occurred as he descended into the tank, or after he had collapsed at the bottom of the tank.

Therefore, there are no records that indicate that 5P was gas free at the completion of the tank cleaning and ventilation process. The readings taken when the chief mate was removed from the tank (16% oxygen at the bottom of the tank and 12% in the middle section) and the fact that the chief mate died from asphyxiation, indicate that the tank was not fully gas free.
