ATSB TRANSPORT SAFETY REPORT  
Aviation Occurrence Investigation AO-2010-089  
Safety Recommendation AO-2010-089-SR-012

# Safety Recommendation

## Rolls-Royce plc Trent 900 engines

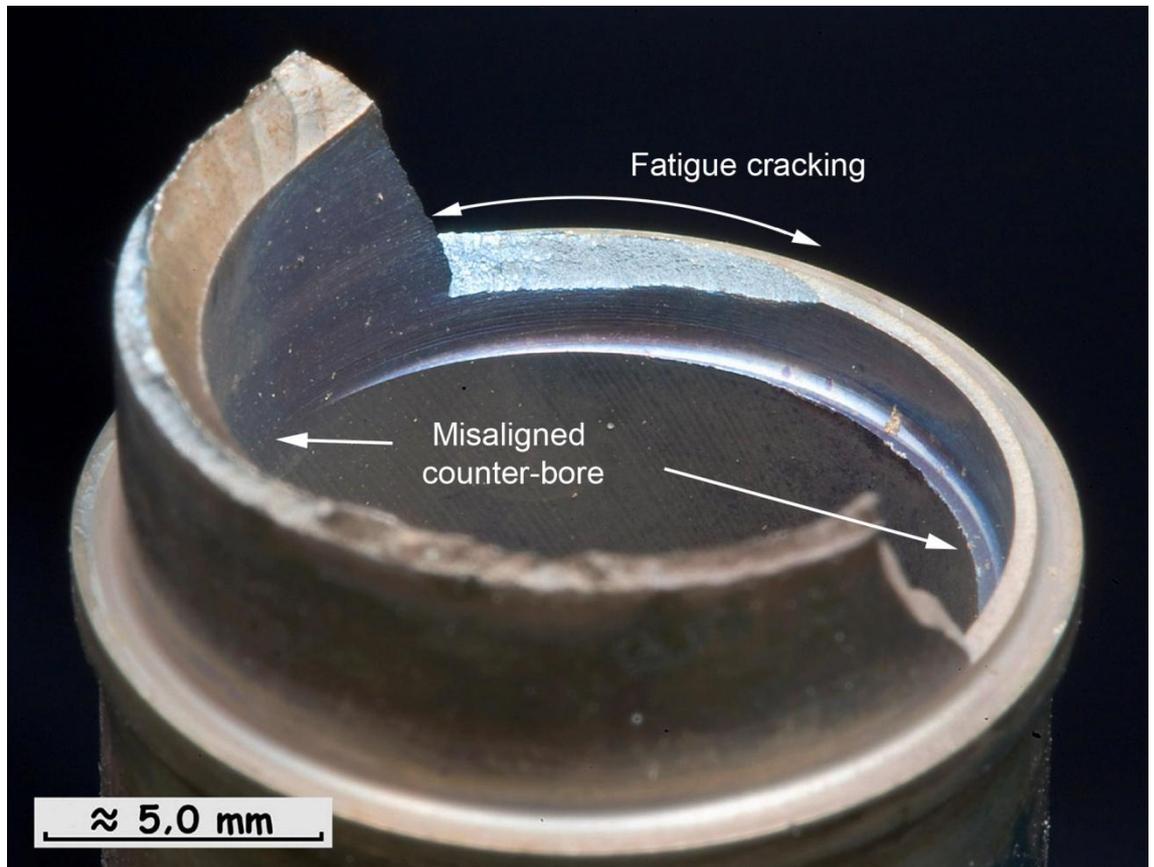
**Figure 1: Detail of stub pipe showing misaligned counter-bore**

Further examination of the cracked area has identified the axial misalignment of an area of counter-boring within the inner diameter of the stub pipe; the misalignment having produced a localised thinning of the pipe wall on one side. The area of fatigue cracking was associated with the area of pipe wall thinning (Figure 1).

Misaligned stub pipe counter-boring is understood to be related to the manufacturing process. This condition could lead to an elevated risk of fatigue crack initiation and growth, oil leakage and potential catastrophic engine failure from a resulting oil fire.

The Australian Transport Safety Bureau recommends that Rolls-Royce plc address the safety issue and take actions necessary to ensure the safety of flight operations in transport aircraft equipped with Rolls-Royce plc Trent 900 series engines.
