Derailment of train 3PW4

Wodonga, Victoria

23 October 2010

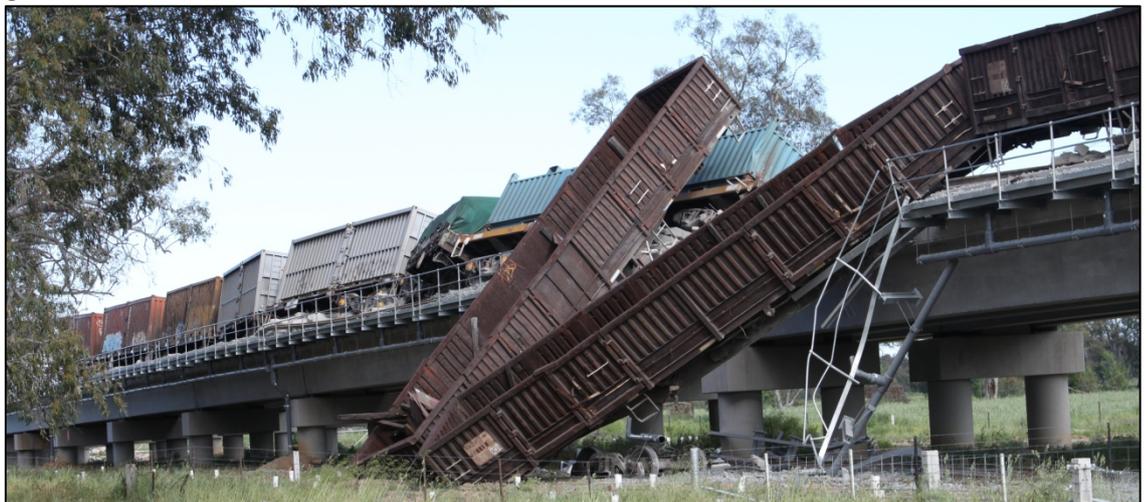
Figure 1: The derailment site

Bogies under three of the following four wagons had also derailed, beyond which a gap of about 140 m existed before the remainder of the train. Most of the derailed wagons had come to rest on one of the Wodonga bypass bridges (spanning the Wodonga Creek). In total, 15 wagons had derailed and were lying at various angles to the track,

including two which had fallen, each with one end resting on the ground and one end on the bridge (Figure 1).

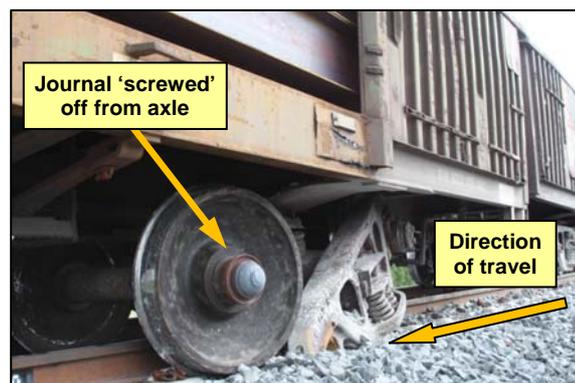
Figure 2: Rear bogie of wagon RKWY-4125C

The second driver walked back to investigate the cause of the brake application and discovered that the rear bogie on wagon RKWY-4125C (the 20th wagon behind the locomotives) had derailed. It was evident that a bearing on the lead axle of the bogie had failed, resulting in the bearing journal separating from the axle (commonly referred to as a screwed journal - Figure 2).

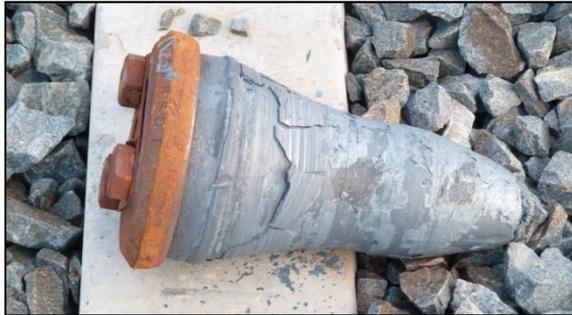
Figure 3: Axle journal

It was evident from on-site examination that the derailment was caused by a 'screwed journal' as a result of a bearing failure on wagon RKWY-4125C. The evidence suggested the following, as the most likely derailment sequence.

As the train approached Wodonga, it is likely that the condition of the wheel bearing on wagon RKWY-4125C had deteriorated to the point where the bearing had seized. As the wheel-set continued turning, the bearing lost interference fit on the axle journal, generating and transmitting sufficient heat to the journal to make it 'plastic' and causing it to 'screw off' (Figure 3).

Once the bearing journal had separated from the axle, the bogie side-frame and axle could not be contained within their normal configuration. The side-frame fell down and dragged along the sleepers and ballast while the wheel-set was permitted to turn and derail. As the train continued, the side-frame and wheels impacted with the concrete sleepers which ultimately failed to maintain track gauge and allowed further wagons to derail.

The bearing that failed was completely destroyed and could not be examined to determine the cause of its failure. The investigation is continuing to identify possible causes and will include an examination of the following:
