Main landing gear failure – Melbourne Aerodrome

20 October 2009

Abstract

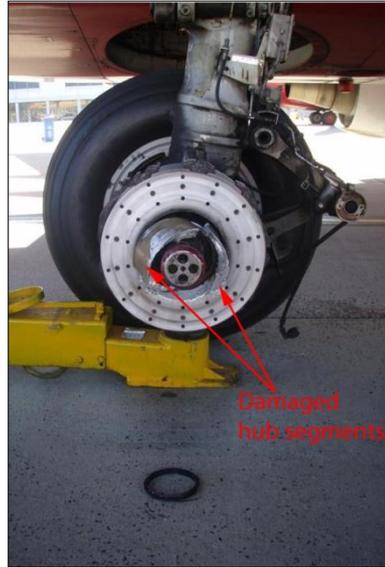
A visual inspection of the landing gear, following arrival at the gate, revealed the number-4 main landing gear wheel (right outboard) to be oriented at an unusual angle with respect to the axle. The wheel was subsequently removed, and the inner wheel hub and bearing mount was found to have detached from the wheel assembly (Figure 1).

The operator later reported to the Australian Transport Safety Bureau (ATSB) that some contact and wear damage had been observed on the brake assembly. No damage was observed on the right main landing gear axle. The number-3 wheel assembly was replaced as a precautionary measure and the number-4 brake assembly replaced due to damage sustained during the wheel failure.

Figure 1: Right main landing gear showing fractured hub after removal of the wheel (image provided by the operator)

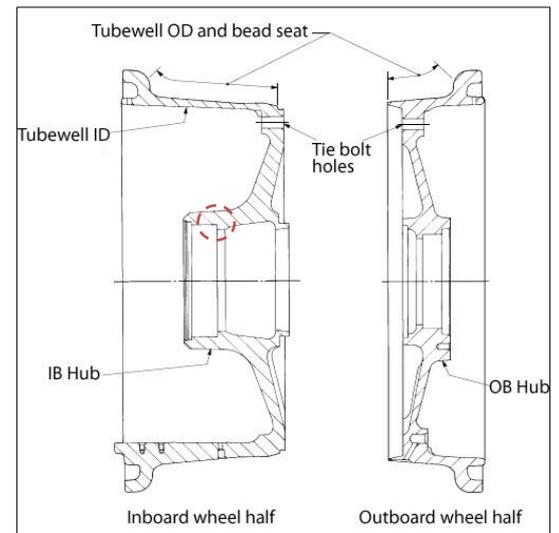
The main landing gear wheels are comprised of inner and outer halves, held together with tie bolts (Figure 2). The internal diameter of each inboard

wheel assembly was shot peened² during manufacture; however, the manufacturing specifications did not require the shot peening to extend beyond the bearing bore to cup intersection tangency.

Figure 2: Schematic diagram showing inboard and outboard wheel halves and the approximate location of the failure origin (circled)

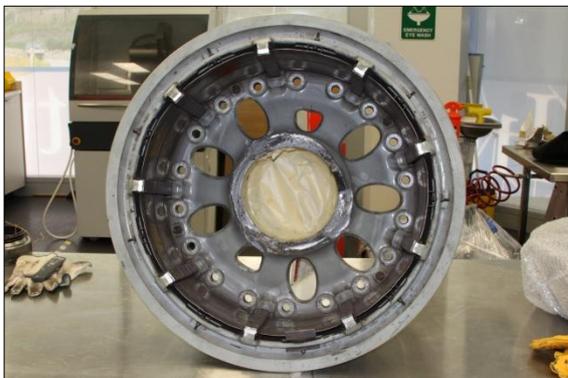
Initial inspection of the wheel showed the hub section to have fractured away from the web of the inboard wheel half, with cracking extending through the transition radius between the two regions (Figure 3).

Figure 3: Inboard wheel segment, showing missing hub area

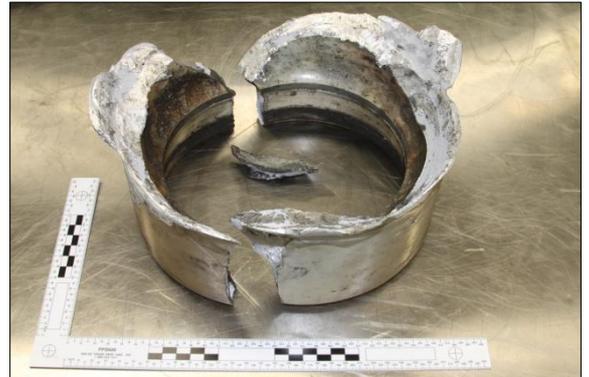
Examination of the separated hub section revealed that the failure was characterised by two predominantly axial planes of fracture. These transitioned into a circumferential fracture within the hub-to-web transition radius region (Figure 4).

Figure 4: Fractured hub segment

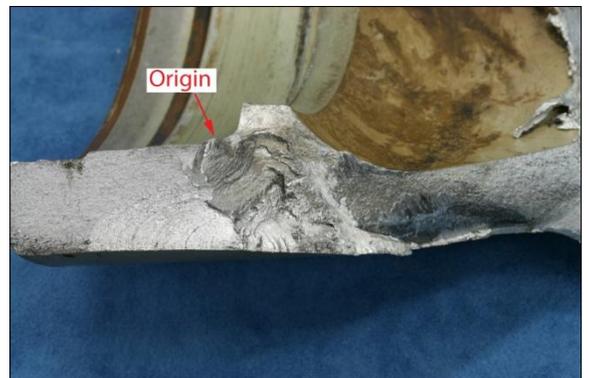
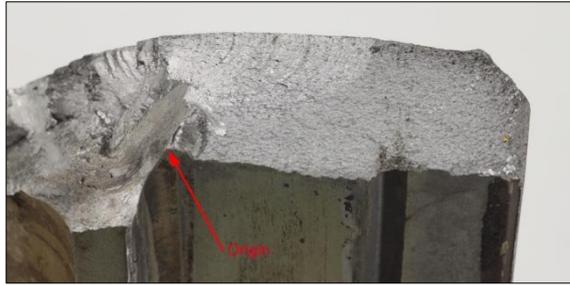
The axial fracture surfaces showed an inclined plane of darker, stained fracture within the hub wall. That location was coincident with the base of the inboard bearing seat. This area was subsequently cleaned and a closer examination showed clear evidence of fatigue fracture.

Several planes of fatigue fracture were evident; each of which were characterised by beach marks. The beach marks radiated outwards from an origin area at the inner bearing seat radius. The fatigue fracture zone extended for approximately 80mm in an inboard direction beneath the bearing seat, and 26mm towards the inner hub end (Figures 5 and 6).

The remainder of the hub fracture surfaces appeared dull grey in colour and exhibited a rough fibrous appearance, considered typical of ductile overstress failure.

Figure 5: Radial fracture surface showing likely origin of failure at the bearing seat.

Figure 6: Same as Figure 5 from the opposite side of the segment.

Failure of the right outboard main landing gear wheel (serial number B8154) of VH-VUI occurred as a result of the initiation and growth of fatigue cracking through the inboard hub. The ATSB investigation identified the initiation of cracking at the bearing bore shoulder radius; the cracking propagating radially until final fracture occurred

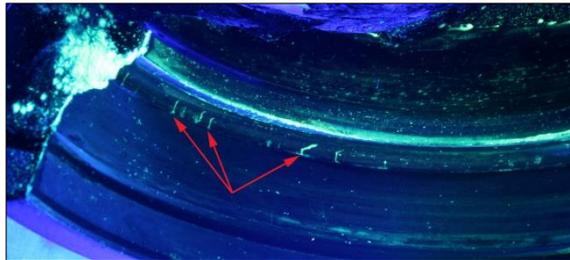
To identify the presence of any further cracking, the remaining sections of inboard hub were examined using a fluorescent penetrant inspection technique. Multiple indications of other radial and circumferential cracks were noted within the region of the bearing bore radius (Figure 7).

Figure 7: Radial cracks identified during fluorescent penetrant inspection

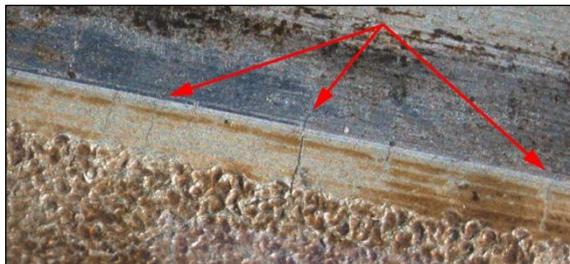
This area was then examined at high magnification and confirmed the existence of additional cracking. The cracks were oriented in the radial direction and were directly adjacent to the shot peened region (Figure 8).

Figure 8: Axial cracks adjacent to the shot peened area.

The hub examination also revealed the presence of multiple smaller cracks around the entire circumference of the bearing bore shoulder radius. Those cracks appeared to have initiated at the region adjacent to the shot peened surface.

The wheel manufacturer made a change to the design of new production wheel components, incorporating shot peening of the entire bearing bore area to help prevent the fatigue cracks from developing. This change was introduced at wheel assembly serial number B15419. The improved wheels were intended for delivery on new aircraft at line number 3099; scheduled for November 2009.

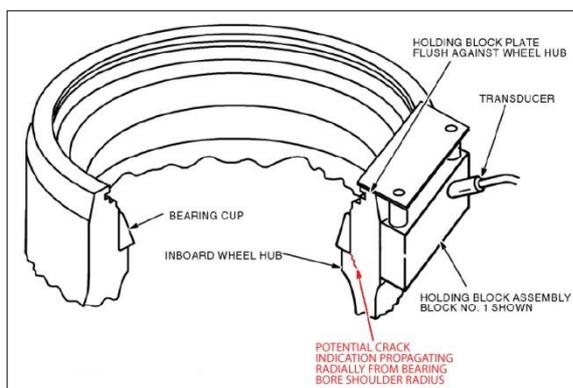
Figure 10: Potential location of crack and ultrasonic test method (SPM).

Following this, the wheel manufacturer developed an ultrasonic inspection method to check for cracks in the bearing bore (Figure 10). This improved inspection method was released as a temporary revision to their Standard Practices Manual (SPM Temporary Revision 32-1) on 1 May 2009. The Service Information Letter, (Publication Number D200904000037), accompanying the change to the SPM stated that inboard wheel halves that exhibited a service history of fatigue cracking at this location should be inspected using this procedure. Of note however, was that there were no corresponding amendments to the updated wheel CMM released in June 2009.

In August 2009, the aircraft manufacturer issued Service Letter 737-SL-32-162, recommending that operators perform periodic ultrasonic checks of the post-2005 wheels, in accordance with the revised SPM-TR-32-1, and to the following schedule:

- new to 10 tyre changes: ultrasonic inspection not required
- 11 to 20 tyre changes: ultrasonic inspection every other tyre change
- 21 and beyond tyre changes: ultrasonic inspection every tyre change.
