### **History of the flight**

On 13 April 2005 at approximately 1130 Eastern Standard Time, the pilot of a Robinson Helicopter Company model R22 Beta, registered VH-HXU, was conducting cattle mustering operations near Mareeba, Qld, when he felt a significant airframe vibration and elected to conduct an immediate precautionary landing. Upon inspection with the engine still running, the pilot reported observing the clutch assembly shaking excessively, followed by the sudden fracture of the clutch shaft at the connection to the main rotor gearbox. The pilot was the only occupant of the helicopter and was not injured. There was no other damage to the helicopter.

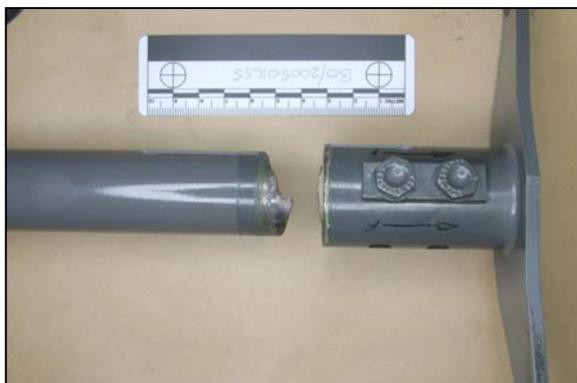
The clutch shaft had fractured at the connection to the main rotor gearbox yoke and presented a characteristic spiral fracture form, with cracking continuing down the bore of the shaft inside the yoke (refer to figure 4). Although damaged by repeated surface-to-surface contact, the fracture surfaces showed clear evidence of fatigue crack progression markings (beach marks) extending along the fracture path, to a small region of ductile overload fracture that represented the area of final shaft failure (refer to figure 5). In total, fatigue cracking had propagated circumferentially for around 450 degrees (i.e. 1¼ times around the shaft), over an axial length of approximately 25 mm.

Fig. 3 Fracture coincident with the end of the forward yoke.

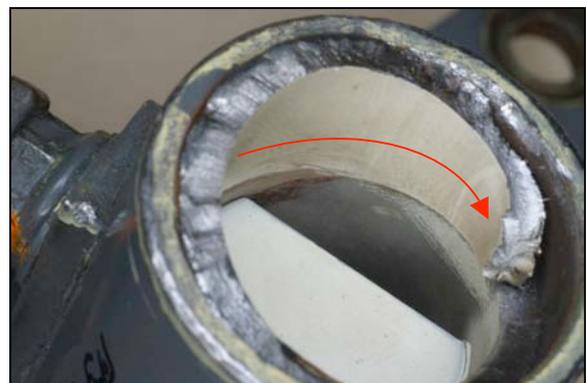
Fig. 4 Progression of cracking from within the shaft bore.

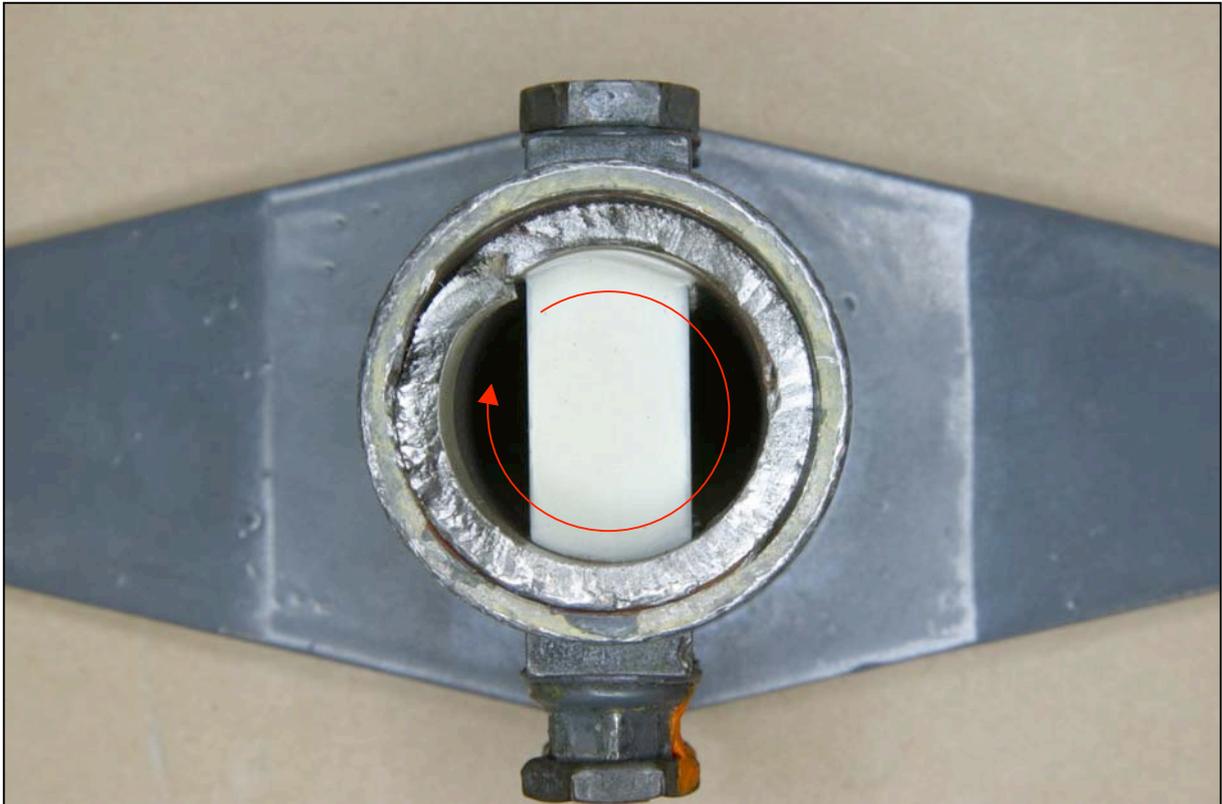
**Fig. 5** Spiral nature of cracking, with direction of crack propagation indicated.

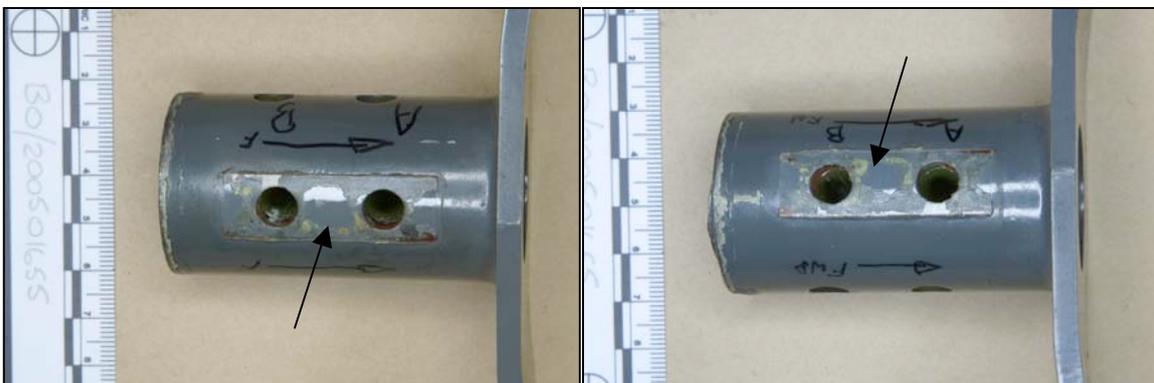
Progressive disassembly of the shaft/yoke connection revealed grey enamel external paint beneath the clamping plates (refer to figures 6, 7), with no evidence of any attempt having been made to remove the paint before the last assembly. Ridging and extrusion of the paint was evident along the edges of the block seating positions (refer to figure 8).

**Figs. 6 & 7** External surfaces of the A907 (forward) yoke, showing paint beneath the clamping block seating locations on both sides.

The assembly of the yoke - shaft connection without first fully cleaning away the external paint from underneath the block seating locations was considered a major factor in the looseness of the connection and the subsequent initiation of cracking. The noted compression and extrusion of the paint underneath the yoke clamping blocks would have allowed a loss of bolt tension and a loss in clamping force within the connection, permitting movement and the observed fretting damage.

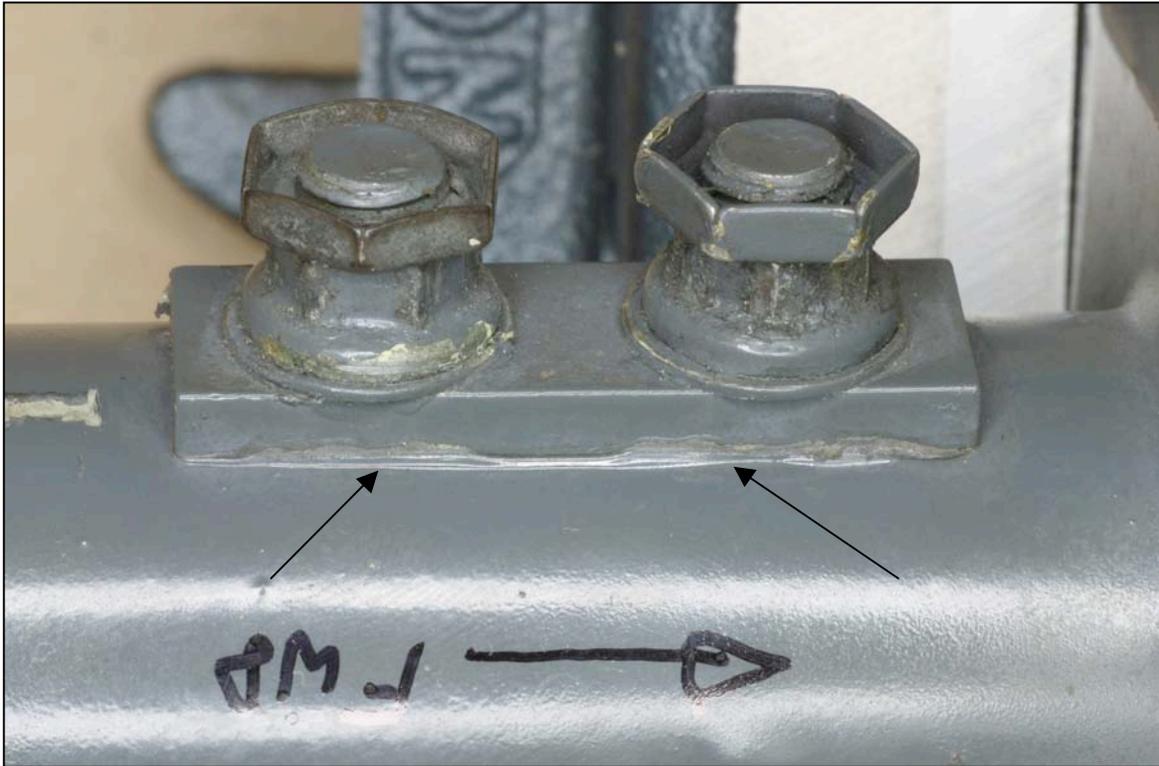
**Fig. 8 Ridging and extrusion of paint (arrowed) from beneath the clamping blocks.**

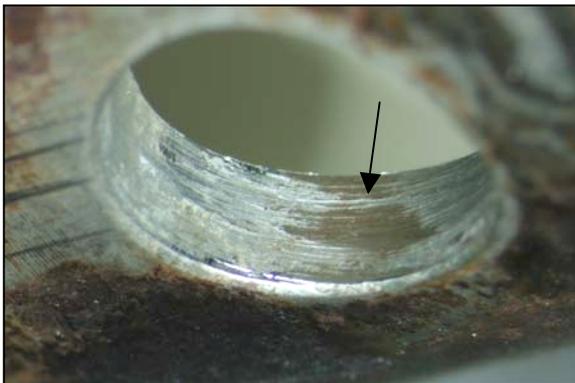
**Fig. 9 Fretting and rubbing contact within the shaft yoke bolting holes.**

Both the inside bore of the clutch shaft bolt holes (refer to figure 9) and the bolt shank surfaces passing through the shaft (refer to figure 10) showed fretting damage associated with the repeated movement of the surfaces against each other under load. The separated clutch shaft and yoke surfaces both showed extensive fretting damage, characterised by distinct surface corrosion and production of a fine brown powder-like product (refer to figures 11 and 12).

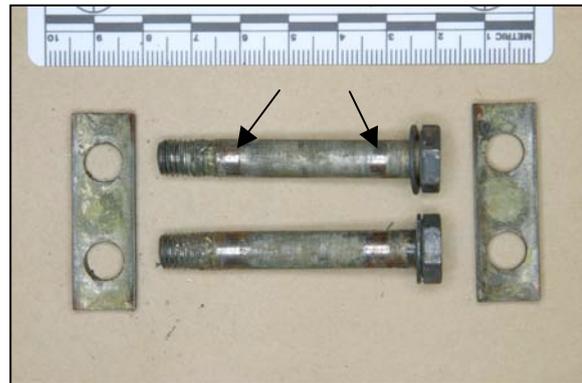
**Fig. 10 Yoke through-bolts, showing comparable shank fretting damage.**

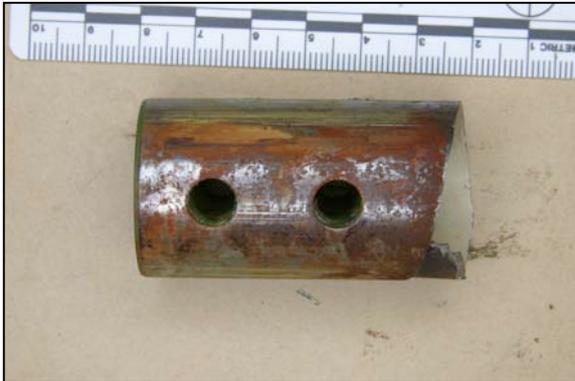
**Fig. 11** Heavily fretted clutch shaft stub after removal from the yoke.

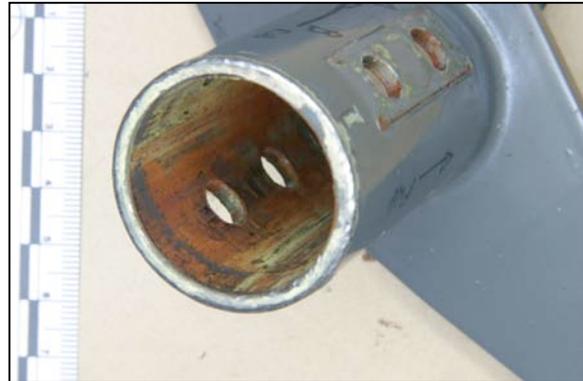
**Fig. 12** Fretting damage inside yoke bore.

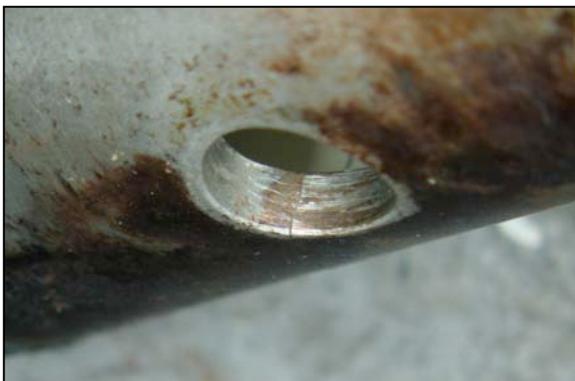
The spiral fatigue crack propagating around the clutch shaft had originated from the bore of a second row bolt hole. Prominent bore surface rubbing and fretting damage surrounded the crack origins (refer to figure 13).

**Fig. 13** Origin of fatigue cracking within a clutch shaft bolt hole. Note associated fretting.

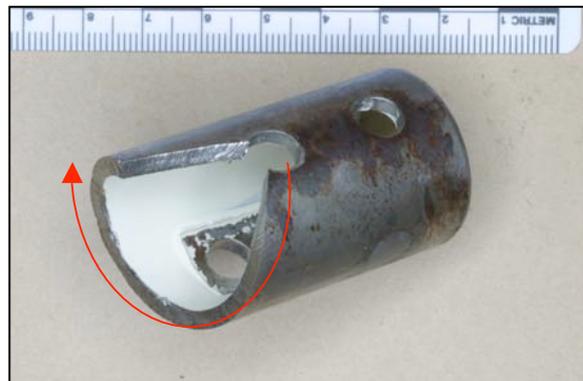
Sectioning of the shaft to intersect the cracked bolt hole allowed the separation and examination of the crack surfaces (refer to figure 14). Clear progression markings characterised the crack length and confirmed the bolt hole origin. Closer light and electron microscopy provided evidence that the cracking had initiated at the outer bolt hole corner and subsequently propagated inward and around the clutch shaft as flight cycles accumulated.

**Fig. 14** Torsional fatigue crack propagation path.

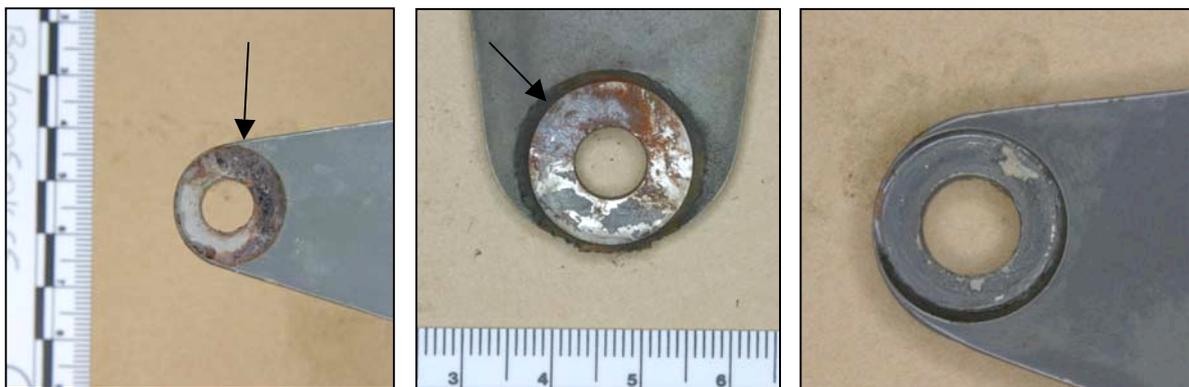
While possibly unrelated to the clutch shaft failure, both the forward yoke and flex plate also showed evidence of fretting and surface movement between the bearing surfaces (figures 15, 16). In a manner similar to the shaft connection, grey enamel paint was found on the bolt clamping surfaces of the yoke arms (figure 17).

**Figs. 15, 16** Fretting damage on the yoke and forward flex-plate bearing surfaces.

**Fig. 17** Paint remaining on the bolt seating surfaces.
