ATSB TRANSPORT SAFETY INVESTIGATION REPORT

Aviation Occurrence Report – 200504340

Flight control system event

VH-OZF

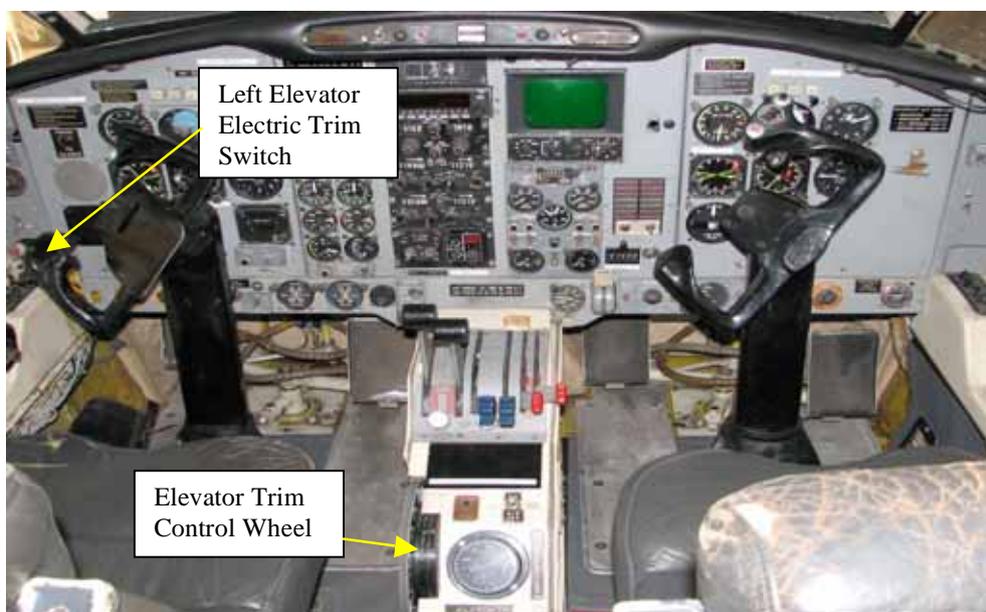
Figure 1: Cockpit Layout

The elevator trim tab could be manually adjusted by rotation of a control wheel on the centre pedestal (Figure 1). The control wheel moved a Teleflex cable, which operated the trim tab. A position indicator adjacent to the control wheel showed the position of the trim tab.

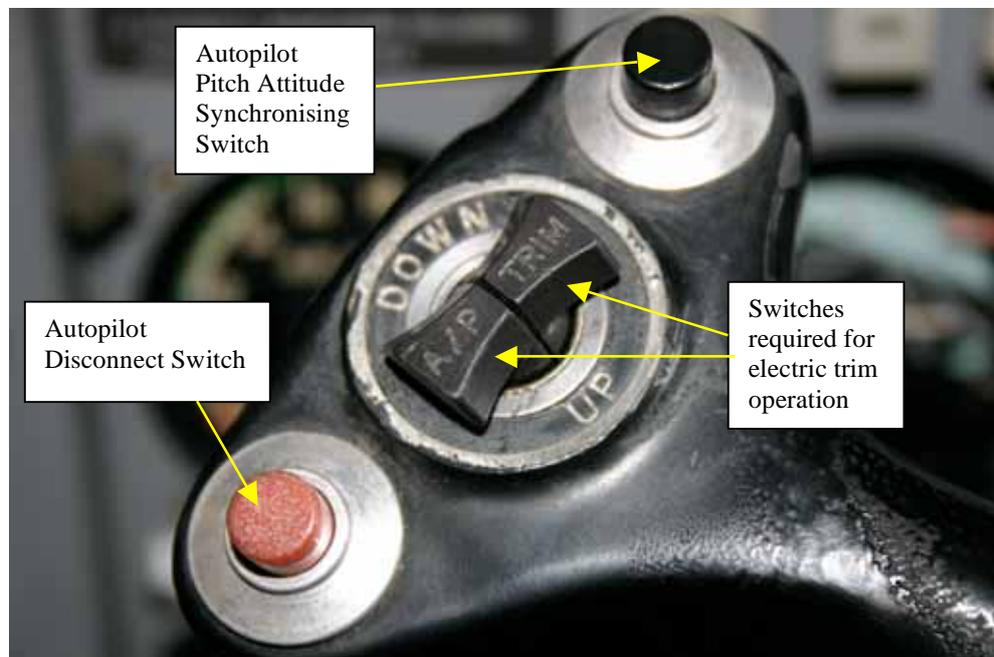
Figure 2: Left yoke switch layout

The trim tab position could also be controlled electrically through simultaneous selection of two yoke⁶-mounted switches, A/P and TRIM (Figure 2). A set of switches were located on the left side of the left yoke and on the right side of the right yoke. Those switches were spring-loaded to the neutral position and had a forward DOWN position and a rear UP position. Selection of both switches provided electrical power via an adaptor box to an elevator trim servo assembly located in the rear fuselage that drove a transmission box, the Teleflex cable, an actuator and the manual trim control wheel in the desired direction. There were no visual or aural warnings to alert a pilot if the switches did not return to the neutral position. The PIC reported that he could not recall activating the electric trim switch immediately prior to the control difficulty.

The left control yoke A/P and TRIM switch was removed and examined. Debris was found inside the switch and a sticky substance was evident between the autopilot switch lever and the elevator trim switch lever. Corrosion was also evident on the pivot bearing of both switch levers and ball roller surfaces. The internal electrical contacts were tested and found to be operational. There was no evidence of electrical arcing in the switch.

The onsite inspection of the left and right yoke AP/TRIM switches confirmed that the right switches returned to the neutral position when operated and released. However, the left switches did not return to the neutral position when operated and released. Accordingly, it is possible that during the high workload phase of takeoff and initial climb, the left trim switches were moved to the nose down position, and being defective, the switch did not return to the neutral position.

- All electric trim systems in company EMB110 aircraft will be removed / deactivated.
- An engineering inspection of the elevator flight control system has been made to ensure no damage to the system has occurred as a result of this incident¹⁰.
