ATSB TRANSPORT SAFETY INVESTIGATION REPORT  
Marine Occurrence Investigation No. 224  
Final

Independent investigation into the collision between the  
Panamanian registered bulk carrier

**Global Peace**

**Tom Tough**

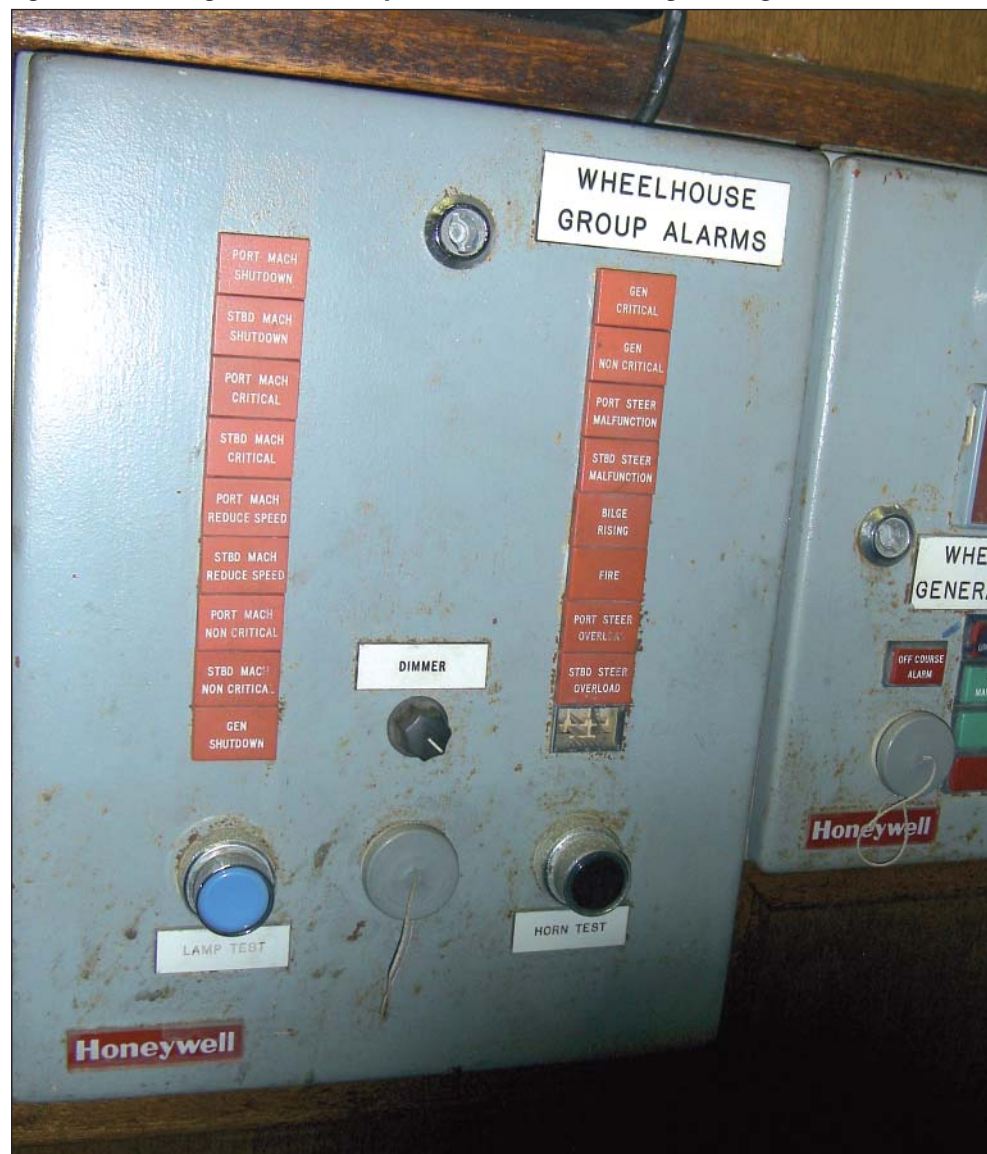
**Figure 7: The engine room alarm panel as fitted on *Tom Tough's* bridge**

The engine room alarm panel is mounted below knee level, to port and behind the tug master's operating position in the wheelhouse. If the alarm sounder and indicator lights had been fitted within the tug master's field of view it is possible that he may have been alerted to the failure earlier. This may have led to an earlier response.

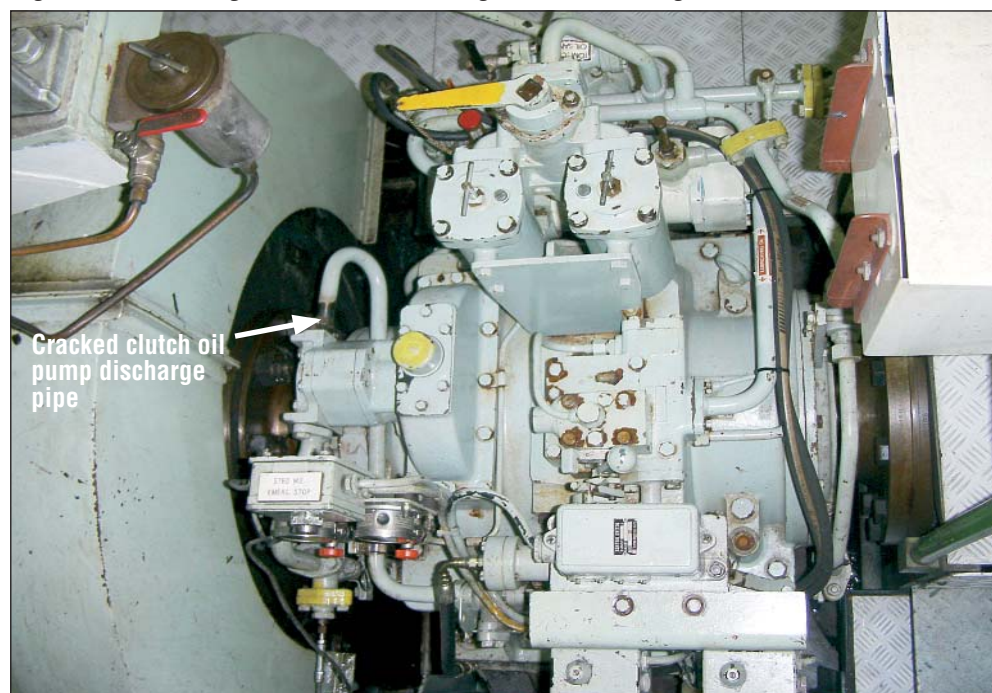
**Figure 10: *Tom Tough*'s Starboard main engine clutch housing**

The engineer accepted the alarms, which cancelled the alarm sounder, then carried out an inspection of the starboard engine. He found a large quantity of oil in the area surrounding the clutch. It was not evident where the oil had come from, but when he checked the clutch sump he found it was empty.

When the clutch sump was full the engineer started the starboard main engine while the IR stood by the clutch housing. Oil immediately started to spray from a crack in the clutch oil pump discharge pipe (Figure 10). The engineer stopped the engine after receiving the signal to do so from the IR.

After the tug returned to its berth *Tom Tough*'s engineer weld-repaired the cracked clutch oil pipe. By about 0417, *Tom Tough* had completed engine trials and VTS was informed that the tug was ready to undertake towage operations.

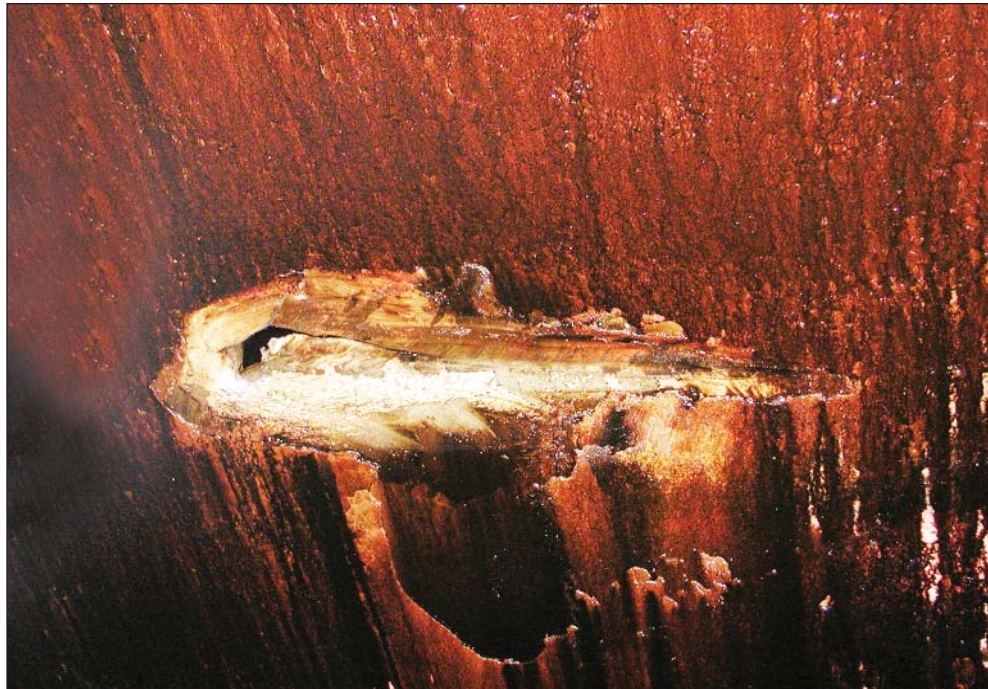
**Figure 11: Damage to *Global Peace*'s hull**

With the tug now in a safe position he de-clutched the port engine and allowed the tug to hang on its tow line. He then switched on the starboard bridge flood light so he could see if the tug had been damaged. He then realised the extent of the collision. He could see a puncture in the ship's side and fuel oil flowing from it.

This resulted in the corroded, and thus already weakened, forward most retaining chain breaking under the strain. The fender was then free to move down, exposing the forward corner of the fender support beam. It was the exposed corner of the support beam that made heavy contact with *Global Peace* and punctured the ship's shell plating.

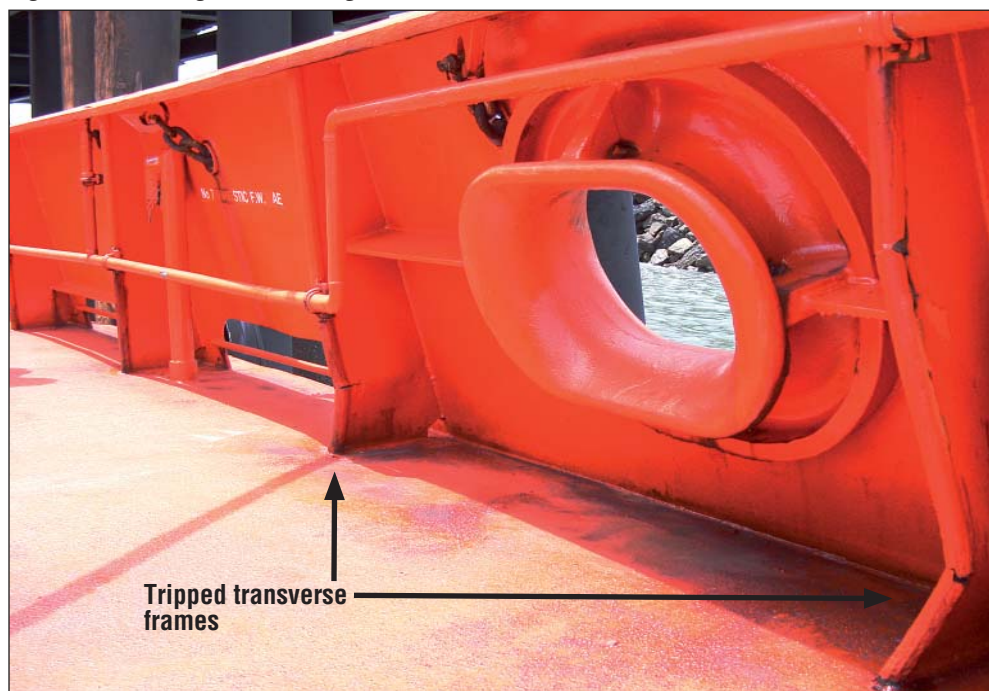
**Figure 12: Damage to *Tom Tough***

The damage sustained by *Tom Tough* in the collision included the tripping of a number of frames supporting the starboard quarter bulwark (Figure 12), deformation of the bulwark just forward of the starboard quarter fender and a broken aft fender retaining chain.

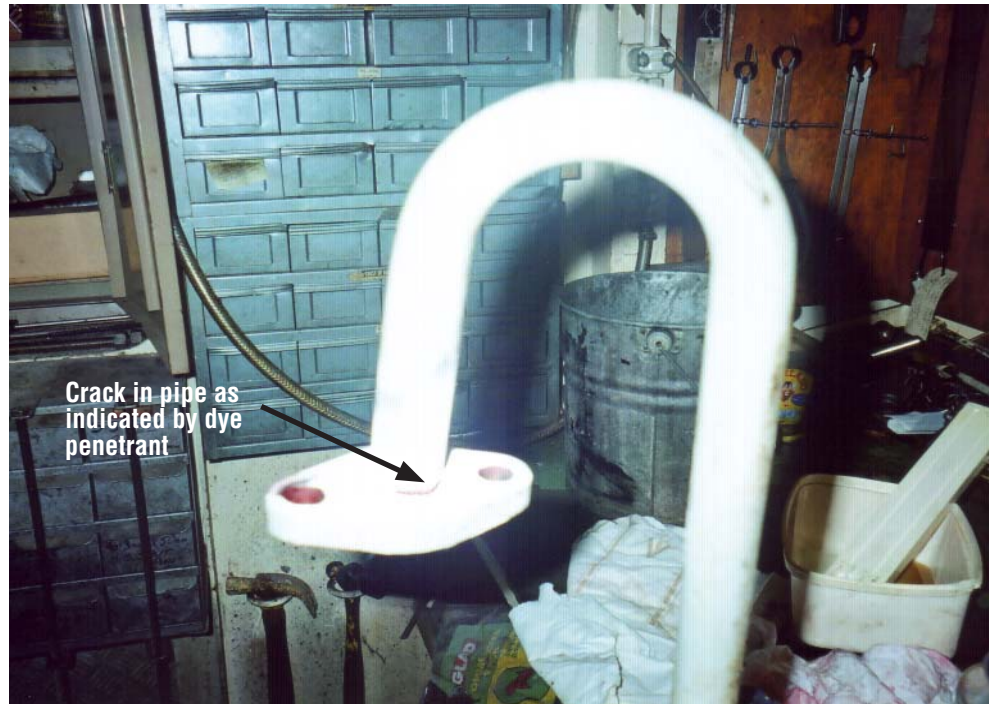
**Figure 13: Cracked clutch oil pump discharge pipe**

Shortly before 2354 on 24 January the starboard main engine clutch oil pump discharge pipe cracked (Figure 13). The leakage of oil from the system through the crack lowered the oil level in the clutch sump. The loss of oil ultimately led to the loss of pump suction and the resultant loss of pump discharge pressure. Eventually the oil discharge pressure dropped to a point where it activated the low clutch oil pressure alarm and then the low clutch oil pressure engine shutdown.

The crack in the clutch oil pump discharge pipe progressed quickly and when repaired was found to measure about one half of the pipe's circumference. This meant that the entire sump, about 50 litres of oil, would have been lost in a relatively short period of time. The crack was in the heat affected zone adjacent to the fillet weld at the pump discharge end of the pipe (Figure 13) and was probably a result of cyclic fatigue. While there are no excessive vibrations in *Tom Tough*'s

engine room, this particular pipe is subject to the pressure pulsations emanating from the clutch oil pump (gear type pump). It is probable that the number of pressure pulses (cycles) that this pipe had been subjected to over its 23 year service life caused the pipe's fatigue and eventual failure.

- The pipe can be subjected to severe vibration if the support clamps are loose.
- The pipe material and fillet welding produce a section which will allow fatigue to initiate and propagate in the region of the toe of the fillet weld.

There had been a failure of the clutch oil pump discharge pipe serving the same purpose on the port main engine in February 2002. The pipe fitted to the port engine had also cracked adjacent to the pump and in an identical way to the starboard pipe failure. At the time, the pipe was temporarily repaired by the tug's engineer and two weeks later a permanent repair was carried out by a Gladstone based engineering firm.

1. An email was sent to all fleet managers reporting the failure of the clutch lubricating oil pipe on *Tom Tough* and requiring that immediate steps be taken to inspect all similar pipes for signs of similar failure or previous repairs and report back to the national fleet and operations manager.

2. The School of Mechanical Engineering at the University of Adelaide was commissioned to investigate and report on the causes of the clutch oil pipe failure and to suggest any changes to the design and construction that might address such causes.

3. The decision has been made to replace both port and starboard pipes on board *Tom Tough* and all vessels fitted with the same model of clutch with the new modified pipe design.

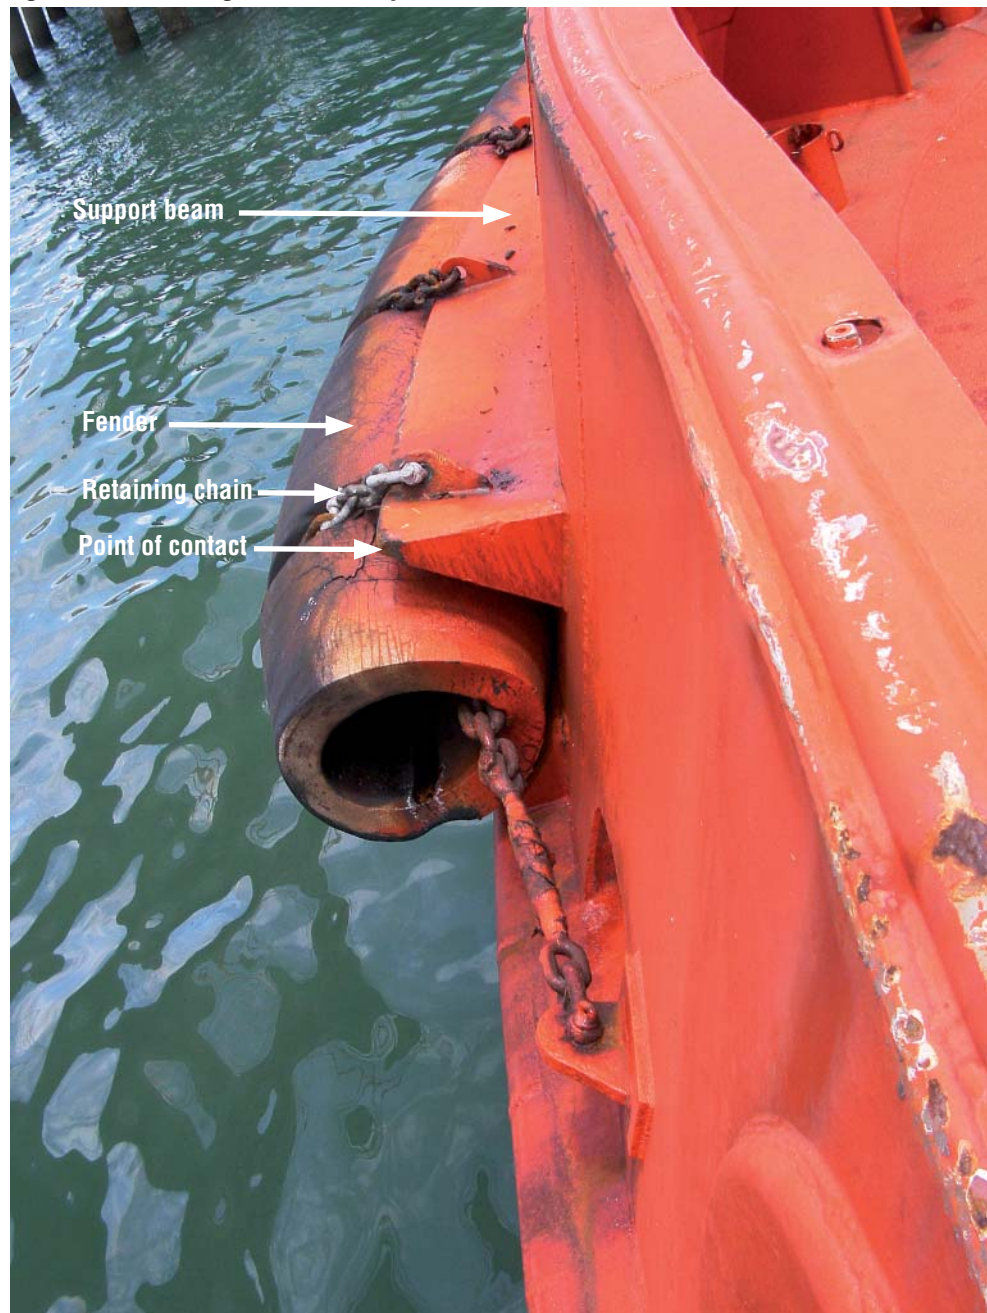
**Figure 14: Tom Tough's starboard quarter fender**

The design of the fender retaining beam was deficient. The exposed end of the beam was finished with a square, almost sharp, corner (Figure 14). There is no reason for the exposed corner to be the shape that it was. If the end of the beam had been rounded it would not have diminished the functionality of the beam, but it may have reduced the damage that resulted from the collision.
