# Collision Between Freight Train 6PM9 and a Track Mounted Excavator

## Summary

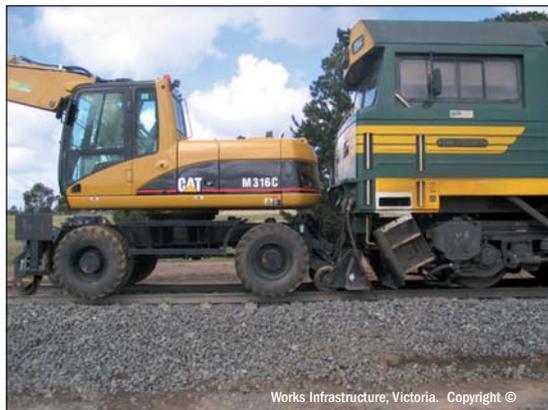
Figure 1: The collision

At about 1005<sup>1</sup> on Monday 25 September 2006 a Melbourne bound freight train, 6PM9, travelling from Perth to Melbourne, collided with a track mounted excavator conducting track-work near Inverleigh, Victoria. There were no injuries and only minor damage to both the train and the excavator as a result of the collision.

At about 1005 the leading locomotive of the train collided with the rear end of the excavator at a speed of 26 km/h. There were no injuries to either the train crew or the track maintenance workers. There was minor damage to the front cowling on the train's leading locomotive but it was able to resume the journey to Melbourne after minor repairs. The track excavator was also damaged and could not be used until repaired.

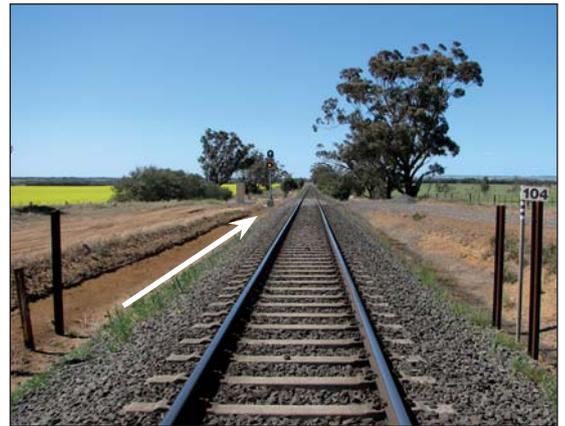
Figure 2: Looking from the 104 km post in direction of travel towards the worksite

In the section between the 104 km and 101 km posts the track is straight with a descending 1:100 grade, the maximum track speed is 115 km/h.

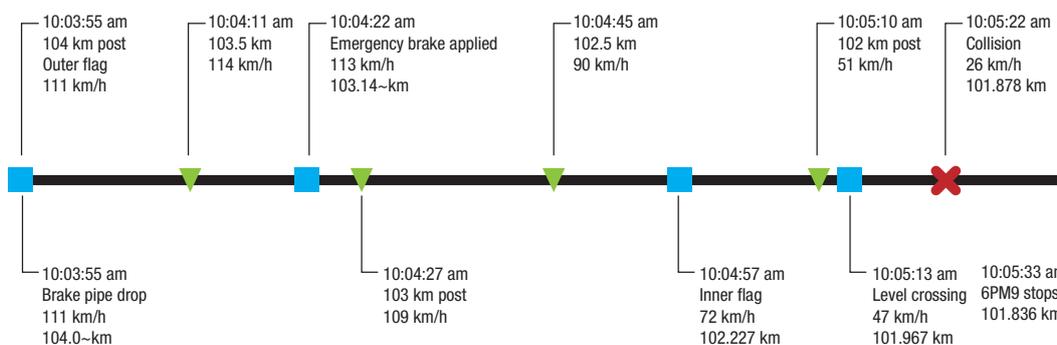
Figure 3: Key events from data logger in locomotive V544

Based on the data logger from locomotive V544 (data summarised in Figure 3) train 6PM9 passed the outer flag person (104 km post) at 1003:55 travelling at 111 km/h. At about that time the brake pipe pressure started to reduce from running pressure.

Twenty seven seconds after this reduction (1004:22) an emergency brake application was made.

From this point the brake pipe exhausted rapidly and the train speed steadily decreased. The train passed the inner flag person's position at 1004:57 at 72 km/h, collided with the track mounted excavator at 1005:22 at 26 km/h and came to a stop at 1005:33. The data logger indicated that dynamic braking was not used. It should be noted that there is a slight time delay between the time the driver makes a brake application and when the brakes respond (and when it is recorded on the data logger).

Pacific National review train handling practices and/or procedures to ensure drivers are prepared to stop in all circumstances when approaching anticipated track works.

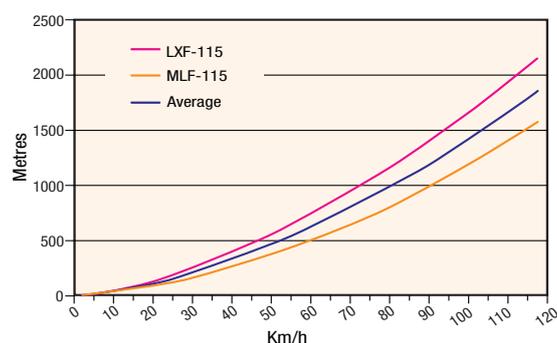
Figure 4: Freight train stopping distances (full service braking)

The graph shows a braking curve for a long express freight train weighing 3480 t (LXF - 115) and a medium freight train weighing 1500 t (MLF - 115). The average line closely represents train 6PM9 weighing 2255 t. Based on the graph, if travelling at 115 km/h train 6PM9 would have needed about 1800 m to stop on level track. On a 1 per cent downhill grade, it would have needed about 2800 m to stop.

Given the required braking distance of about 2800 m, the outer flag person was not positioned far enough away from the work site given the speed of the anticipated train traffic approaching on the descending gradient. The track speed of 115 km/h meant that the drivers of heavy trains would have real difficulty stopping their trains before the site if they were reliant on sighting and responding to the outer flag person alone. In these circumstances, there was an unacceptably high risk of a collision.

The ARTC should review their policies and/or procedures to ensure that factors such as the type and speed of train traffic and the gradient of the line are adequately considered when placing outer flag persons to protect track-work sites.
