ATSB TRANSPORT SAFETY INVESTIGATION REPORT
Rail Occurrence Investigation 2006013
Final

Collision between
**freight train 9351 and an
overturned semi-trailer**

at Illabo, New South Wales

2 November 2006

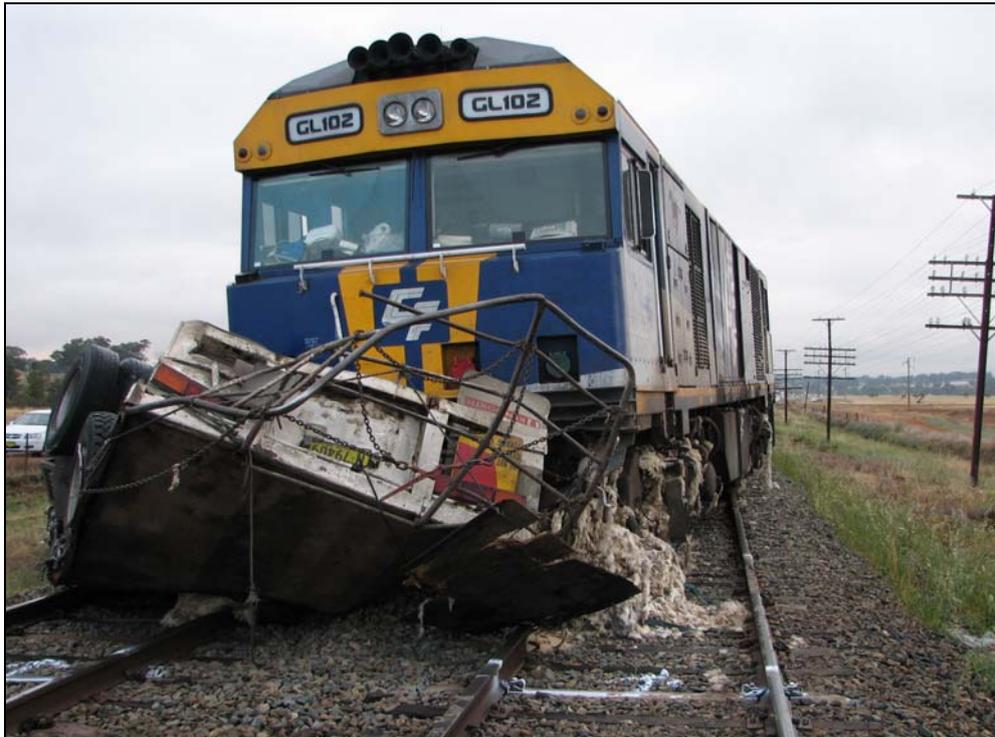
Figure 1: Locomotive GL102

At about 2324:35 on Thursday 2 November 2006 , freight train 9351, travelling at about 94 km/h, collided with an overturned semi-trailer on the Olympic Highway level crossing at Illabo, New South Wales (NSW). The leading bogie on leading locomotive, GL102, derailed as a result of the collision, shown in Figure 1.

The train also received moderate damage to the leading locomotive's front cowling and leading bogie but was able to resume its journey at reduced speed after minor repairs. The truck's prime mover received minor damage but the trailer was destroyed. The baled wool loaded on the truck was scattered by the impact, shown in Figure 2. There were no serious injuries but the train crew were treated for minor injuries. Coincidentally, this train journey was the last for GrainCorp due to the drought conditions.

There was moderate damage to the leading locomotive GL102 of train 9351. The locomotive was able to continue the journey once re-railed and initial repairs were made.

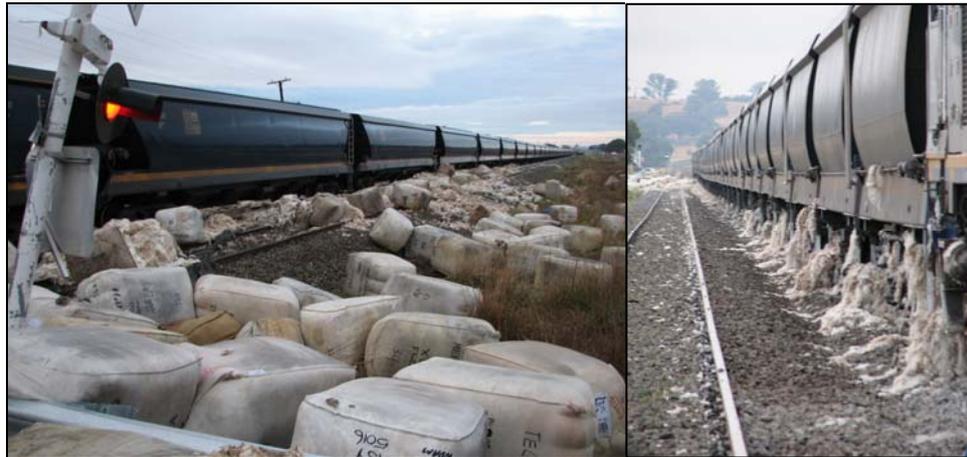
Figure 2: Some of the aftermath of the collision

There was significant damage to the level crossing signals, signage, and auxiliary trackside equipment.

There was moderate damage to the truck's prime mover but the trailer was extensively damaged.

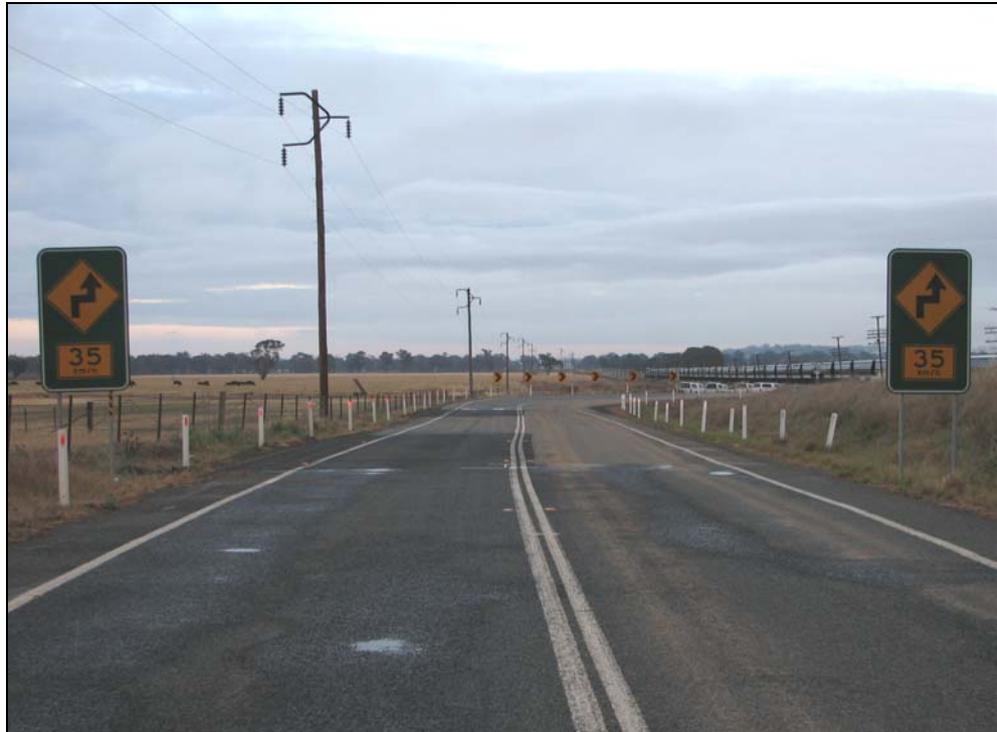
Figure 4: Approach to the level crossing

Figure 4 shows the approach to the Olympic Highway level crossing where the semi-trailer overturned. Note the advisory speed limit sign of 35km/h.

Given the inclement weather conditions, it is likely that the truck driver was driving too fast to safely negotiate the curve approaching the level crossing, or the load shifted, resulting in a loss of control of the truck and it subsequently overturned on the level crossing obstructing both railway lines. The truck did not have an on-board data recorder that could be used to provide information regarding its speed, nor was there evidence of failed or inadequate securing of the load.

Based on accident history which identifies excess speed as a significant factor in a number of incidents involving road vehicles it is suggested that a review of signage size, type, placement and applicability to the road's physical characteristics becomes a Safety Recommendation on the Road Authority responsible for Olympic Highway.
