Fatal Level Crossing Collision – Virginia, SA

16 November 2007

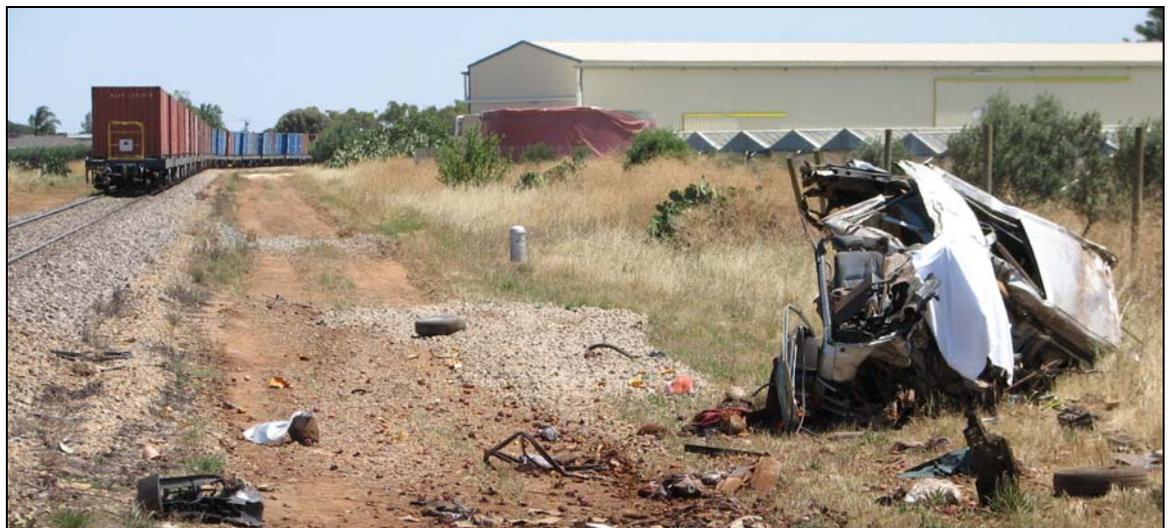
Figure 1: Moloney Road, looking north-west. View of van (foreground) and train 6117

At approximately 0935¹ on 16 November 2007 a small passenger van drove into the path of a Patrick Portlink freight train (6117) at the Moloney Road passive level crossing (Figure 1) near Virginia in SA. As a result of the collision, the two occupants in the van were fatally injured. The locomotive crew were shaken but not hurt. The train sustained minor damage but the van was destroyed.

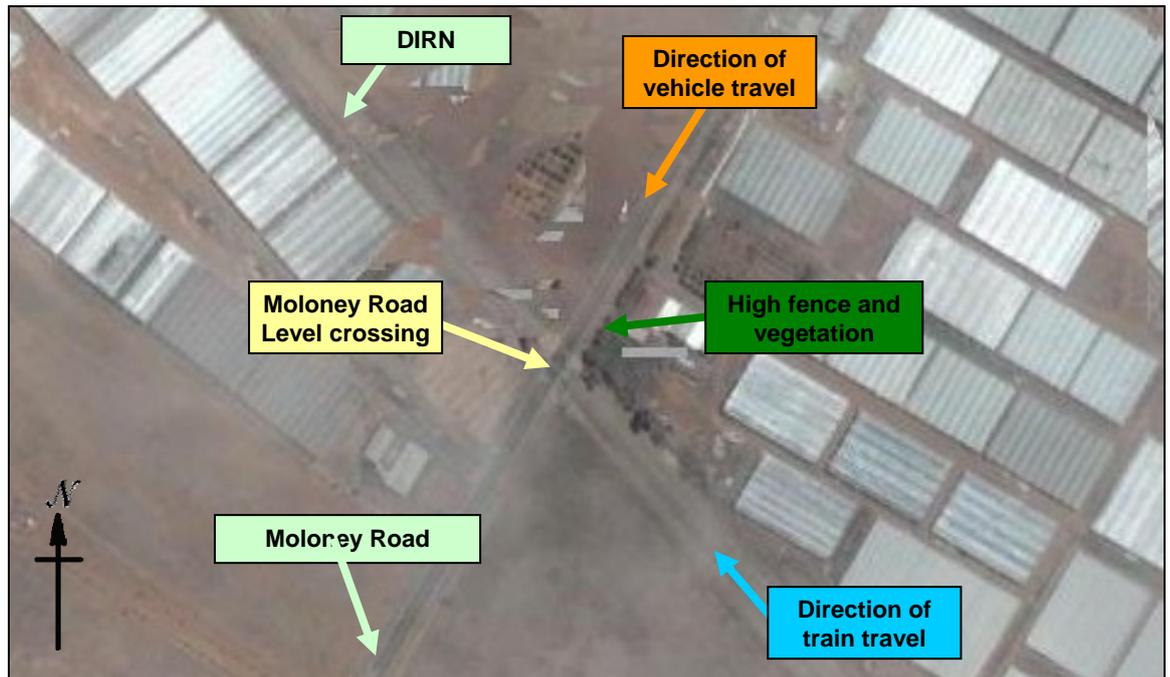
Figure 2: Aerial view of Moloney Road level crossing, Virginia SA

was travelling before the collision) the sighting of the rail line to the south-east (the direction from which the train was approaching the crossing) was obstructed by a high galvanised iron fence and vegetation. The sighting along the rail line remained obstructed for a road vehicle approaching the crossing from this direction until it was about 12.6 m from the crossing and adjacent to the 'railway crossing width marker assembly' (RX-9), see Figure 3. Visibility then improved to be in excess of 1000 m at the stop line at the crossing.

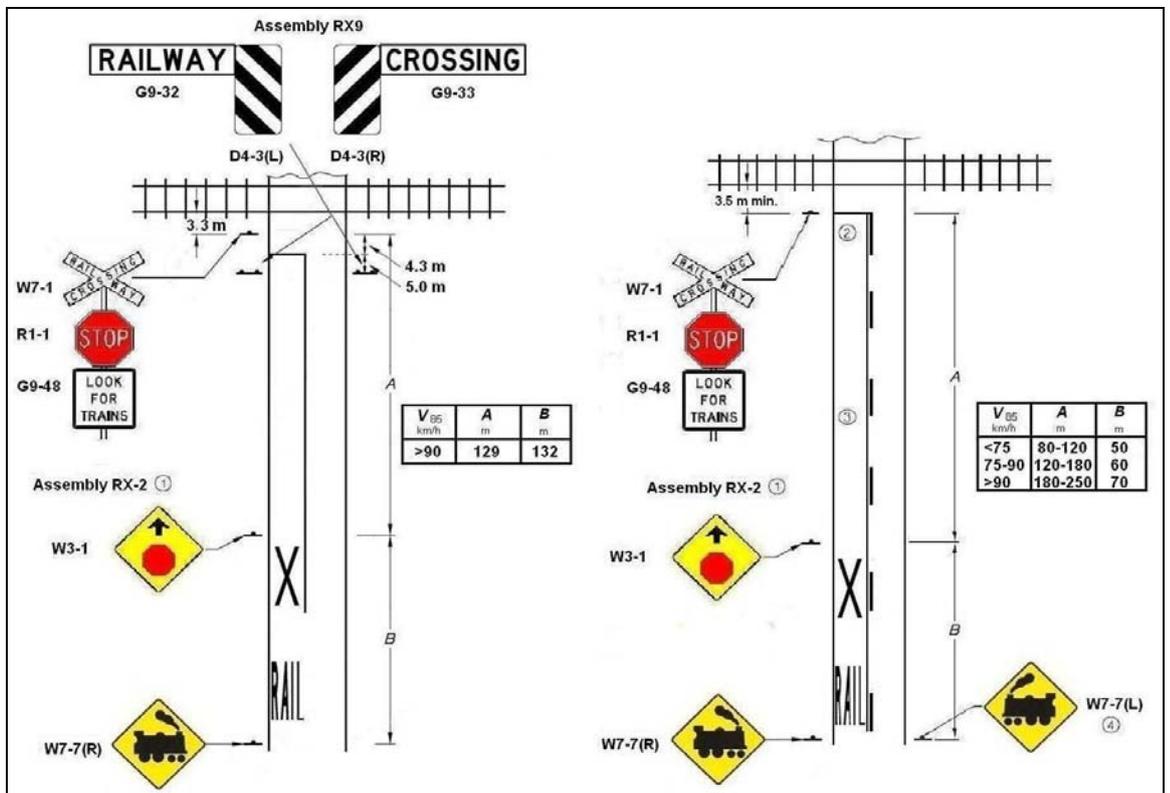
Moloney Road level crossing was required to comply with this standard. An examination of the signage (Figure 3) when approaching from the north-east (direction of road vehicle travel, see Figure 5) established that it was generally in compliance with the requirements of the

Figure 3: Signage at Moloney Rd level crossing. Assembly RX-9 is optional

Figure 4: Signage prescribed in AS1742.7 with W7-7(L) being optional

standard (Figure 4). There were some minor non-conformances described hereunder, however, these were unlikely to have been factors that contributed to the collision:

- The distance of the RX-2 assembly from the closest rail was 3.3 m. The standard specifies a minimum distance of 3.5 m.
- The stop line was set back from the RX-2 assembly by 4.3 m.
- The standard specifies that the stop line and RX-2 assembly should be adjacent to one another⁶. However, the location of the stop line was unlikely to have been a factor in the collision but closing the distance between the RX-2 assembly and stop line can, under certain circumstances, improve sighting along the track.
- The distance between the 'Railway level crossing ahead' signs W7-7 (R) and the 'Stop Sign Ahead' sign W3-1 was 60 m in excess of that specified in the standard.
- The distance between the 'Stop Sign Ahead' sign W3-1 and the RX-2 assembly was 50 m closer than that specified in the standard.

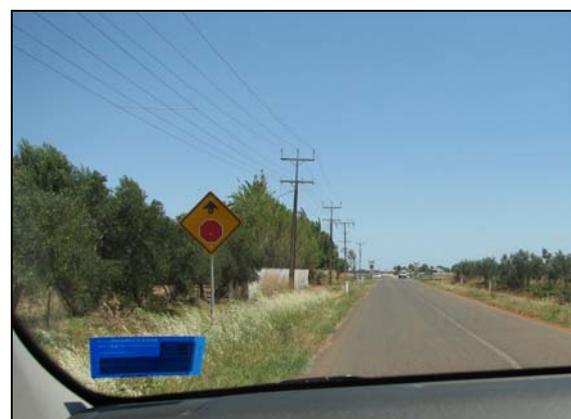
Figure 5: Motorist's view of Moloney Road level crossing, travelling in a south-westerly direction (direction of vehicle travel)

When driving along Moloney Road in a south-westerly direction and with a train coming from the south-east, the train is completely obscured by the high galvanised iron fence and vegetation. It is therefore essential for a motorist come to a stop at the level crossing if they are to be able to adequately sight and respond to an approaching train.

at the 'Stop' sign/line as required the driver would have been able to clearly see the train.
