ATSB TRANSPORT SAFETY INVESTIGATION REPORT

Aviation Occurrence Investigation Report – 200601509

**Collision with Terrain
55 km South-west of Narrandera, NSW
Cessna 188B Agwagon, VH-ZIP
26 March 2006**

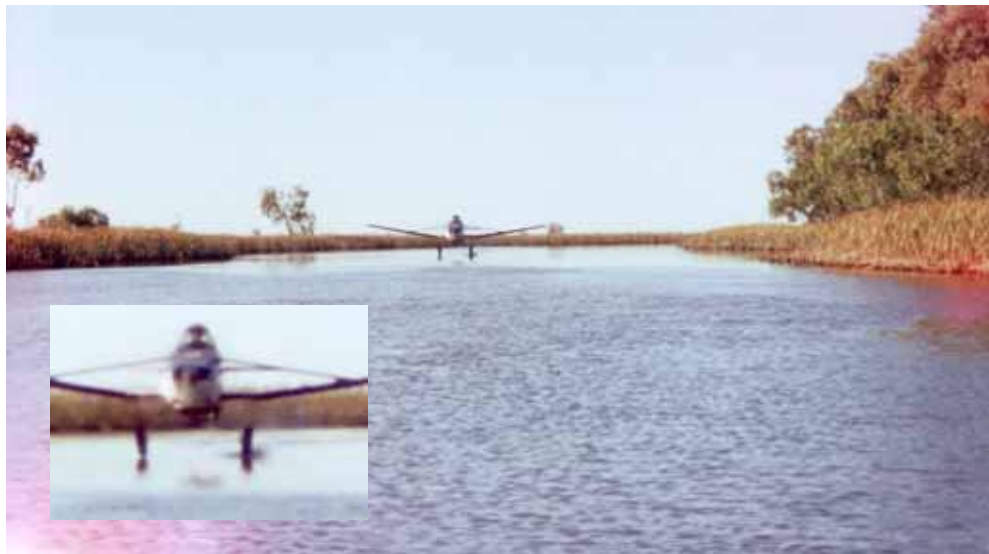
Figure 2: VH-ZIP at water-ski area

The pilot's camera was recovered from the aircraft wreckage in a severely damaged condition. However, the investigation was able to successfully recover the film. The film was torn and some light damage was evident, however a number of images were usable, including some depicting the pilot conducting a number of low passes along the river and contacting the surface of the water with the aircraft's main wheels (Figure 2). The person who took the photographs at the water-ski site reported that three exposures remained when he handed the camera back to the pilot prior to the final flight. There was evidence on the recovered film that at least two exposures had been taken inside the aircraft during the final flight. Due to the damage to the film, the exact nature of those photographs could not be determined.

Note: Left main wheel contacting water surface (inset)

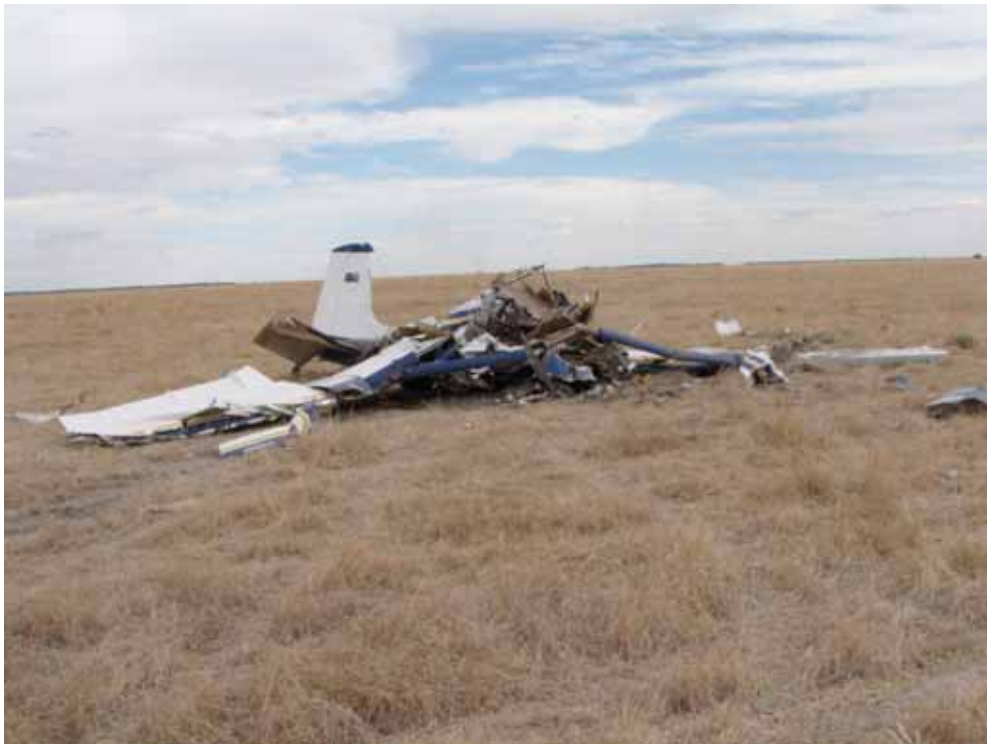
Figure 3: Accident site

Examination of the aircraft wreckage indicated that it had impacted the ground heavily, in a nose-down, right wing-low attitude (Figure 3). All components of the aircraft were accounted for at the accident site and the aircraft was not fitted with an

emergency locator transmitter. There was no evidence of a flight control or systems problem which could have contributed to the accident.

Due to the rupture of the fuel tanks on impact, the amount of fuel on board could not be established. However, an examination of the engine and propeller indicated that they were producing power at the time of impact. Additionally, the pilot had remarked to a person at the water-ski site that he had enough fuel on board to return to the landing area at the family property.
